PHOTO DOCUMENTATION

Appendix no. 2
to the Final Report on implementation of measures determined in EMP
for the Contract 3A.3

Odra-Vistula Flood Management Project

| Contract Task | 3A.3 Section 4 – The right embankment of the Vistula River from the estuary of Skawinka to the Kościuszko Barrage |

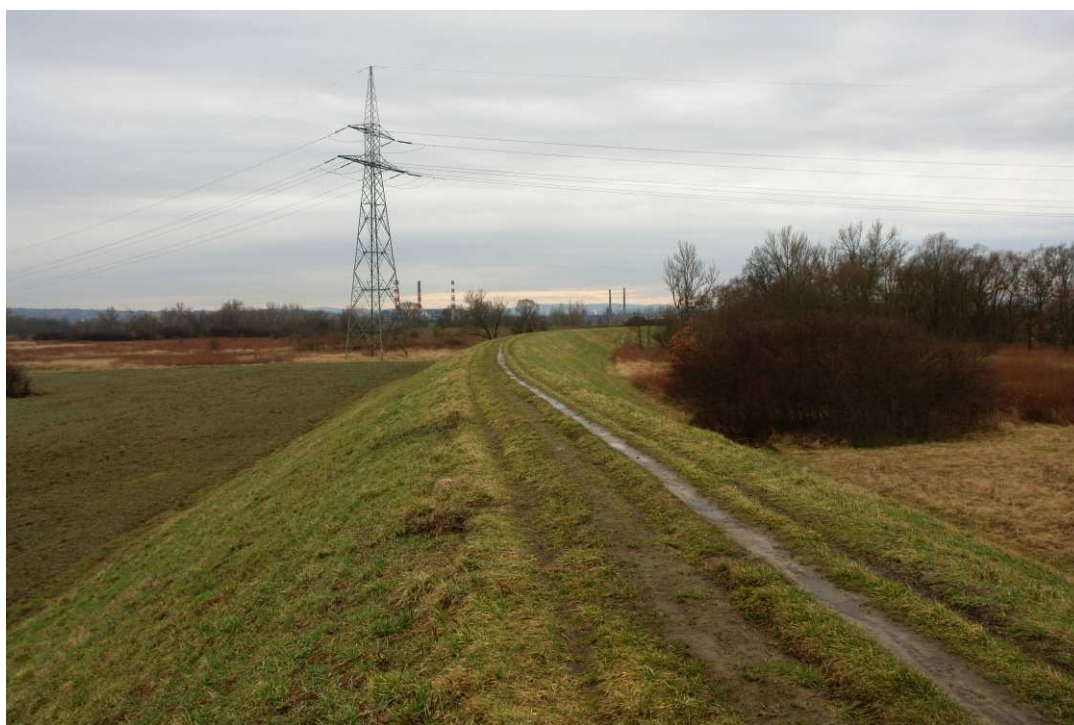
Fig. 1. Site condition in the first month of the works implementation period – the right Vistula embankment within *Task 1*, status in the third decade of February 2020 (upstream view).

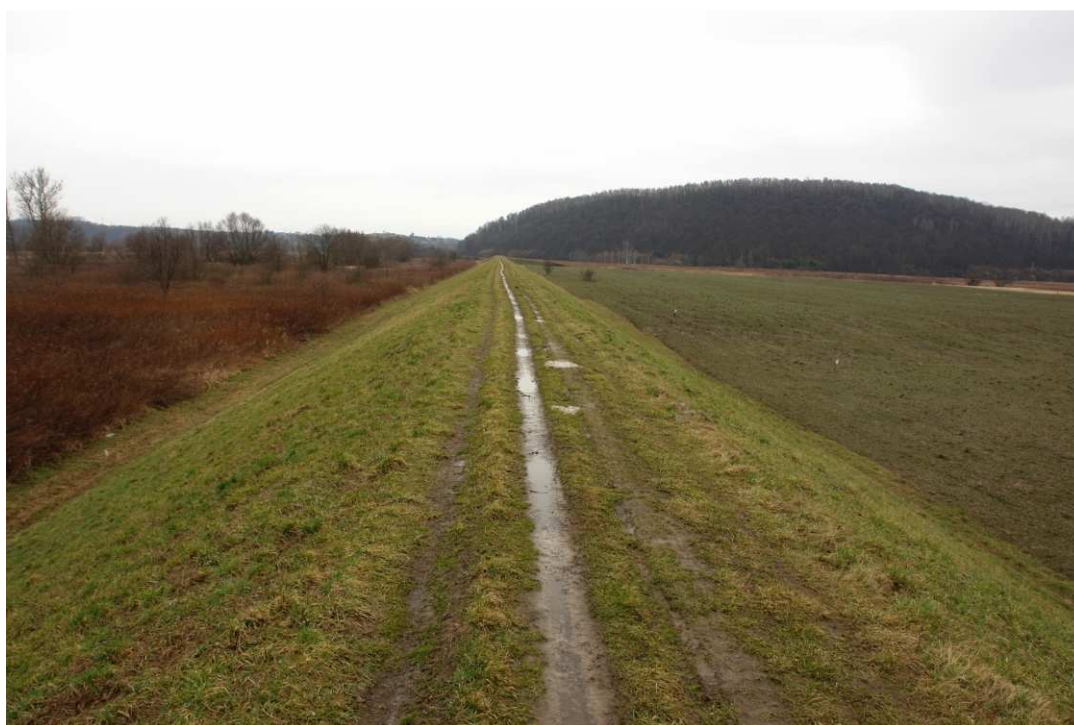
Fig. 2. Site condition in the first month of the works implementation period – the right Vistula embankment within *Task 1*, status in the third decade of February 2020 (downstream view).

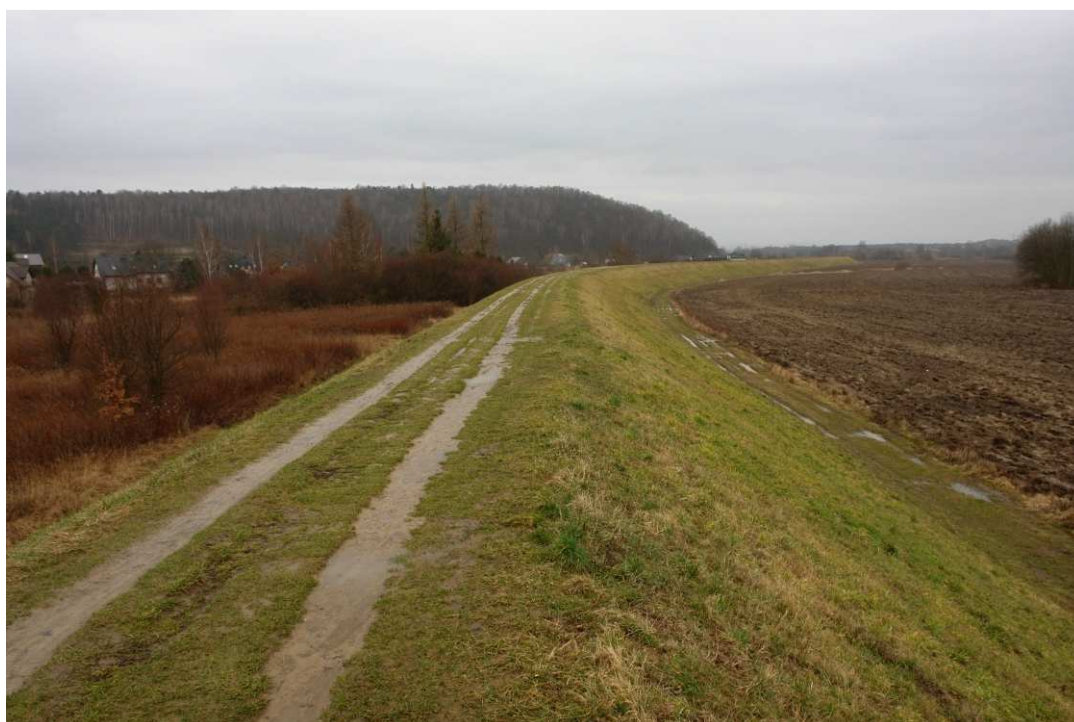
Fig. 3. Site condition in the first month of the works implementation period – the right Vistula embankment within *Task 2*, status in the third decade of February 2020 (upstream view).

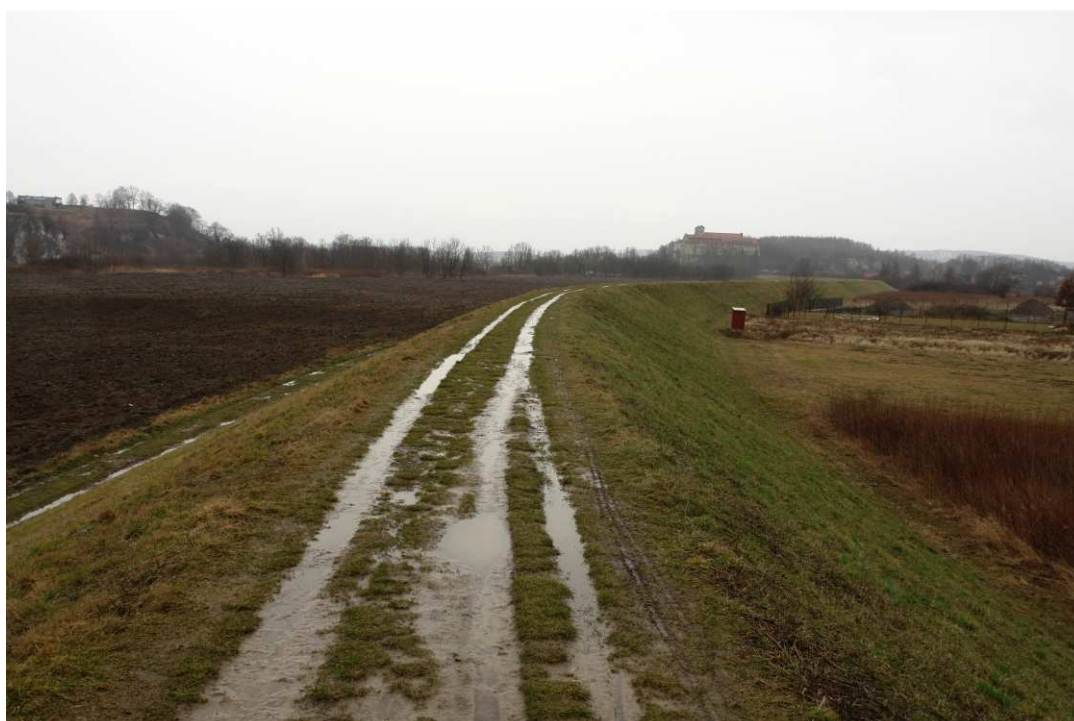
Fig. 4. Site condition in the first month of the works implementation period – the right Vistula embankment within *Task 2*, status in the third decade of February 2020 (downstream view).

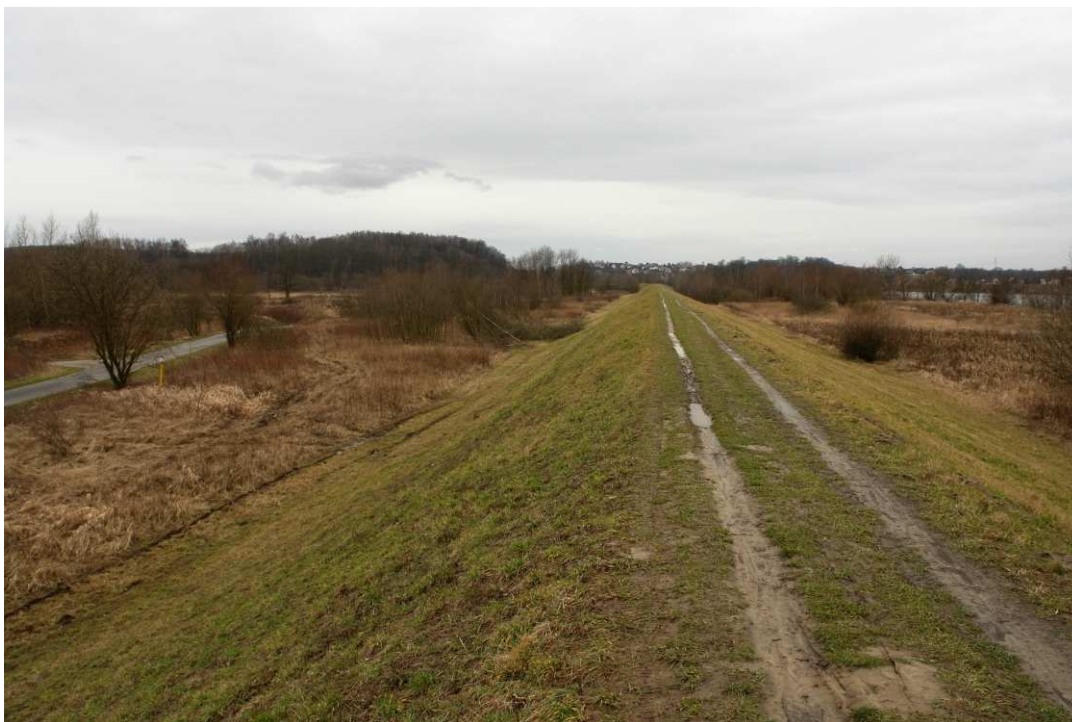
Fig. 5. Site condition in the first month of the works implementation period – the right Vistula embankment within *Task 3*, status in the third decade of February 2020 (upstream view).

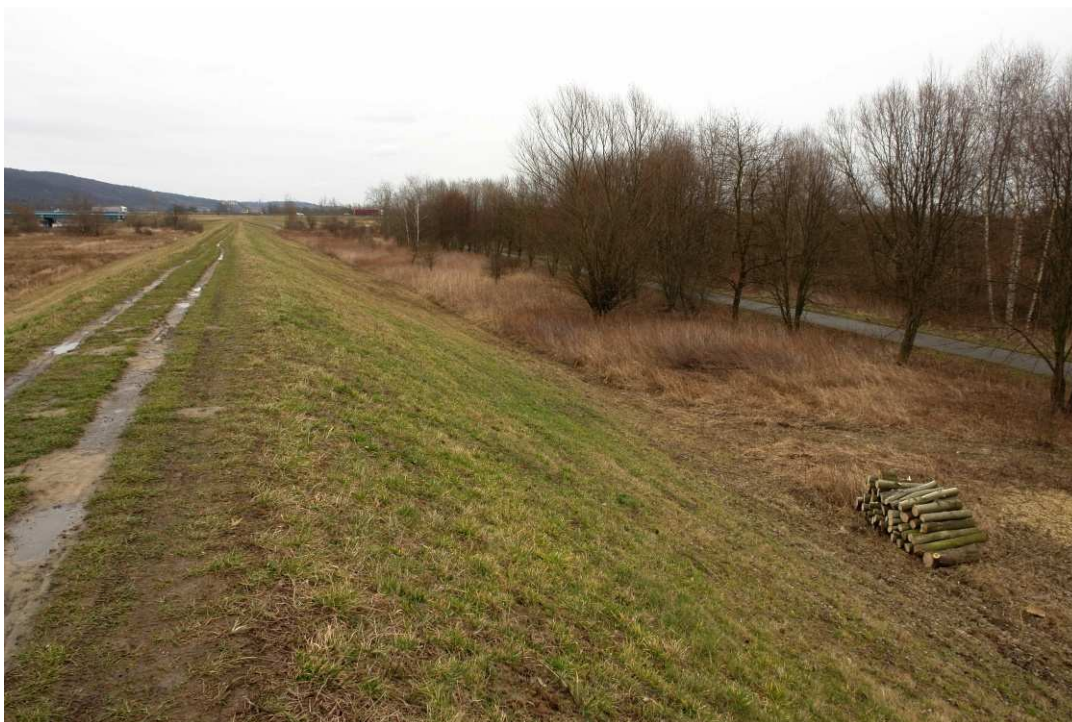
Fig. 6. Site condition in the first month of the works implementation period – the right Vistula embankment within *Task 3*, status in the third decade of February 2020 (downstream view).

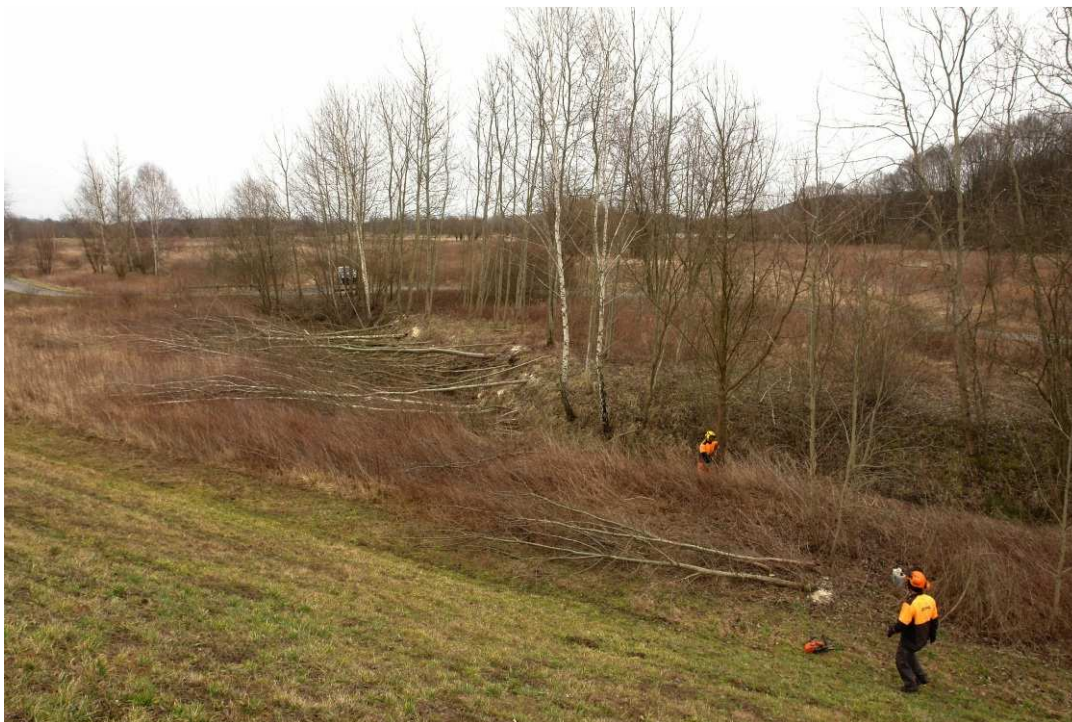
Fig. 7. Tree felling within *Task 3*,
status in the third decade of February 2020
(view towards the area beyond the embankment).

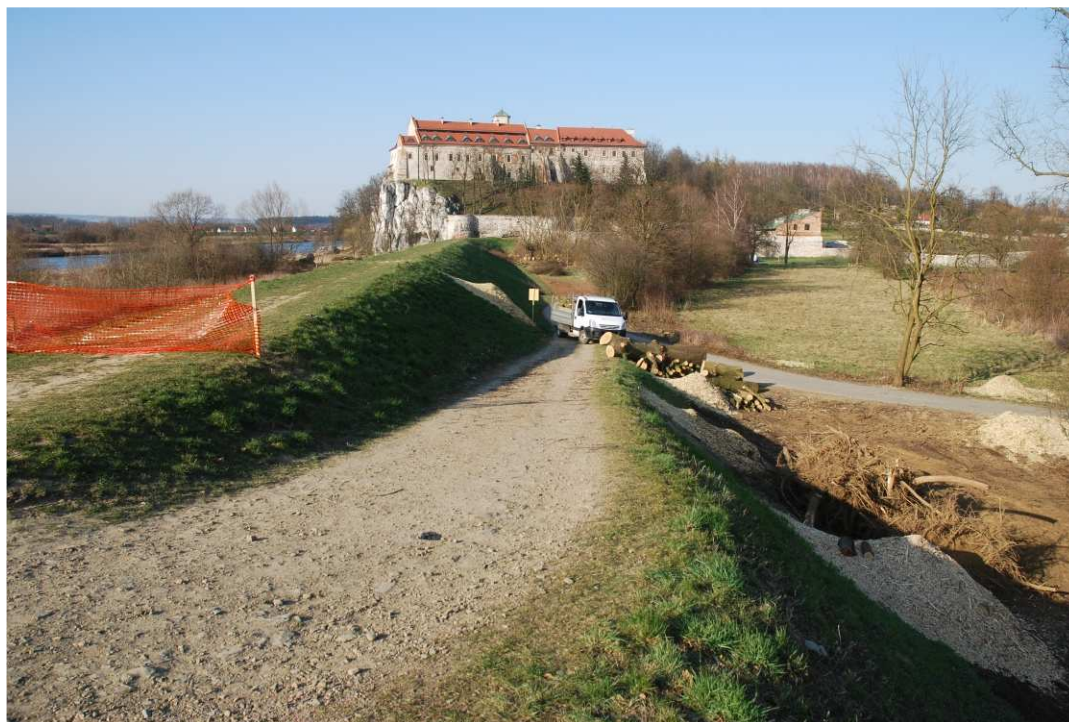
Fig. 8. Cleaning up after felling trees within *Task 2*,
status in the third decade of March 2020 (downstream view).

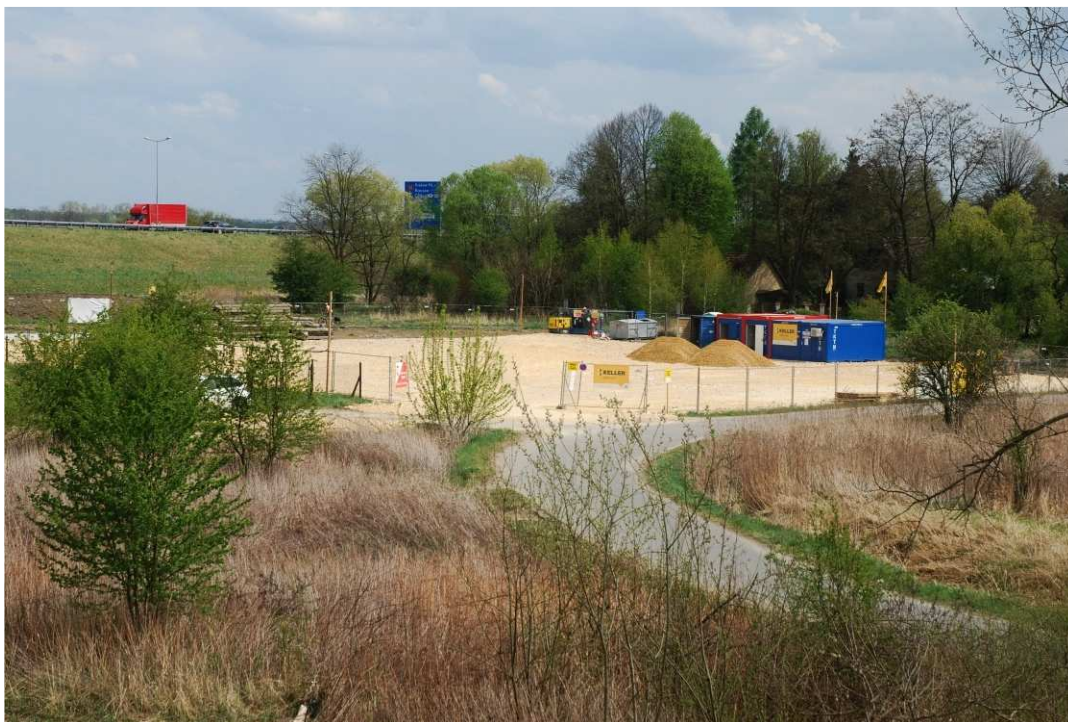
Fig. 9. Site facilities in the area beyond the right Vistula embankment at the height of *Task 3*, status in the third decade of April 2020 (view towards the south-east).

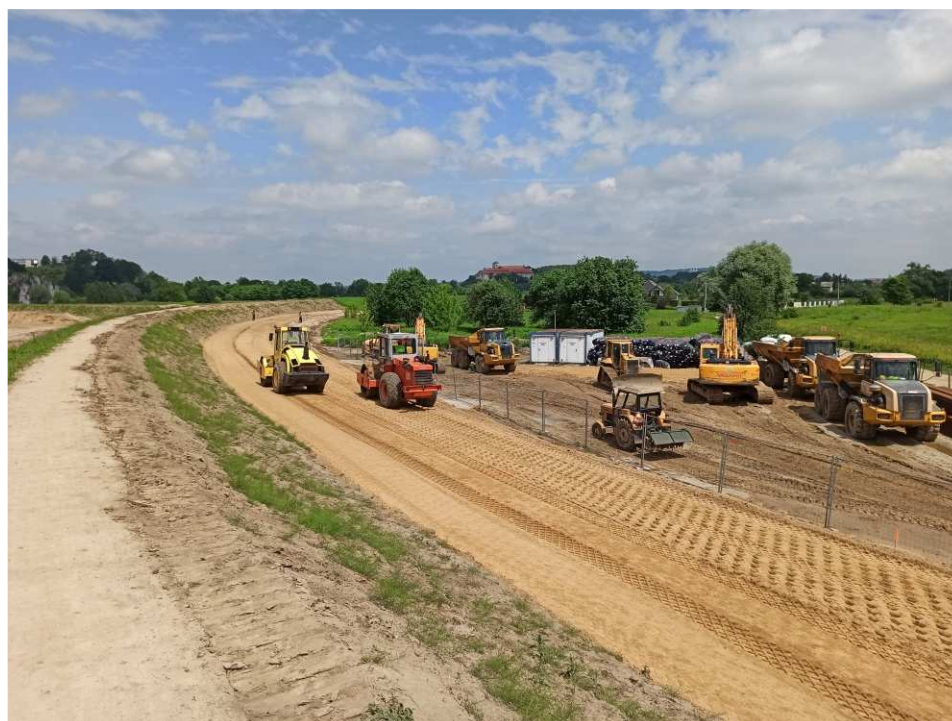
Fig. 10. Site facilities in the area beyond the right Vistula embankment at the height of *Task 2*, status in the third decade of June 2020 (downstream view).

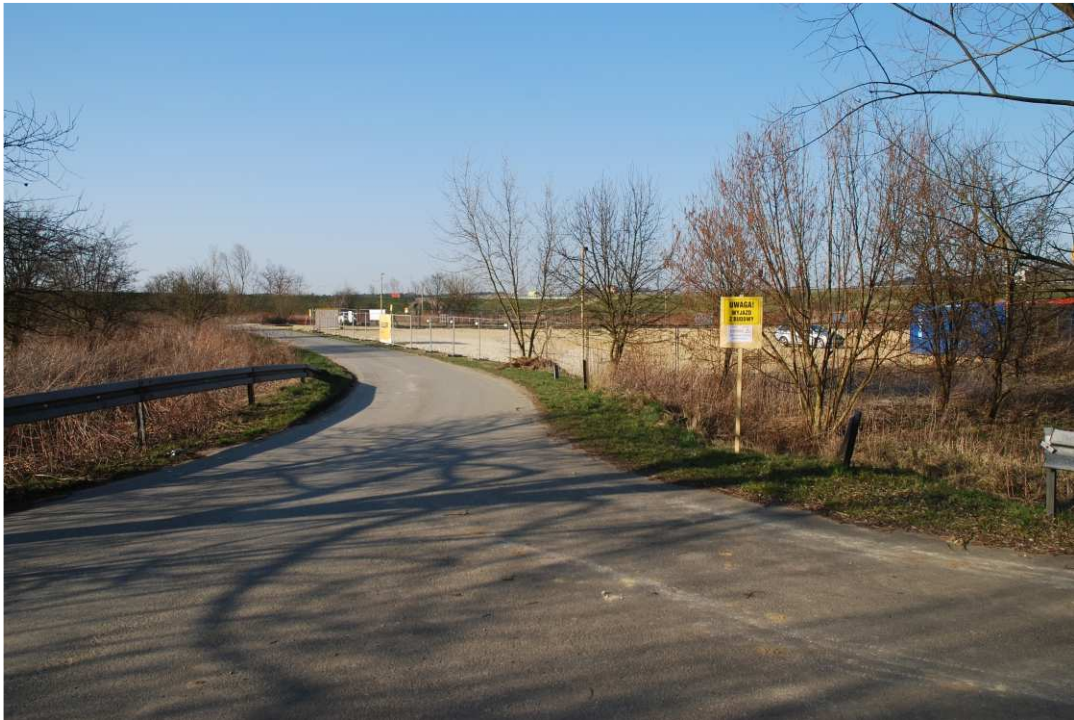
Fig. 11. Marking of the public road near the exit from the site facilities within *Task 3*, status in the third decade of March 2020 (view towards the north).

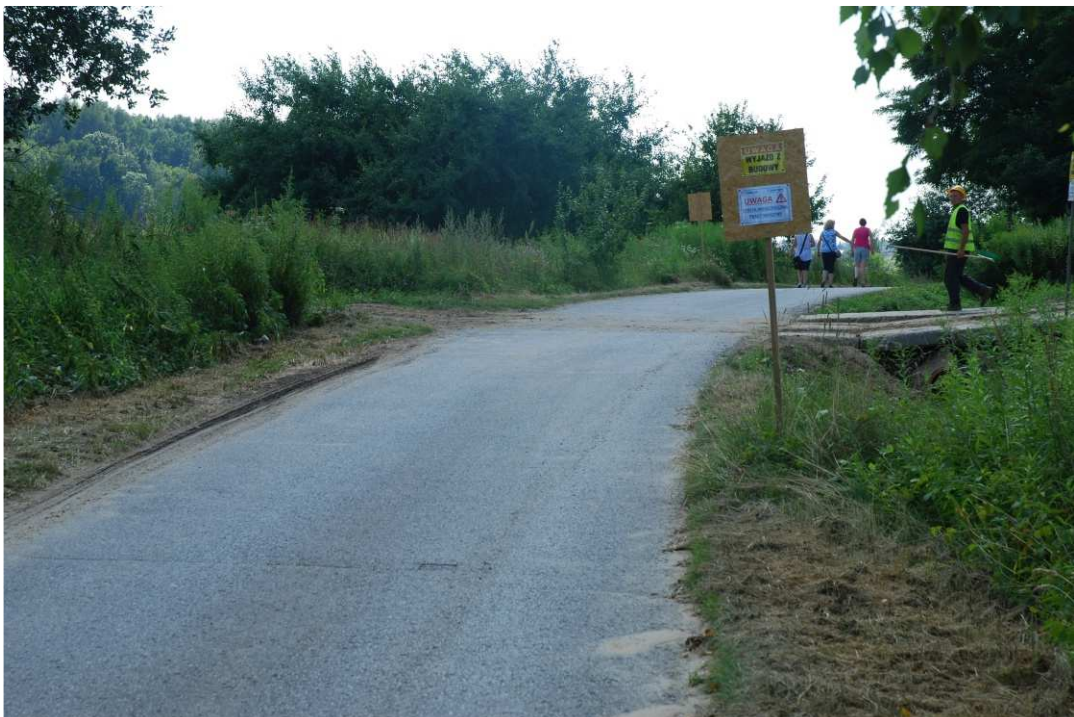
Fig. 12. Marking and keeping the public road clean near the exit from the construction site within *Task 3*, status in the third decade of July 2020 (upstream view).

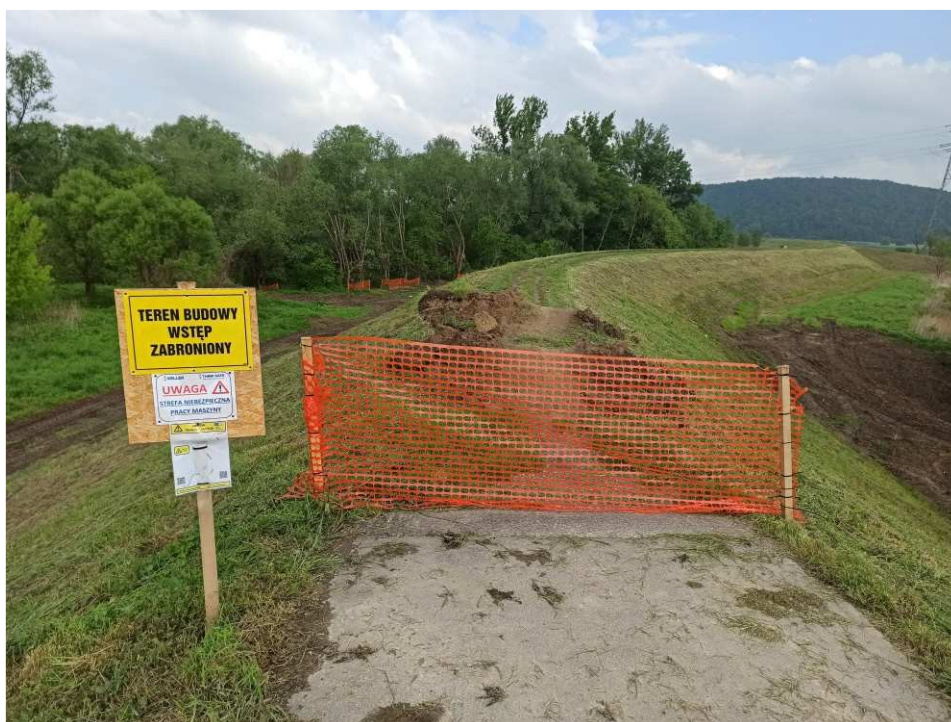
Fig. 13. Marking of the construction site within *Task 1*, status in the third decade of May 2020 (downstream view).

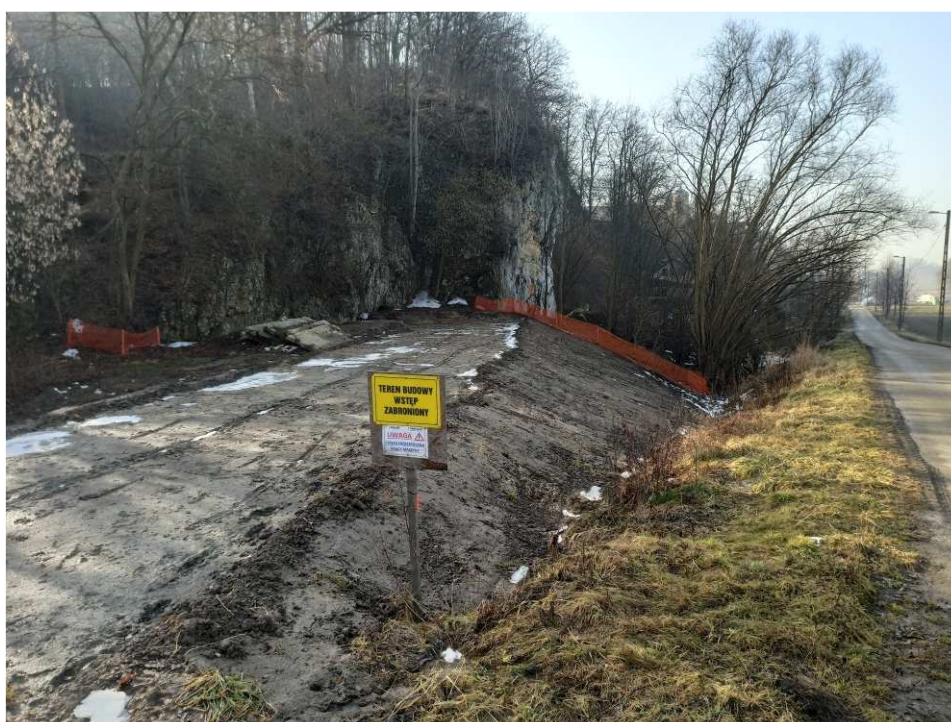
Fig. 14. Marking of the construction site within *Task 3*, status in the third decade of February 2021 (upstream view).

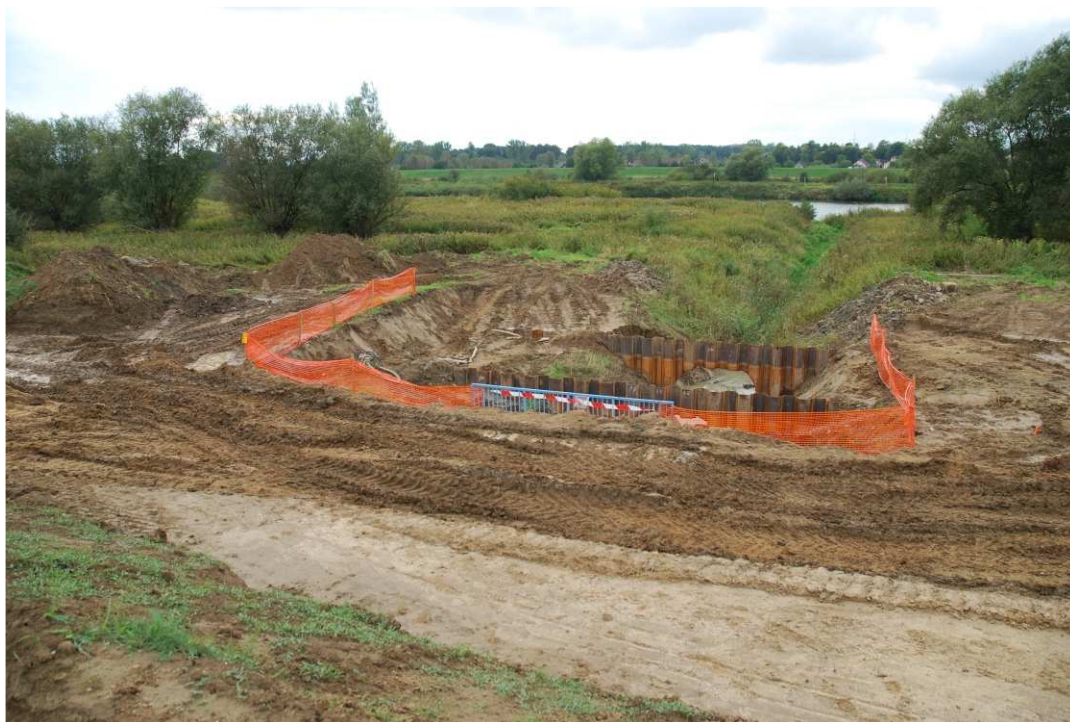
Fig. 15. Protection of hazardous sites within *Task 1*,
status in the third decade of September 2020 (view towards the embanked area).

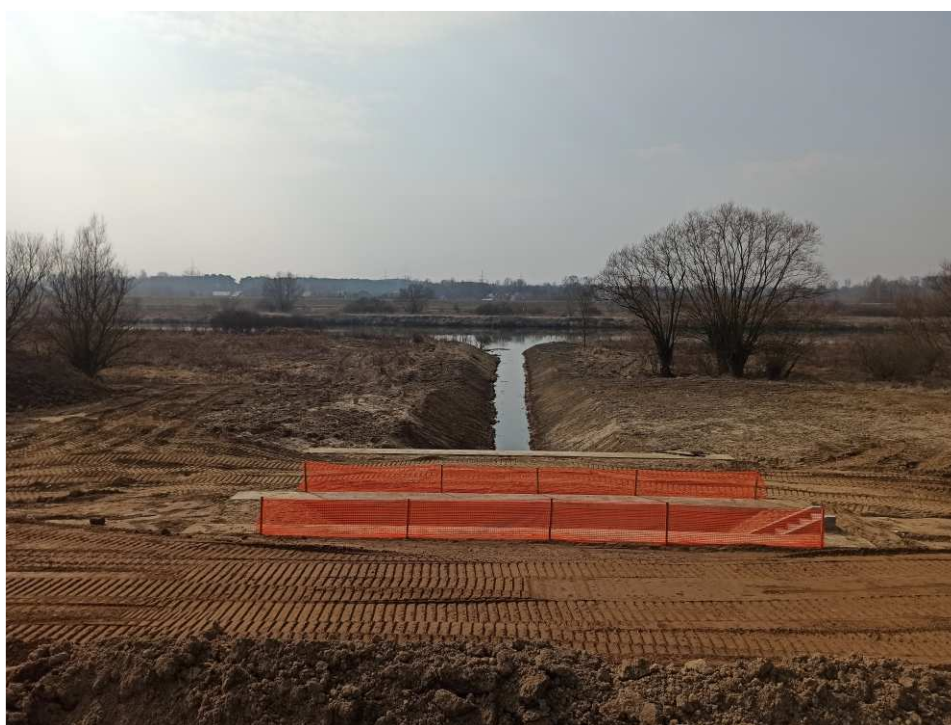
Fig. 16. Protection of hazardous sites within *Task 1*,
status in the third decade of March 2021 (view towards the embanked area).

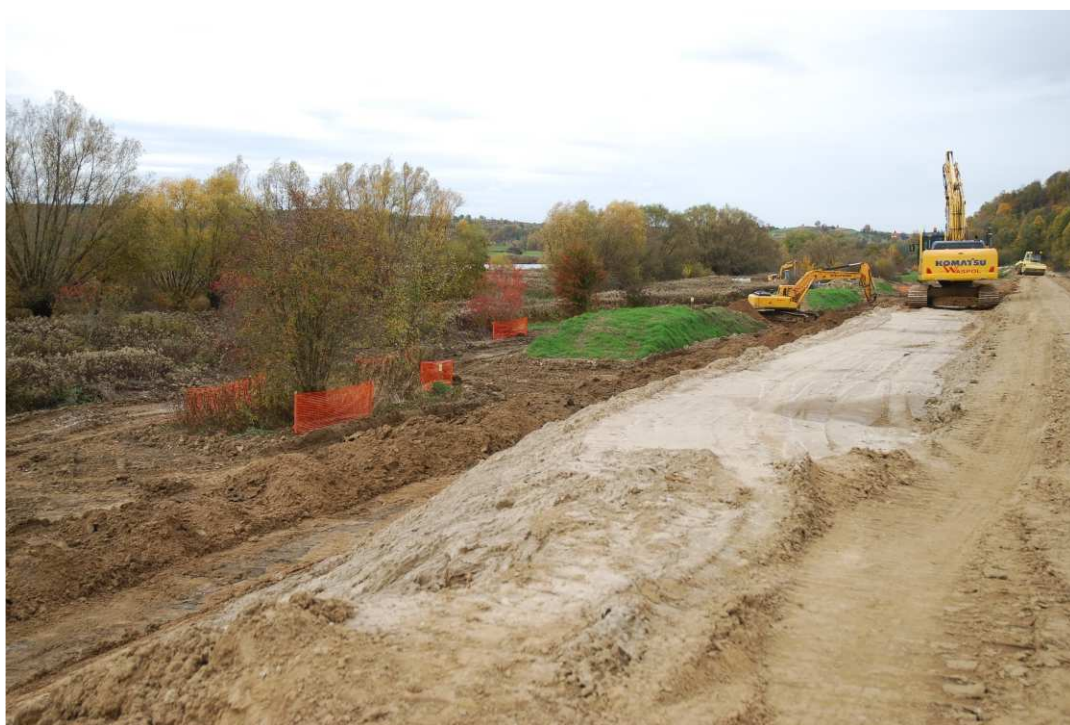
Fig. 17. Protection of trees and shrubs not intended to felling within *Task 1*, status in the third decade of October 2020 (downstream view).

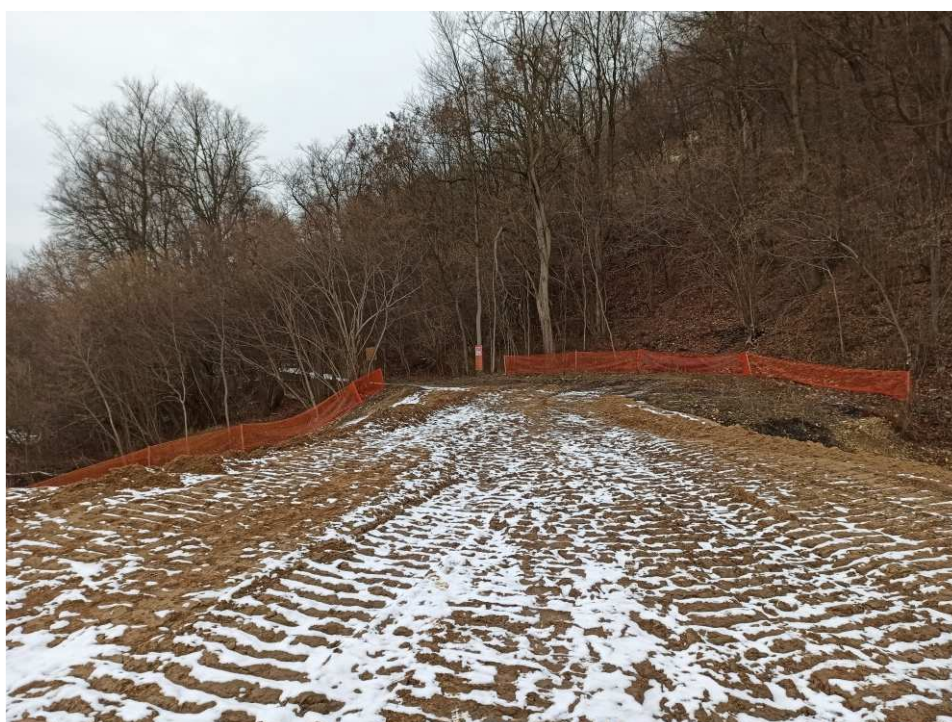
Fig. 18. Protection of trees and shrubs not intended to felling within *Task 1*, status in the third decade of January 2021 (downstream view).

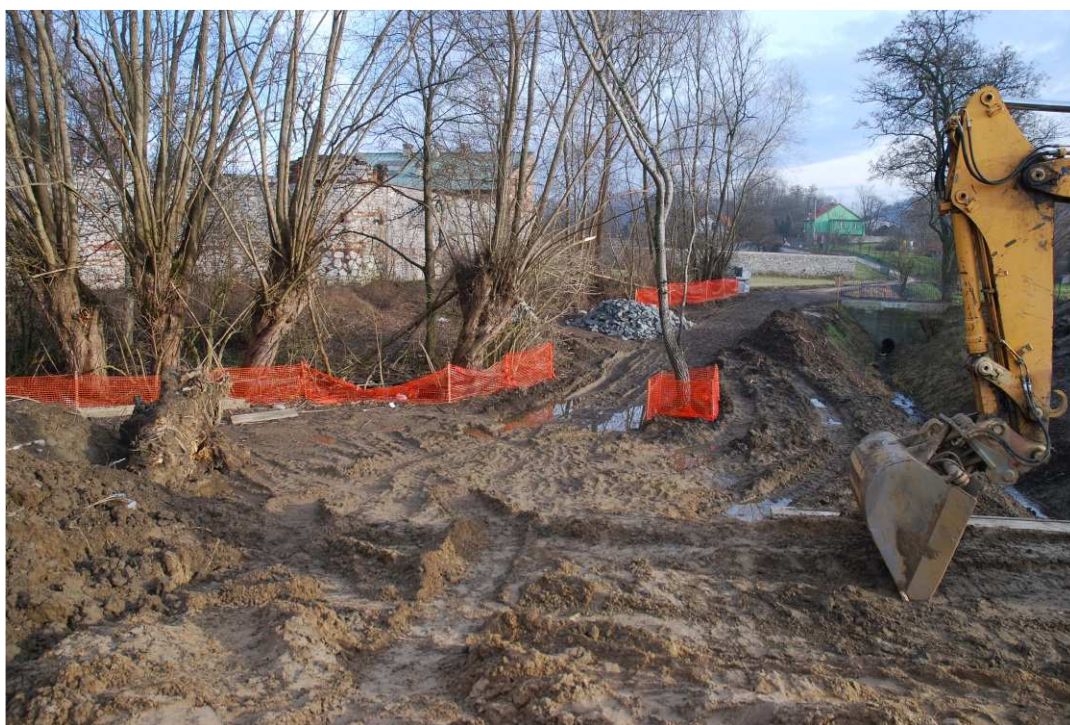
Fig. 19. Protection of trees and shrubs not intended to felling within *Task 2*, status in the third decade of December 2020 (view towards the area beyond the embankment).

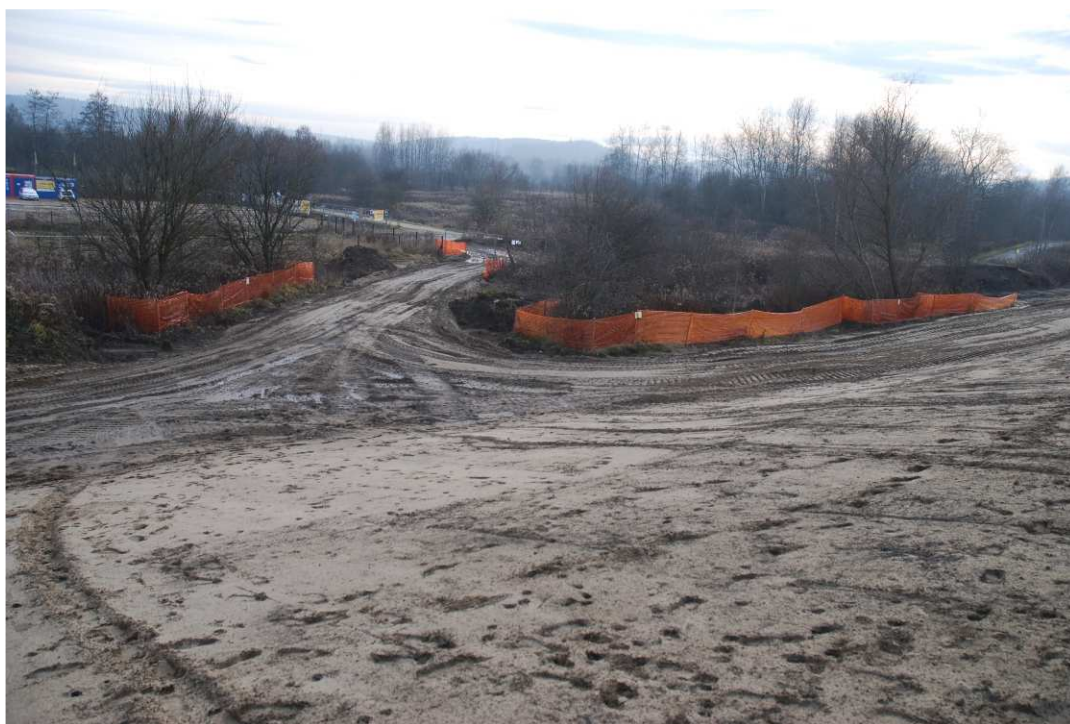
Fig. 20. Protection of trees and shrubs not intended to felling within *Task 3*, status in the third decade of December 2020 (view towards the area beyond the embankment).

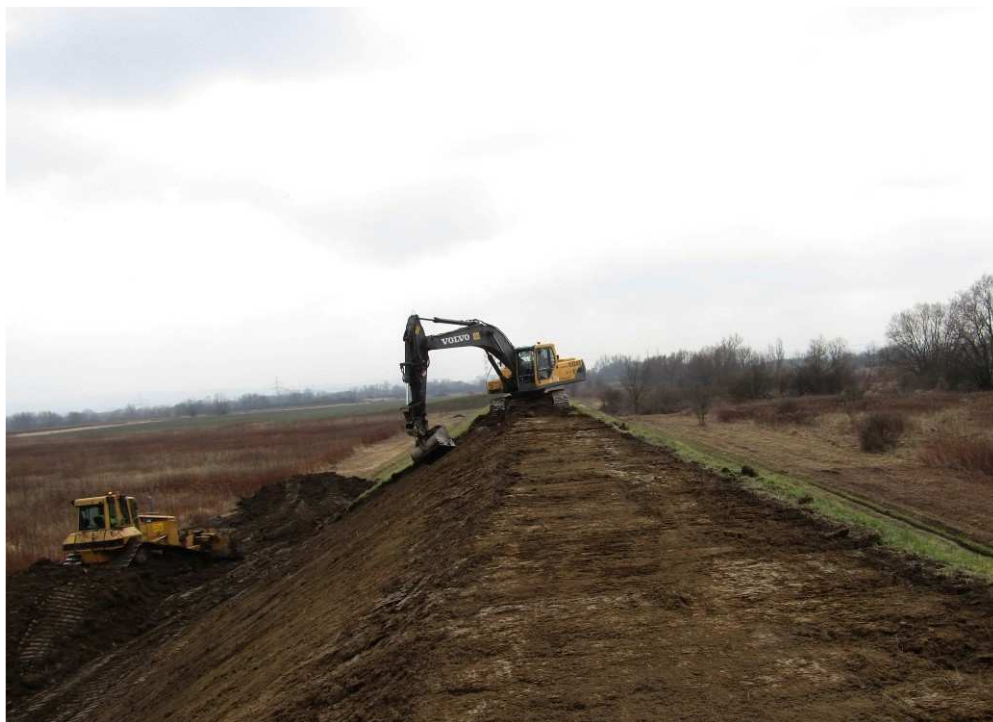
Fig. 21. Removal of a top-soil layer within *Task 1*, status in the third decade of February 2020 (upstream view).

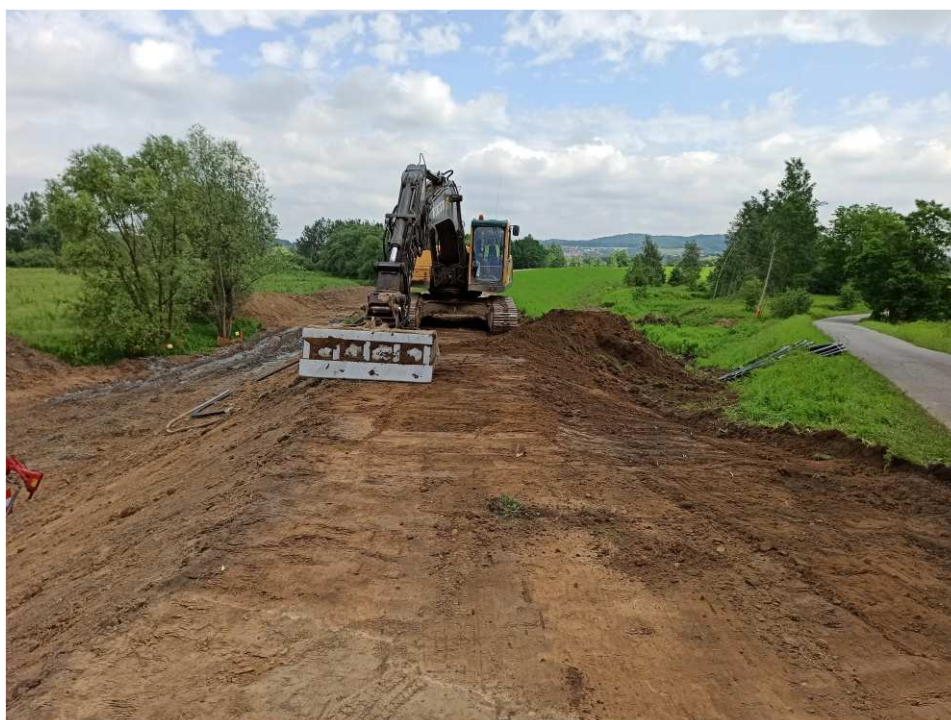
Fig. 22. Removal of a top-soil layer within *Task 3*, status in the third decade of June 2020 (downstream view).

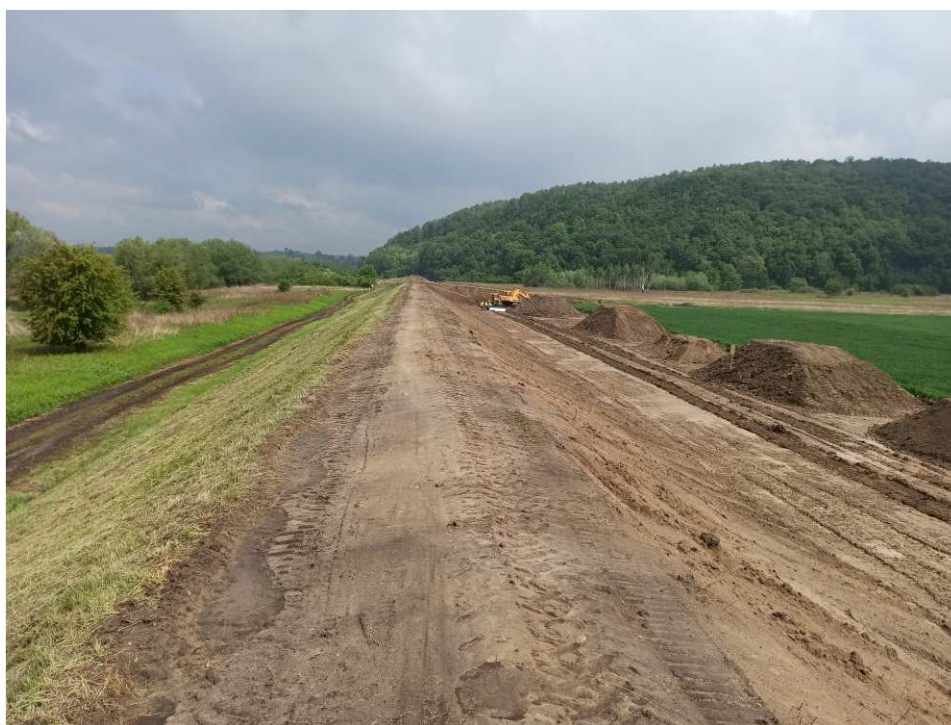
Fig. 23. Protection of top-soil piles within *Task 1*,
status in the third decade of May 2020 (downstream view).

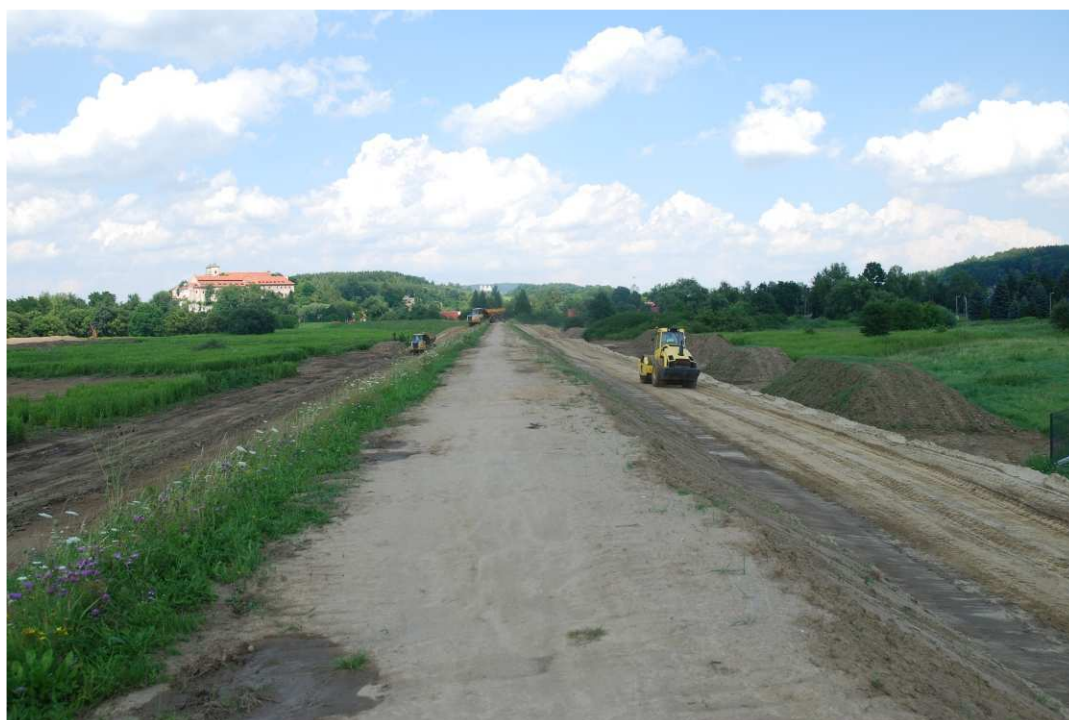
Fig. 24. Protection of top-soil piles within *Task 2*,
status in the third decade of July 2020 (downstream view).

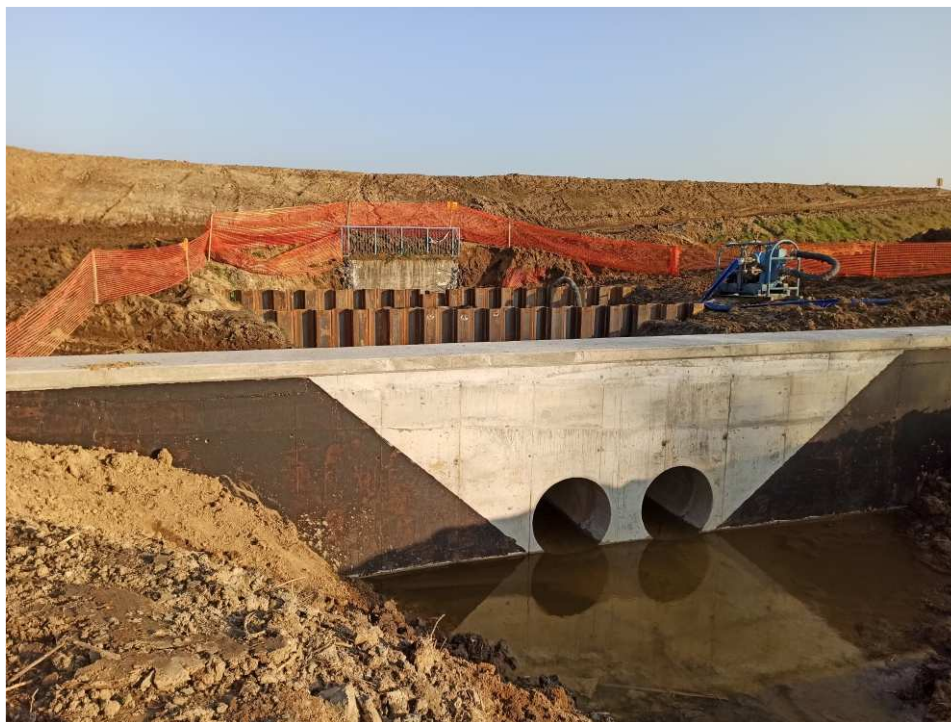
Fig. 25. Redevelopment of the embankment culvert at km 61+239 of the Vistula embankment on *Task 1*, status in the third decade of November 2020 (view from the embanked area).

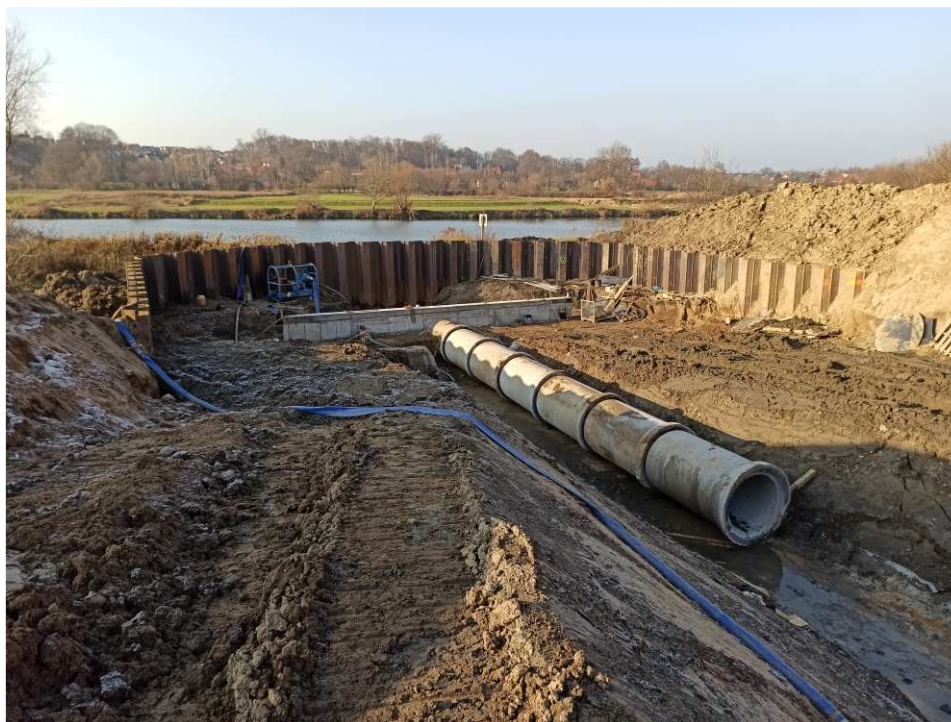
Fig. 26. Redevelopment of the embankment culvert at km 63+115 of the Vistula embankment on *Task 2*, status in the third decade of November 2020 (view towards the embanked area).

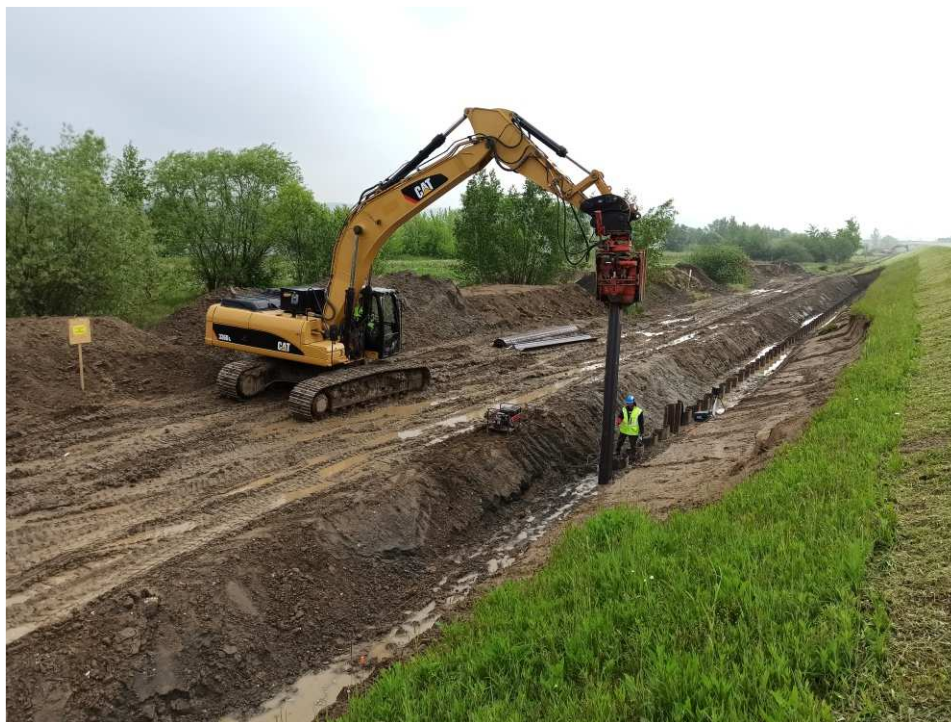
Fig. 27. Construction of a sheet piling barrier within *Task 3*, status in the third decade of May 2020 (downstream view).

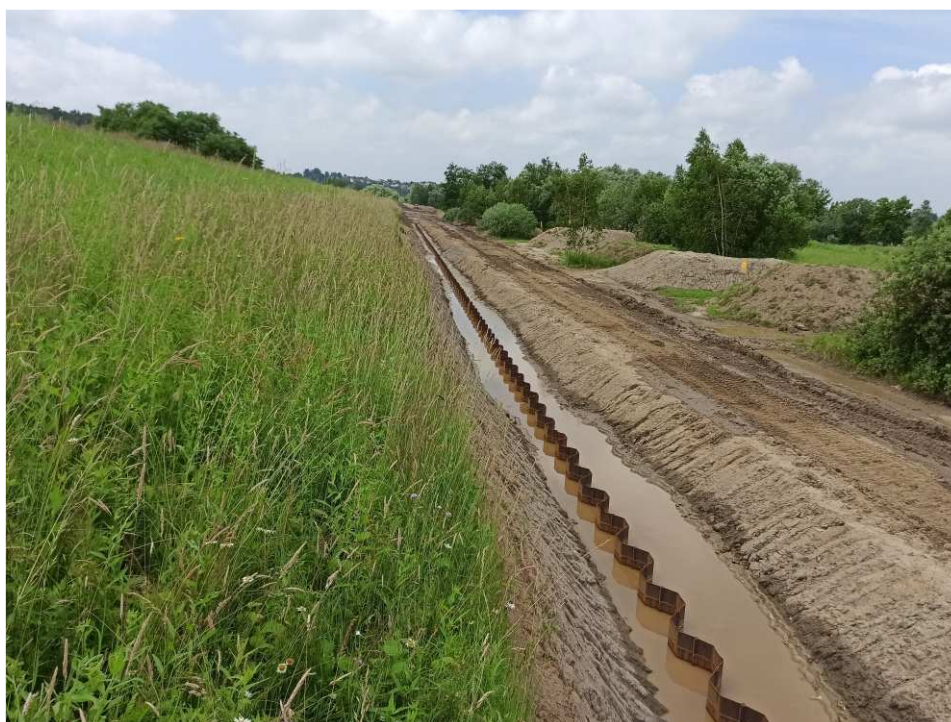
Fig. 28. Construction of a sheet piling barrier within *Task 3*, status in the third decade of June 2020 (upstream view).

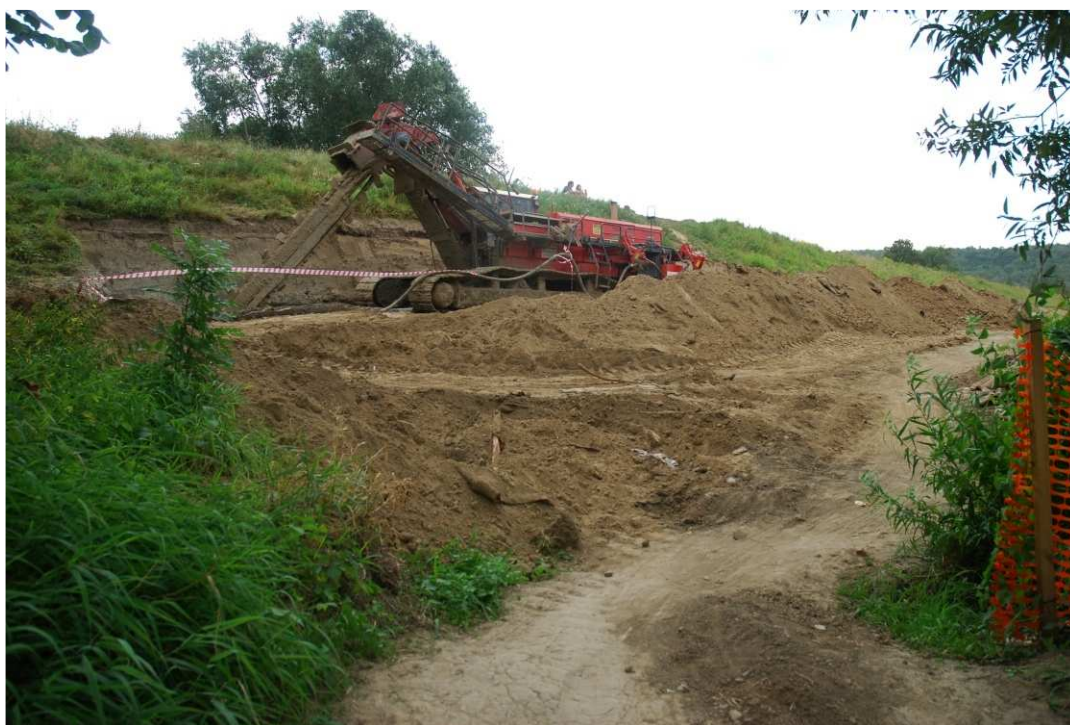
Fig. 29. Construction of a cement-bentonite barrier within *Task 2*, status in the third decade of August 2020 (upstream view).
