PHOTO DOCUMENTATION

Appendix no. 2
to the Final Report on implementation of measures determined in EMP
for the Contract 3A.3

Odra-Vistula Flood Management Project

| Contract Task | 3A.3 Section 4 – The right embankment of the Vistula River from the estuary of Skawinka to the Kościuszko Barrage |

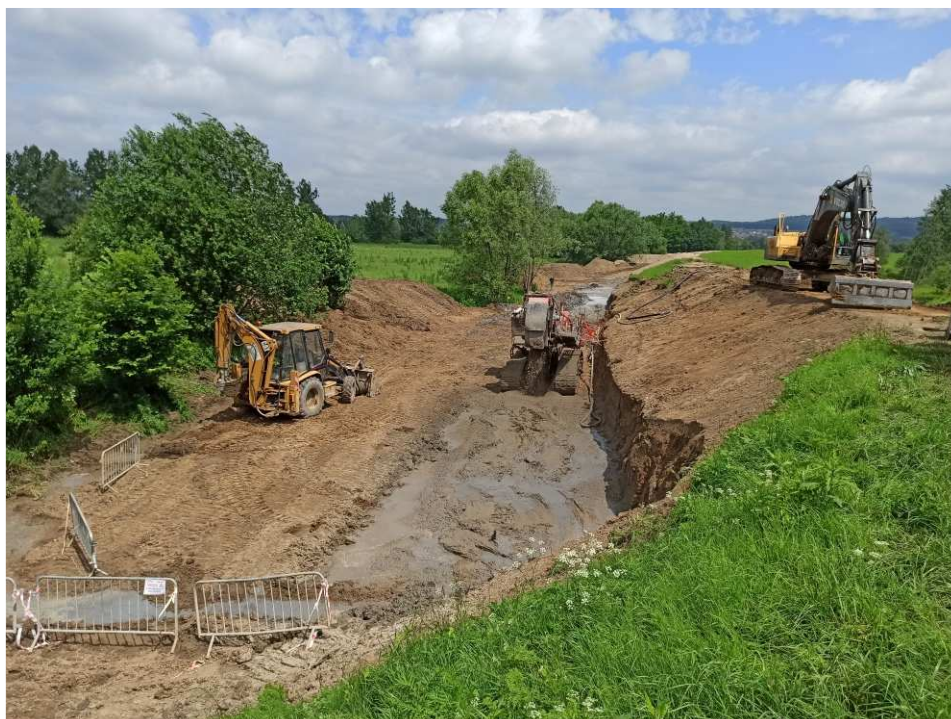
Fig. 30. Construction of a cement-bentonite barrier within *Task 3*, status in the third decade of June 2020 (downstream view).

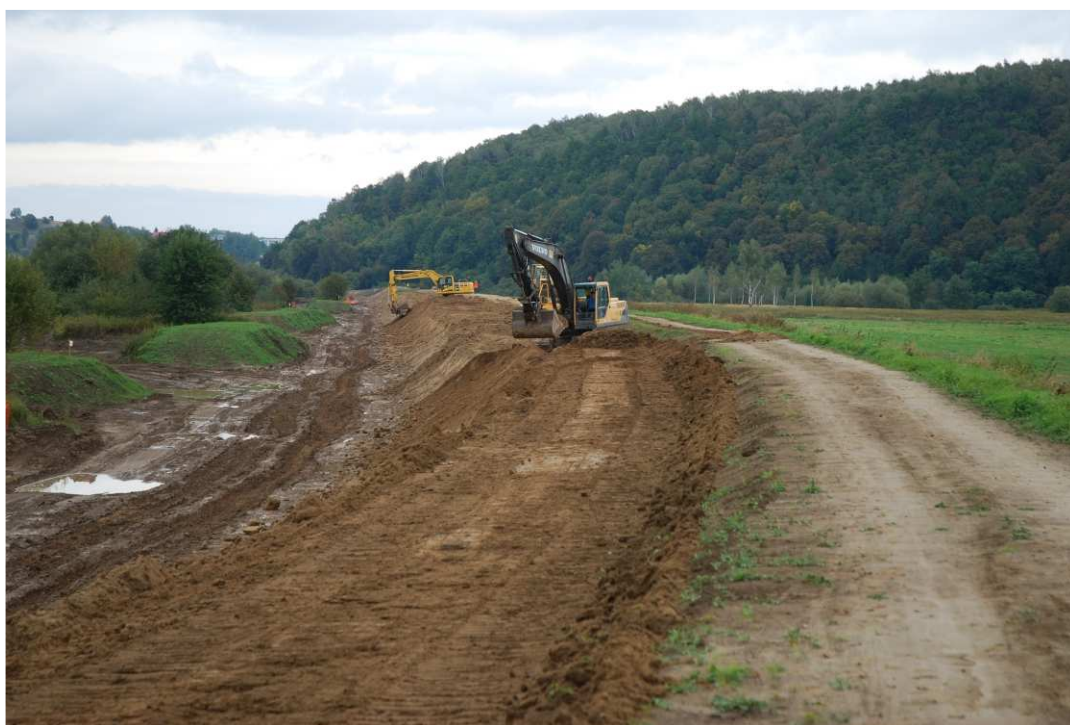
Fig. 31. Shaping the slopes of the flood embankment within *Task 1*, status in the third decade of September 2020 (downstream view).

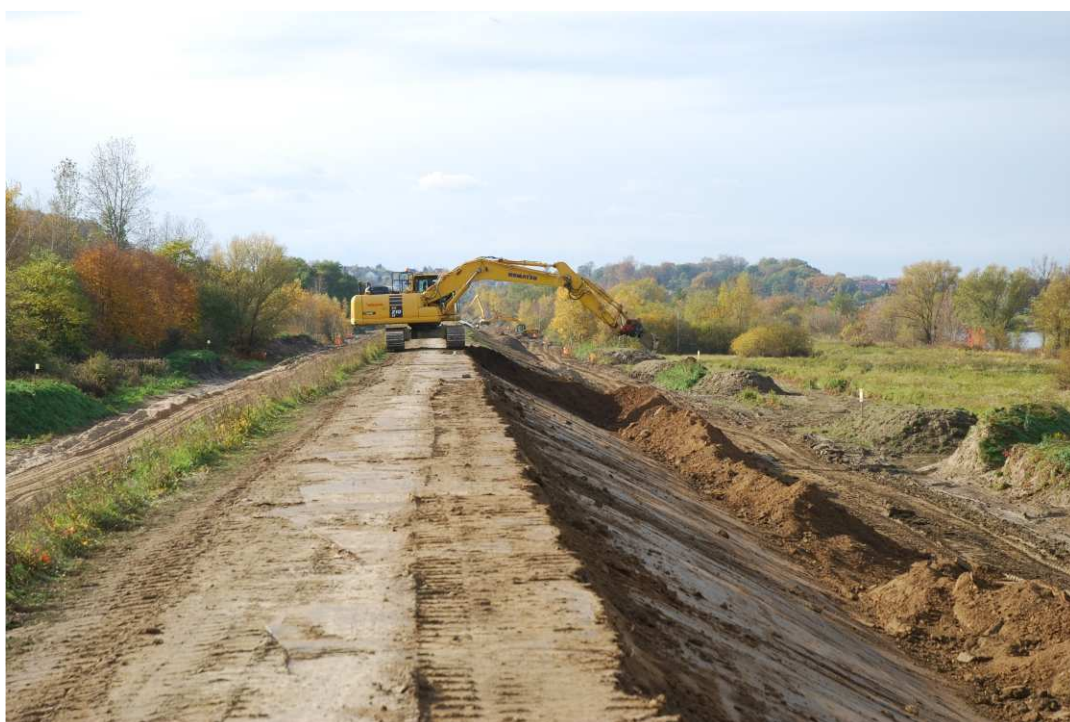
Fig. 32. Shaping the slopes of the flood embankment within *Task 3*, status in the third decade of September 2020 (upstream view).

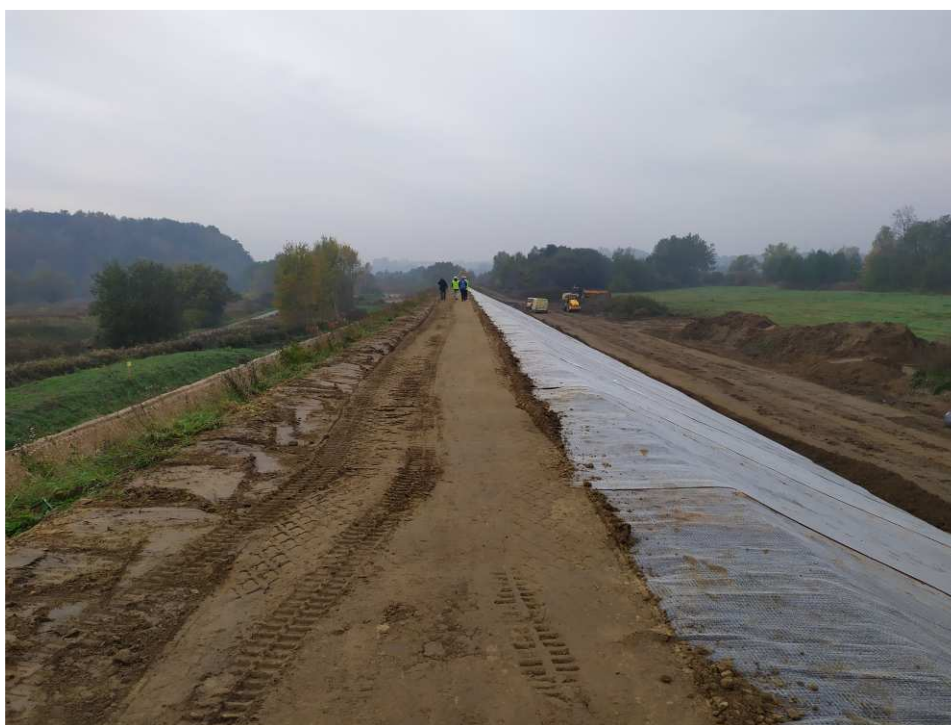
Fig. 33. Placement of bentomat on the slope of the flood embankment within *Task 3*, status in the third decade of October 2020 (upstream view).

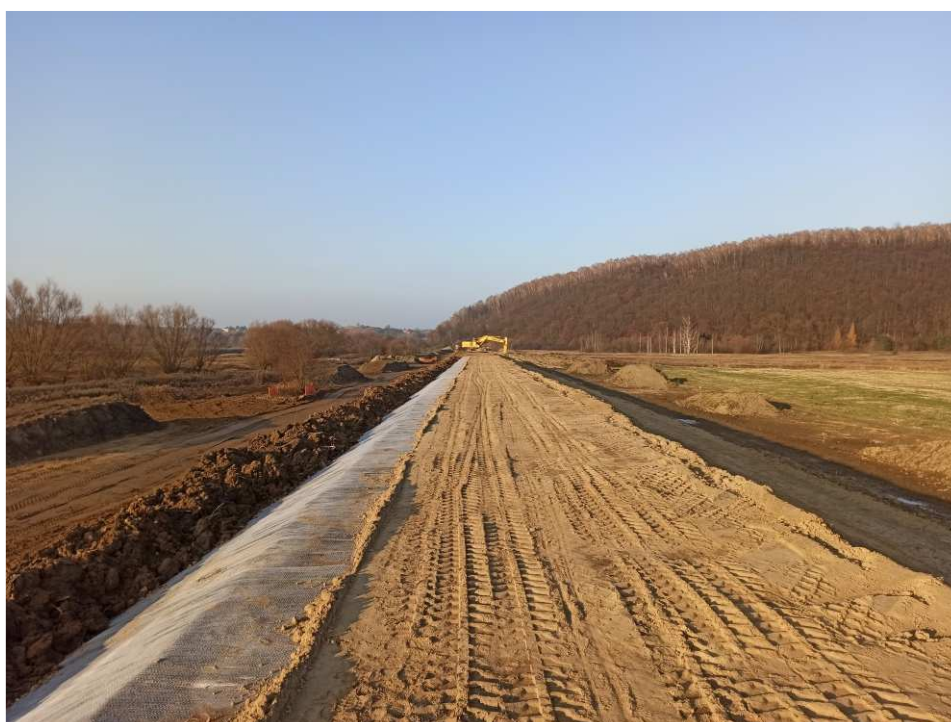
Fig. 34. Placement of bentomat on the slope of the flood embankment within *Task 1*, status in the third decade of November 2020 (downstream view).

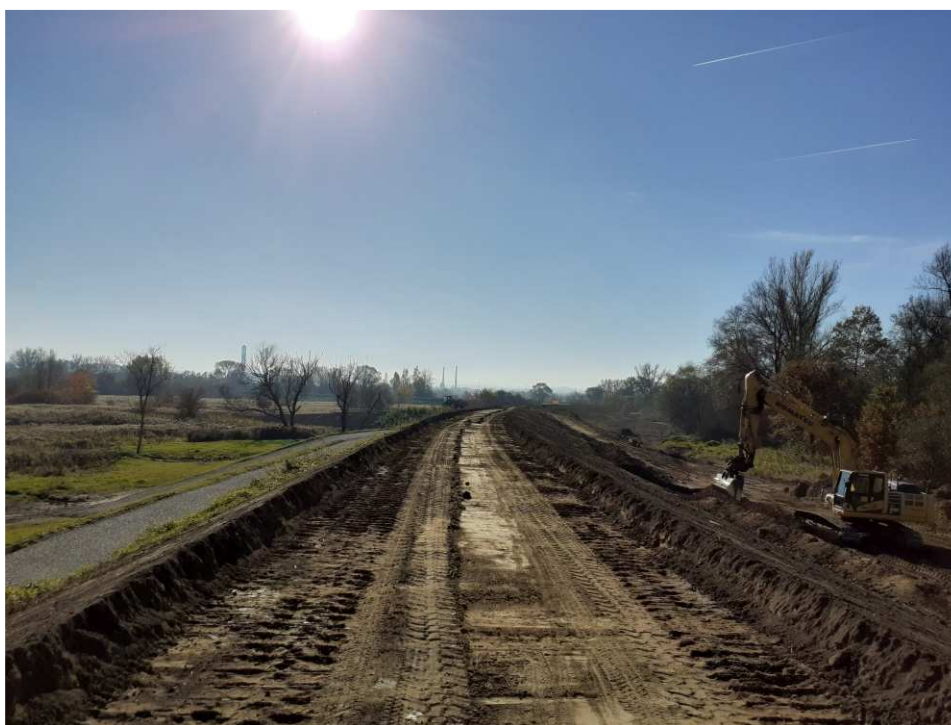
Fig. 35. Covering slopes of the flood embankment with a top-soil layer within *Task 1*, status in the third decade of October 2021 (upstream view).

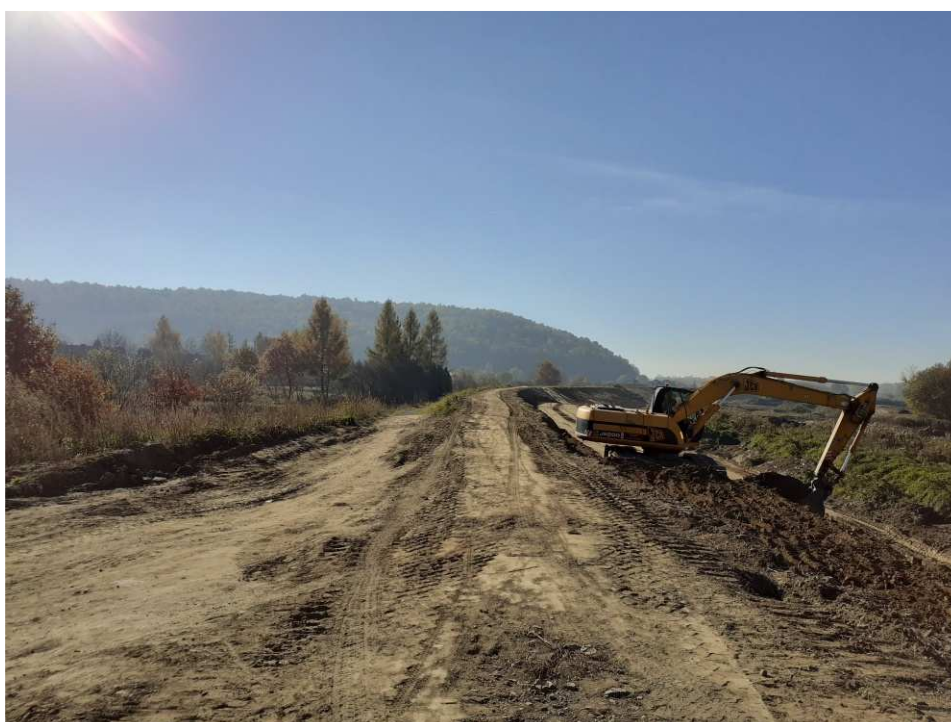
Fig. 36. Covering slopes of the flood embankment with a top-soil layer within *Task 2*, status in the third decade of October 2021 (upstream view).

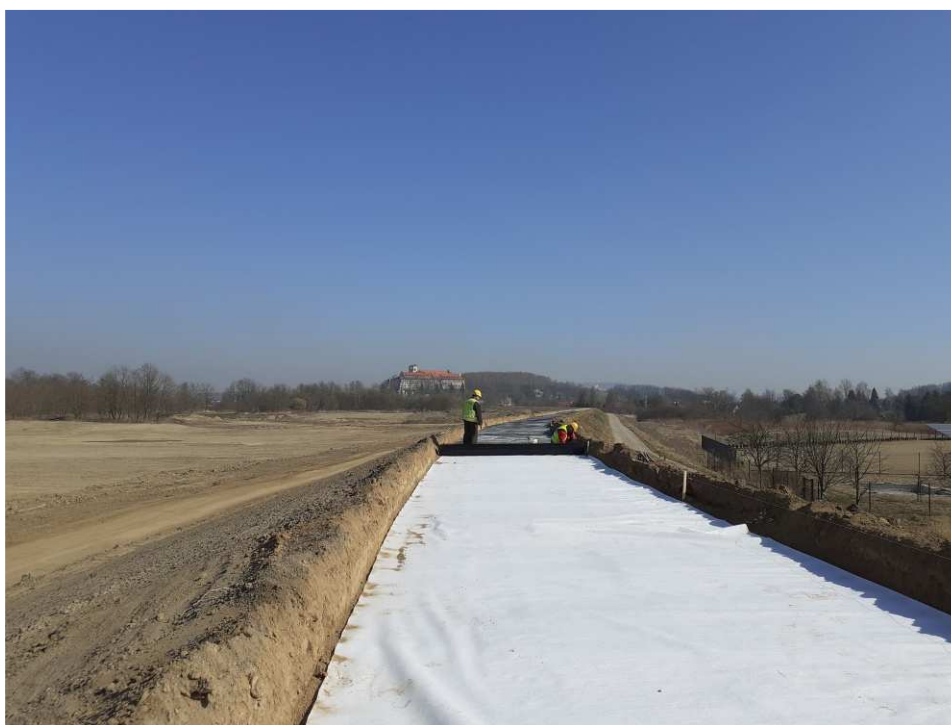
Fig. 37. Construction of a road on the crown of the flood embankment within *Task 2*, status in the third decade of March 2022 (downstream view).

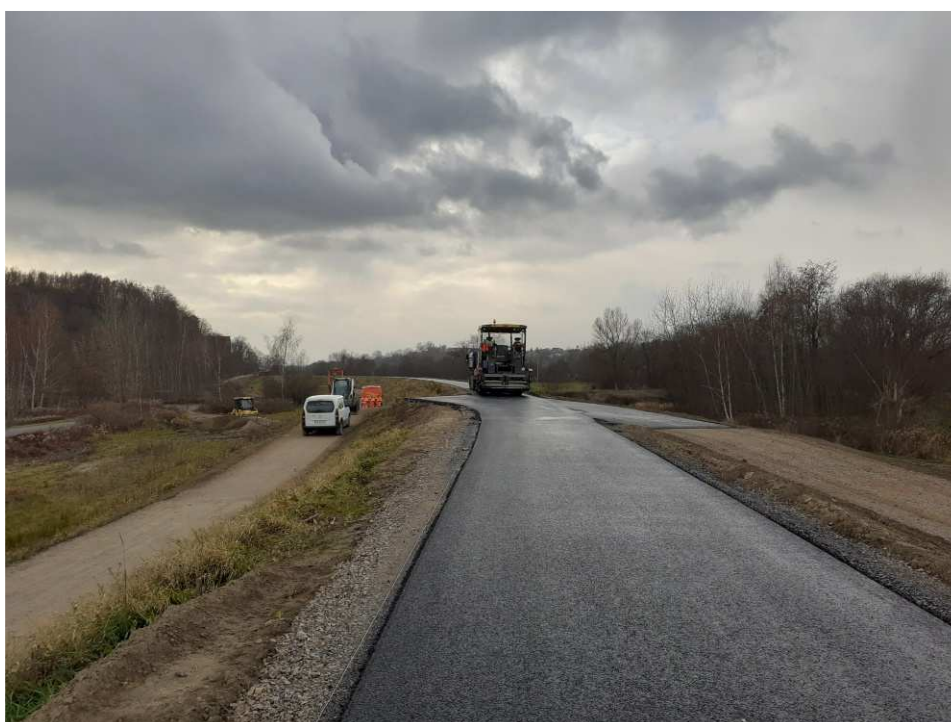
Fig. 38. Construction of a road on the crown of the flood embankment within *Task 3*, status in the third decade of November 2021 (upstream view).

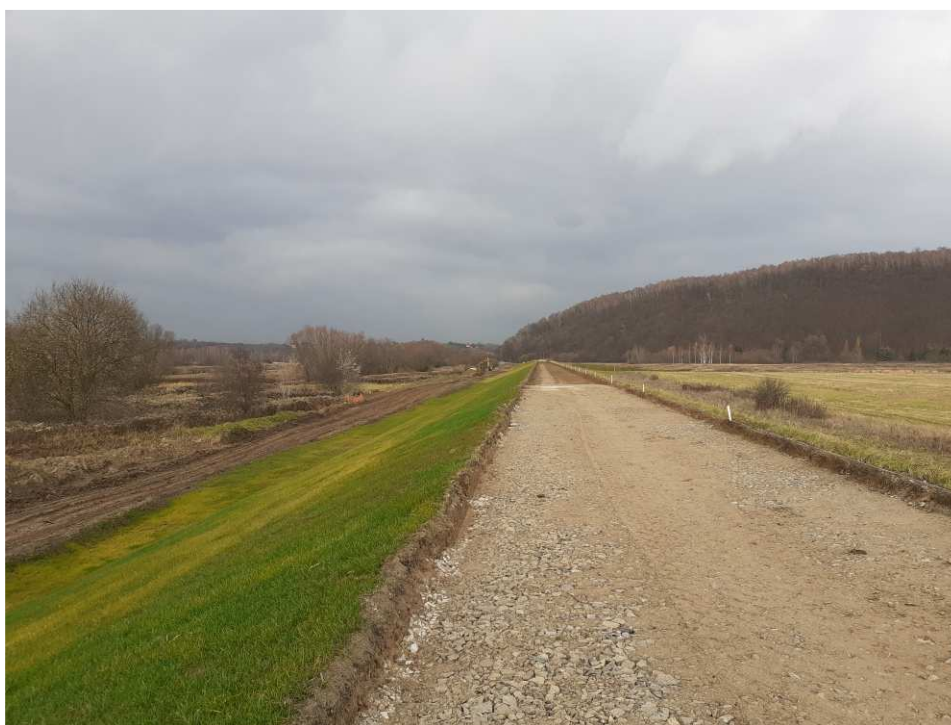
Fig. 39. Growth of grasses sown on the slope of the flood embankment within *Task 1*, status in the third decade of November 2021 (downstream view).

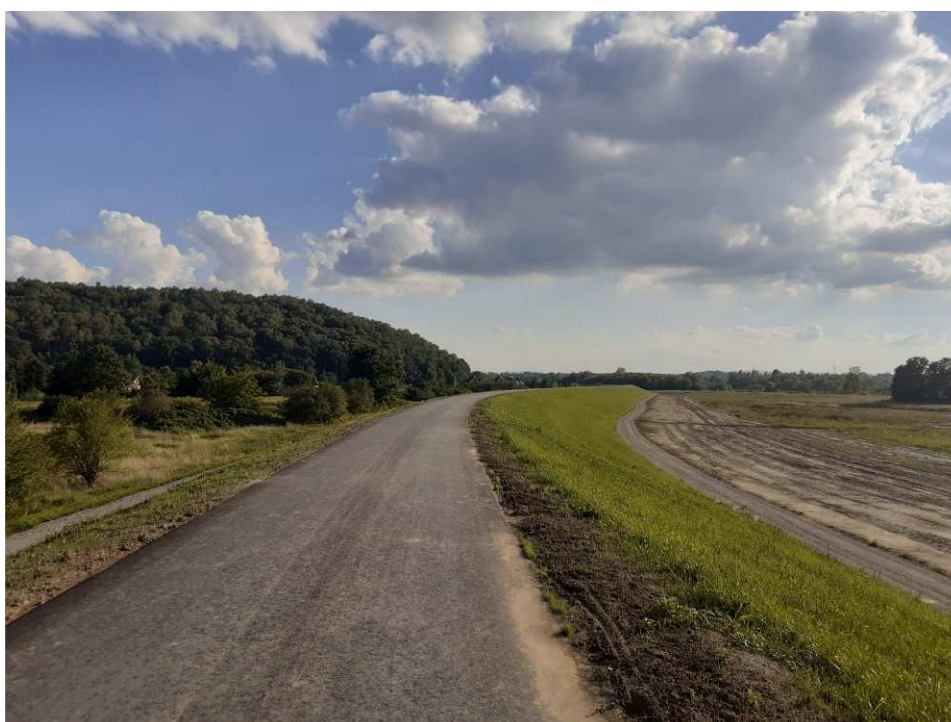
Fig. 40. Growth of grasses sown on the slope of the flood embankment within *Task 2*, status in the third decade of August 2022 (upstream view).

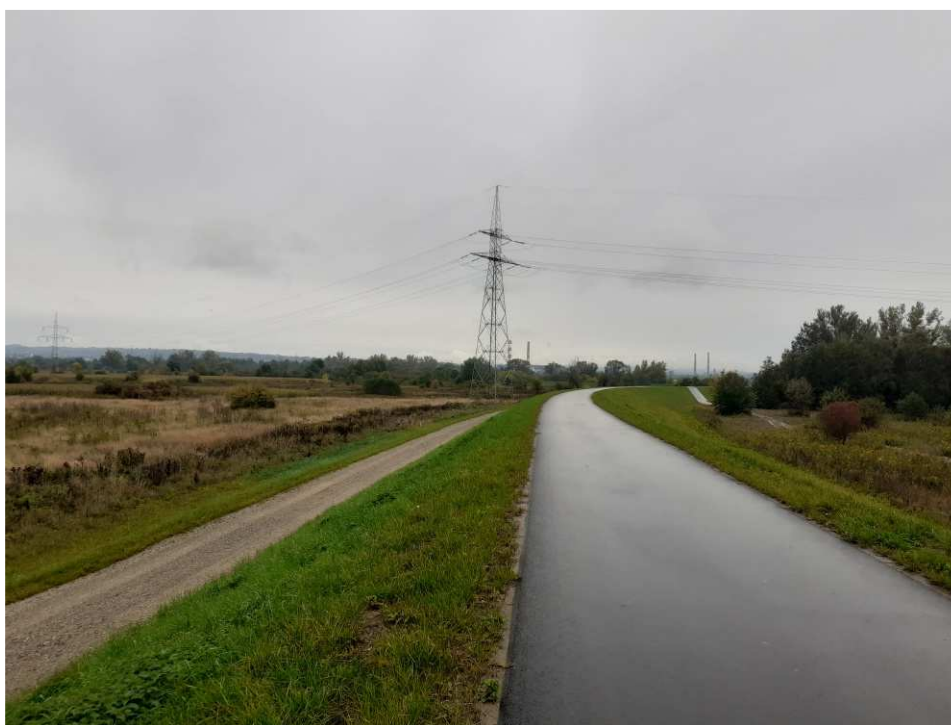
Fig. 41. Site condition in the last month of the works implementation period – the right Vistula embankment within *Task 1*, status in the third decade of September 2022 (upstream view).

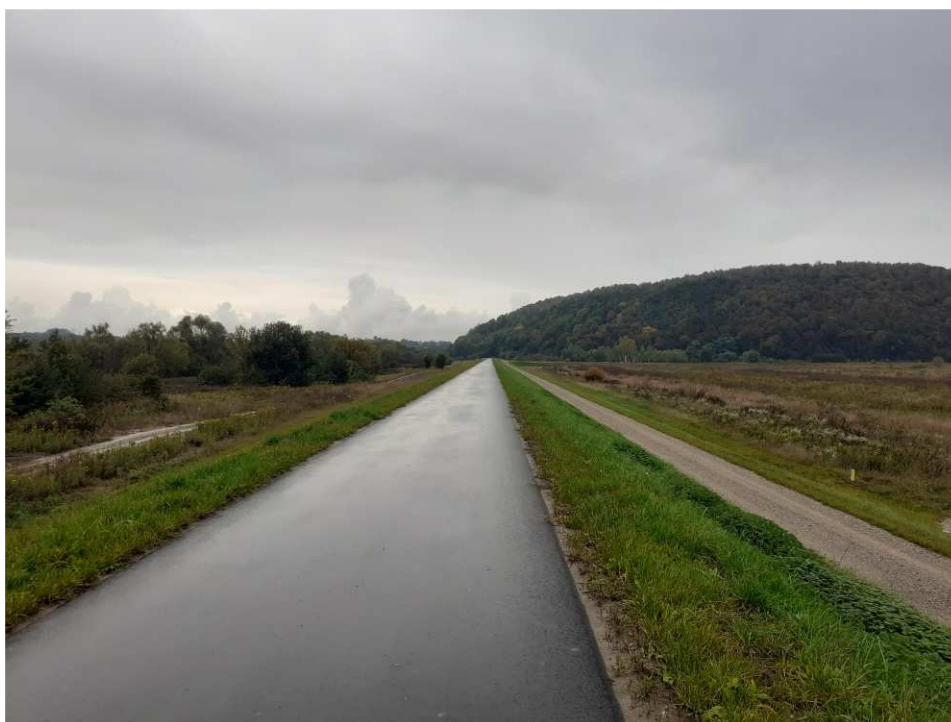
Fig. 42. Site condition in the last month of the works implementation period – the right Vistula embankment within *Task 1*, status in the third decade of September 2022 (downstream view).

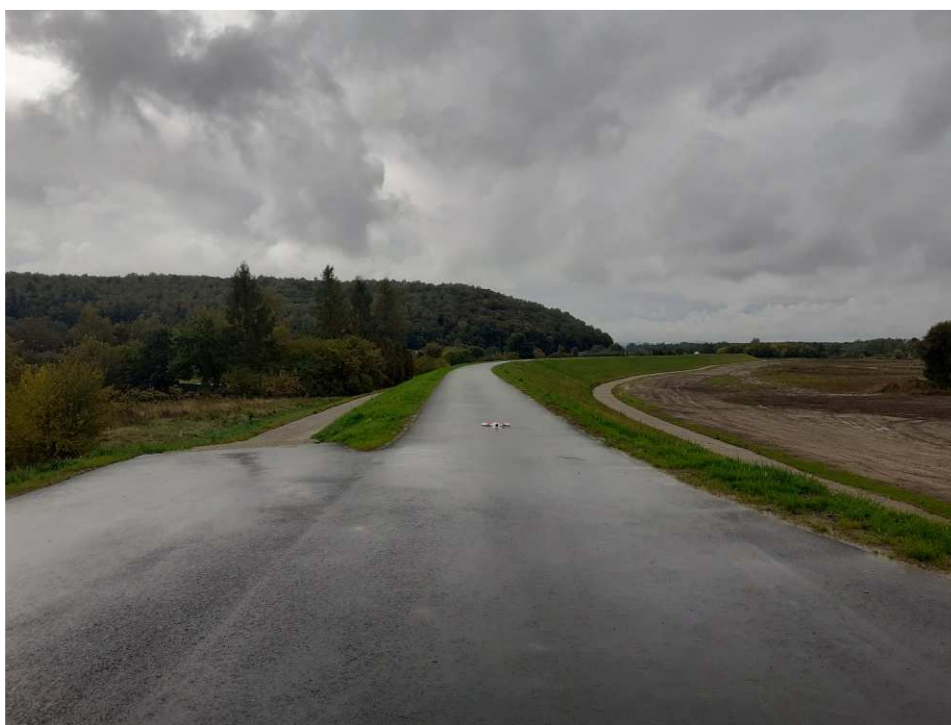
Fig. 43. Site condition in the last month of the works implementation period – the right Vistula embankment within *Task 2*, status in the third decade of September 2022 (upstream view).

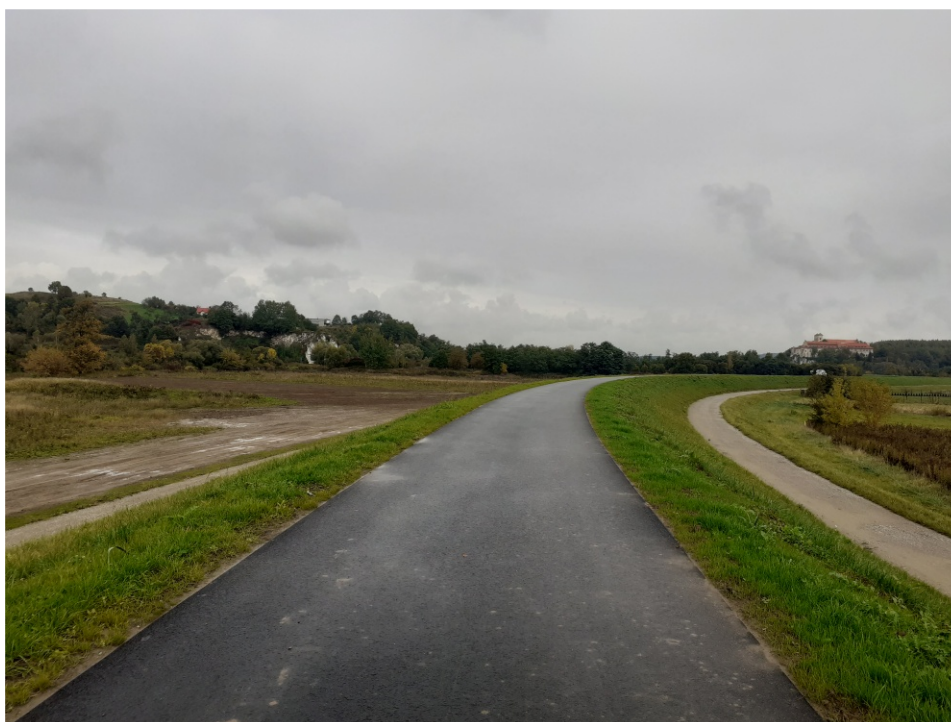
Fig. 44. Site condition in the last month of the works implementation period – the right Vistula embankment within *Task 2*, status in the third decade of September 2022 (downstream view).

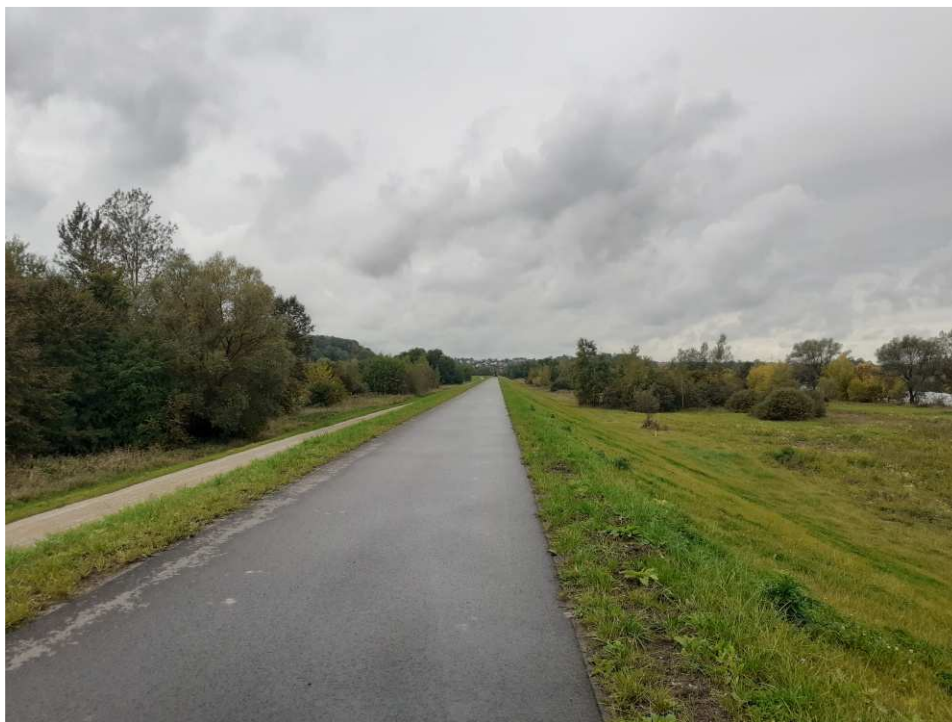
Fig. 45. Site condition in the last month of the works implementation period – the right Vistula embankment within *Task 3*, status in the third decade of September 2022 (upstream view).

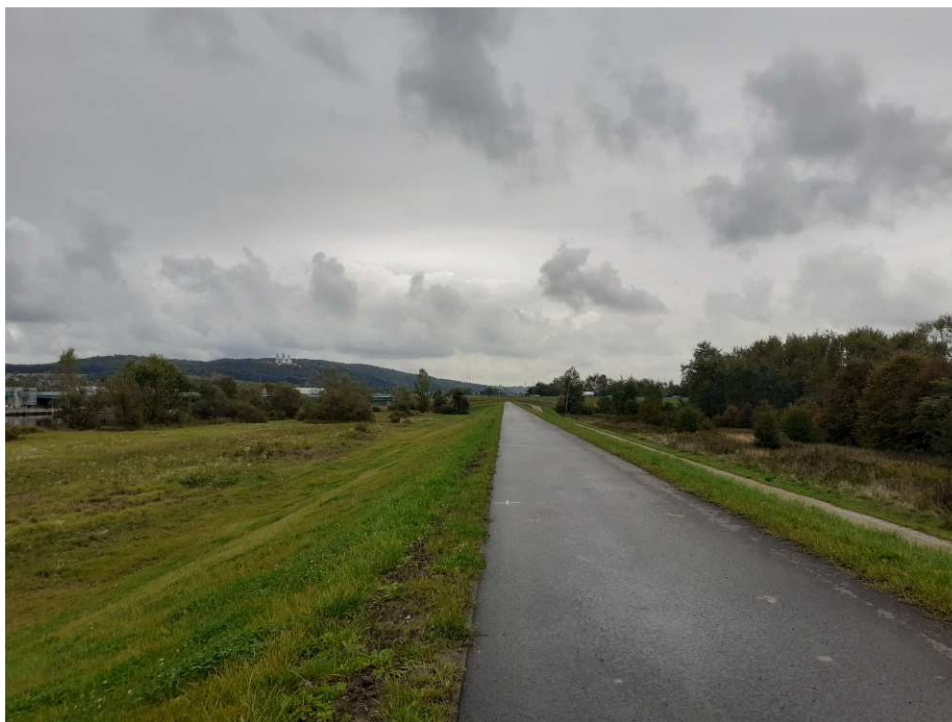
Fig. 46. Site condition in the last month of the works implementation period – the right Vistula embankment within *Task 3*, status in the third decade of September 2022 (downstream view).

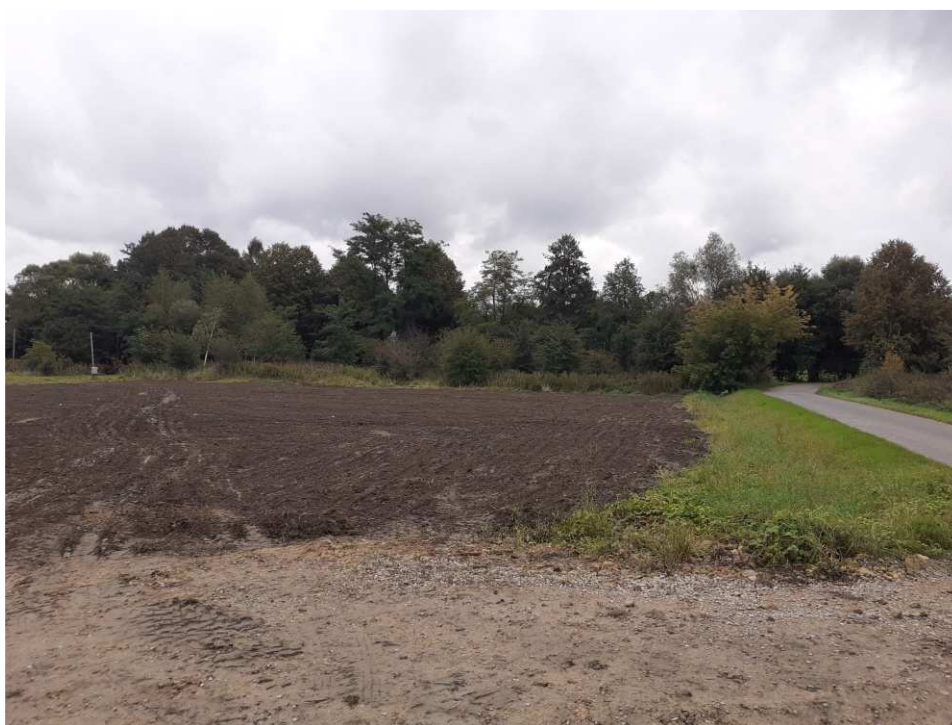
Fig. 47. Reclaimed area of the former site facilities in the area beyond the right Vistula embankment at the height of *Task 3*, status in the third decade of September 2022 (view towards the south).

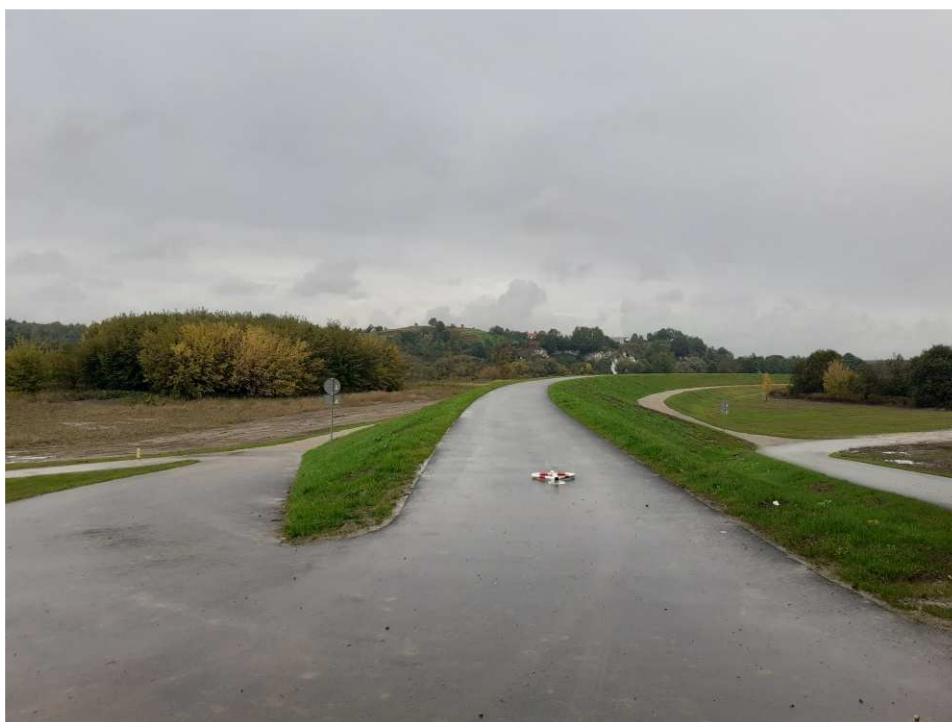
Fig. 48. Reclaimed area of the former site facilities in the area beyond the right Vistula embankment at the height of *Task 2*, status in the third decade of September 2022 (downstream view).
