PHOTO DOCUMENTATION

to the Final Report on implementation of measures determined in EMP
for the Contract 3A.6

Odra-Vistula Flood Management Project

OVFMP Subcomponent	3A Flood Protection of Upper Vistula Towns and Cracow
Contract Task	3A.6 Construction of a pumping station for mobile pumps to drain the Lesisko complex
Investor / Project Implementation Unit	State Water Holding Polish Waters Regional Water Management Authority in Cracow 22. Marszałka J. Piłsudskiego Street, 31-109 Cracow, Poland
Project Implementation Office (PIO)	Project Implementation Office in Cracow 22. Marszałka J. Piłsudskiego Street, 31-109 Cracow, Poland
Contractor of Works	Przedsiębiorstwo Budownictwa Wodno-Inżynieryjnego w Krakowie Sp. z o.o. 17. Bogucka Street, 30-020 Wieliczka, Poland
Engineer	AECOM Polska Sp. z o.o. Project Office: 1. Pokoju Alley, 31-548 Cracow, Poland

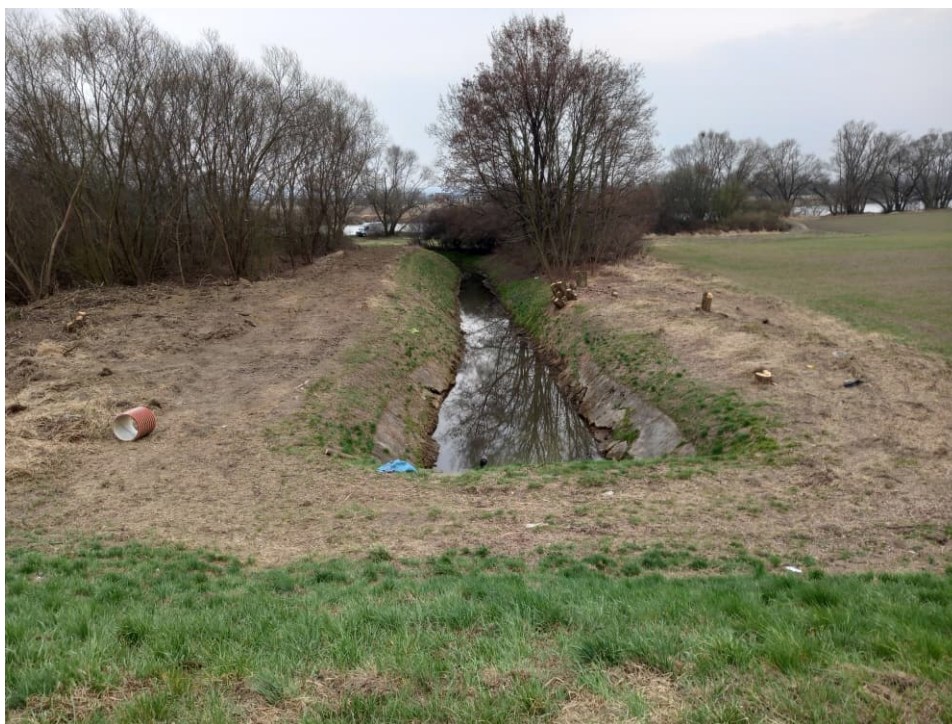
Fig. 1. Site condition in the first month of the works implementation period – construction area of an embankment lock on the Ditch 2a on the embanked area of the Vistula River, status in the third decade of March 2022 (view towards the south).

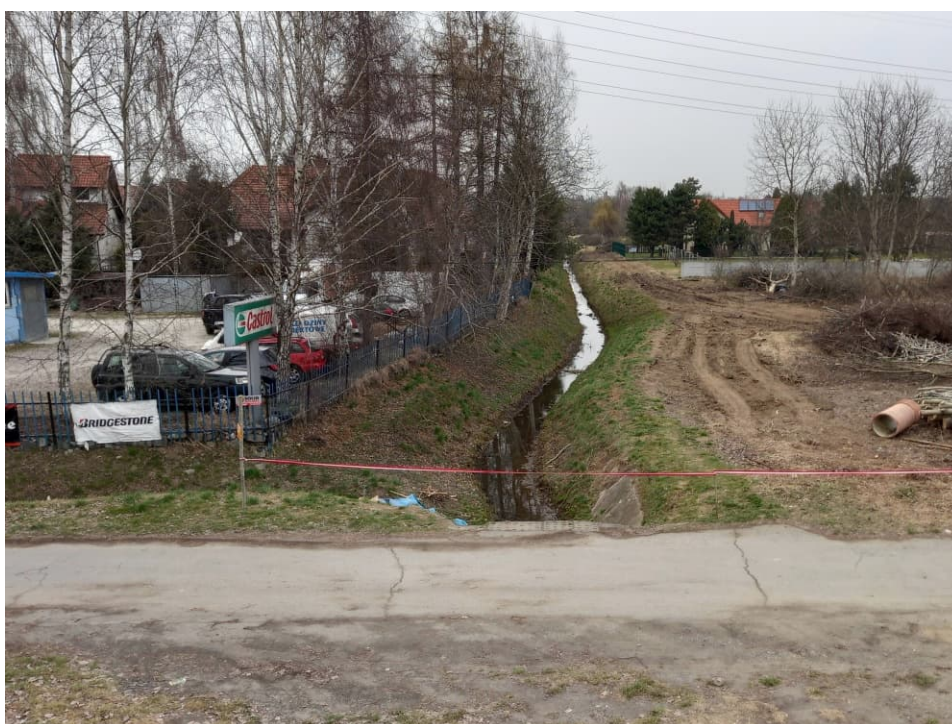
Fig. 2. Site condition in the first month of the works implementation period – construction area of an embankment lock on the Ditch 2a on the area beyond the Vistula River embankment, status in the third decade of March 2022 (view towards the north).

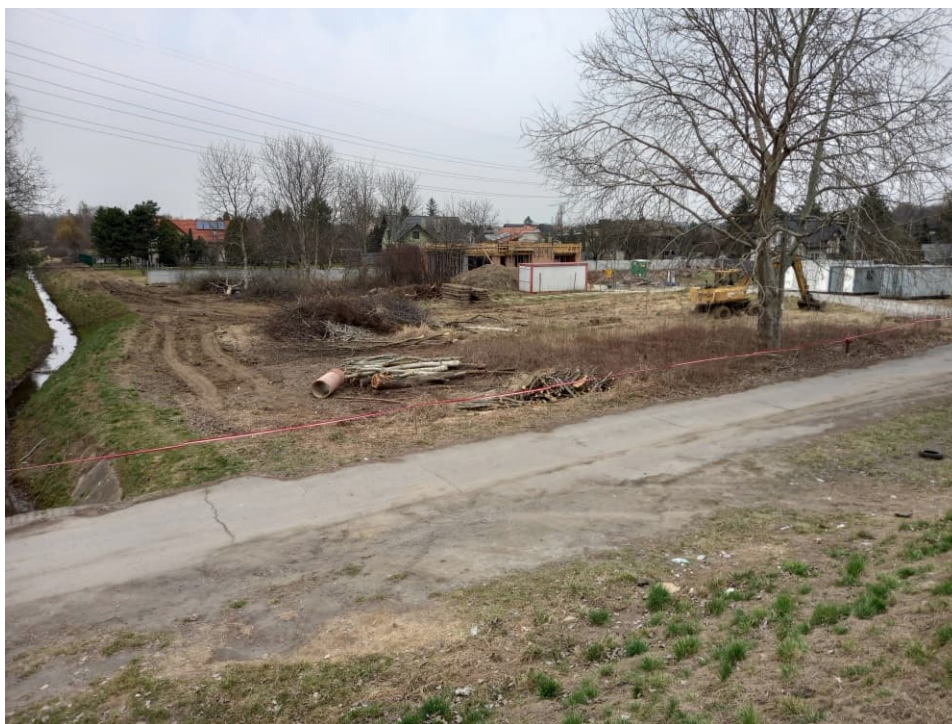
Fig. 3. Site condition in the first month of the works implementation period – construction area of a pumping station for mobile pumps and a site flood storage reservoir upstream of the embankment lock status in the third decade of March 2022 (view towards the north).

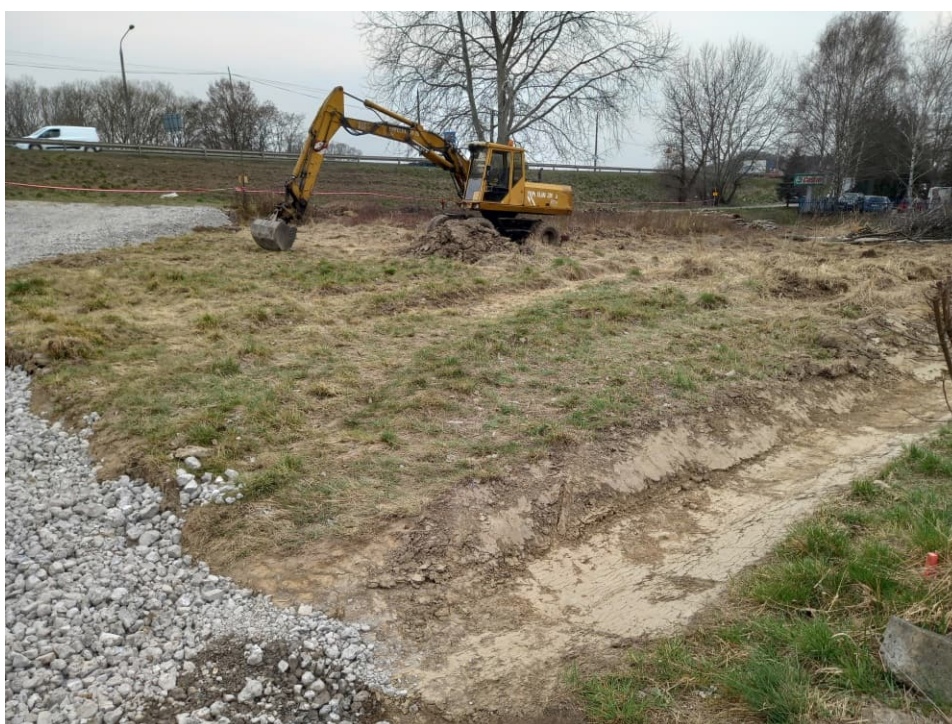
Fig. 4. Site condition in the first month of the works implementation period – construction area of a site flood storage reservoir upstream of the embankment lock and a pumping station for mobile pumps, status in the third decade of March 2022 (view towards the south).

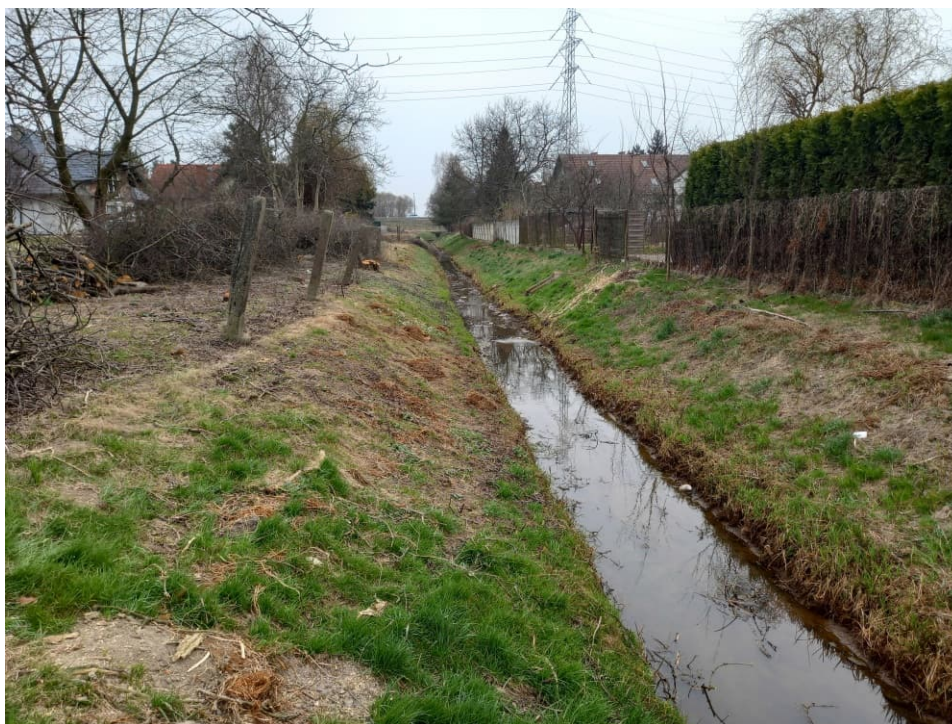
Fig. 5. Site condition in the first month of the works implementation period – redeveloped section of the Ditch 2a – downstream part, status in the third decade of March 2022 (view towards the south).

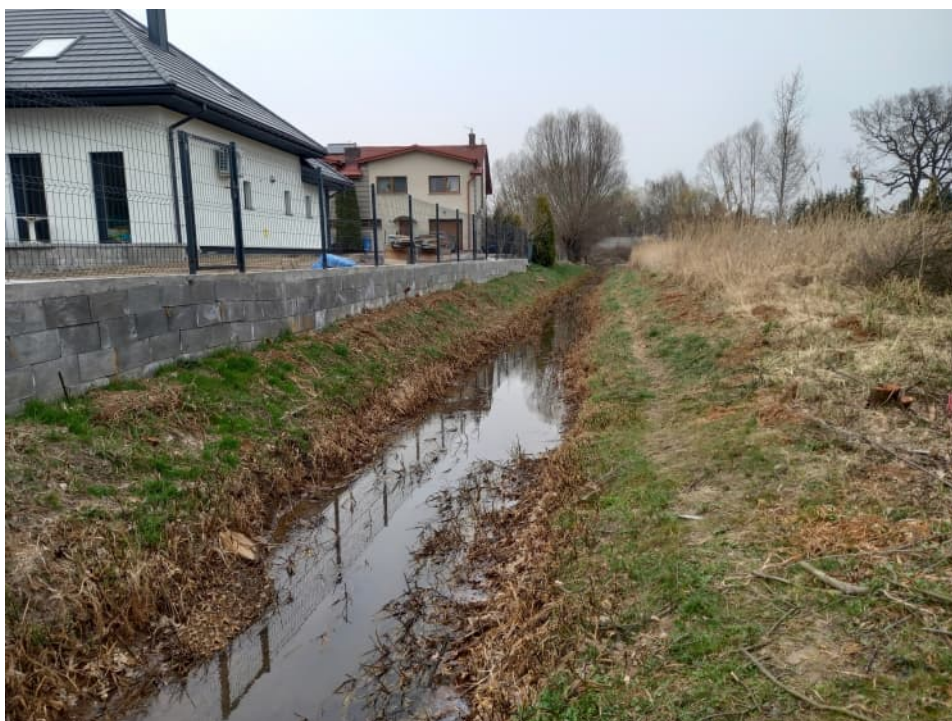
Fig. 6. Site condition in the first month of the works implementation period – redeveloped section of the Ditch 2a – upstream part, status in the third decade of March 2022 (view towards the north).

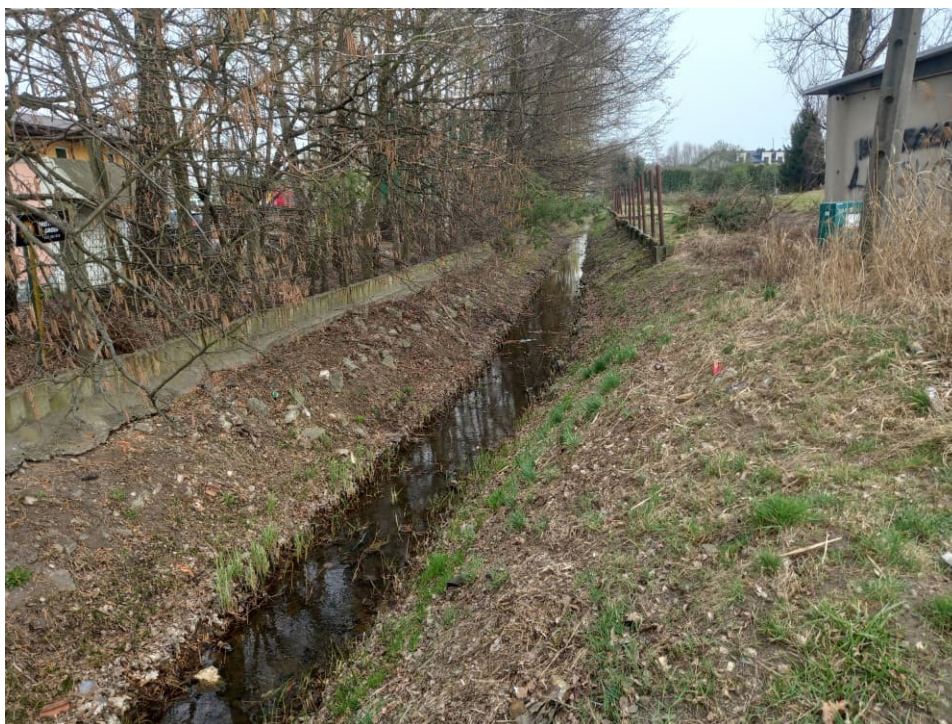
Fig. 7. Site condition in the first month of the works implementation period – redeveloped section of the Ditch 2 – downstream part, status in the third decade of March 2022 (view towards the east).

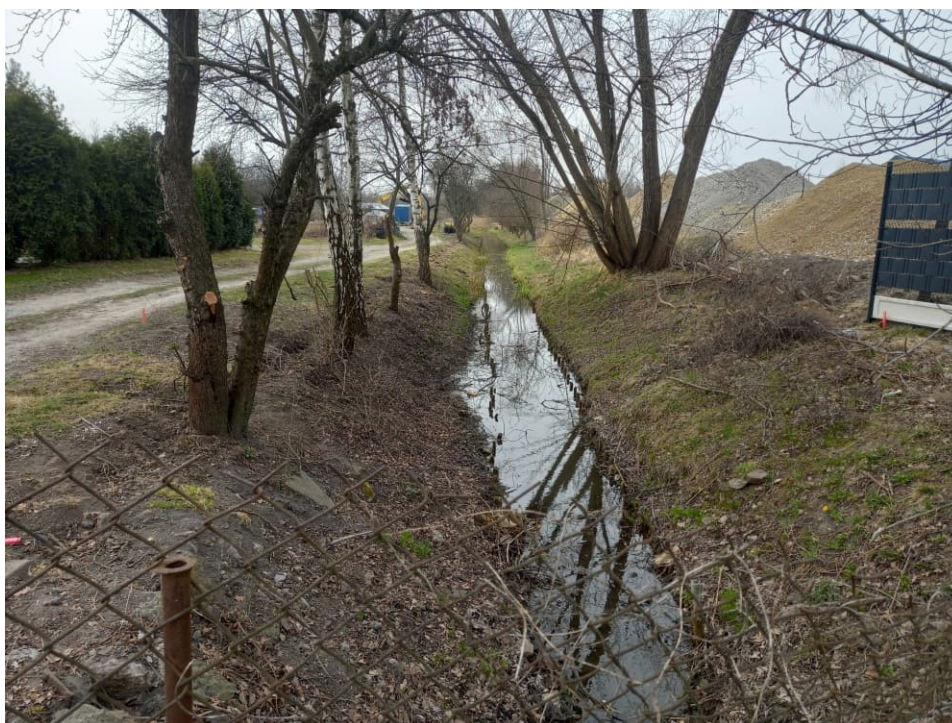
Fig. 8. Site condition in the first month of the works implementation period – redeveloped section of the Ditch 2 – upstream part, status in the third decade of March 2022 (view towards the west).

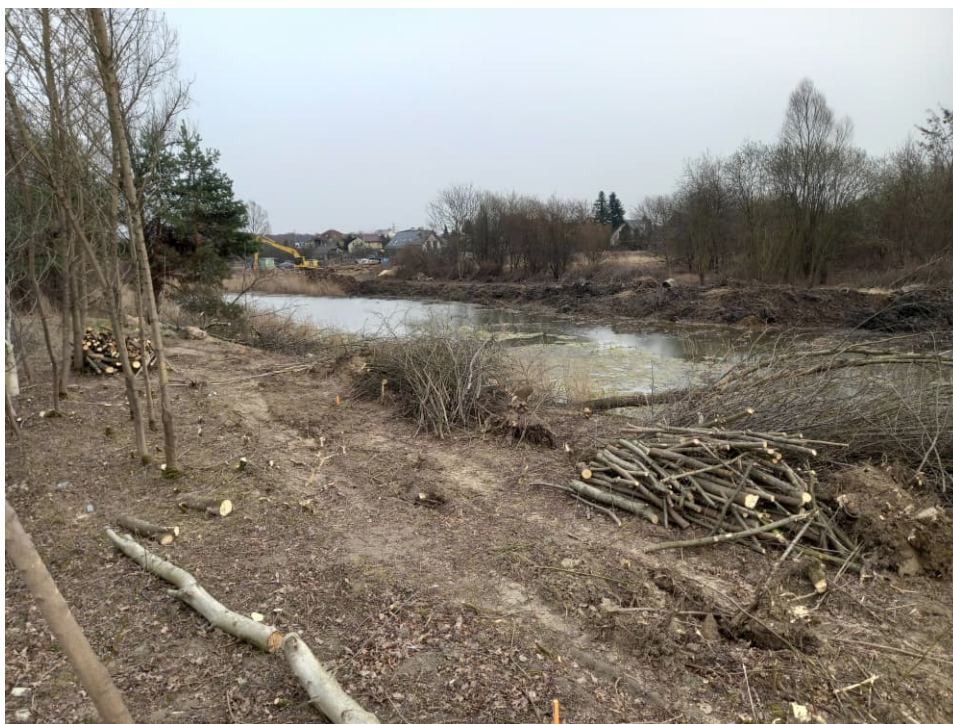
Fig. 9. Site condition in the first month of the works implementation period – redeveloped reservoir on the Ditch 2, eastern part, status in the third decade of March 2022 (view towards the east).

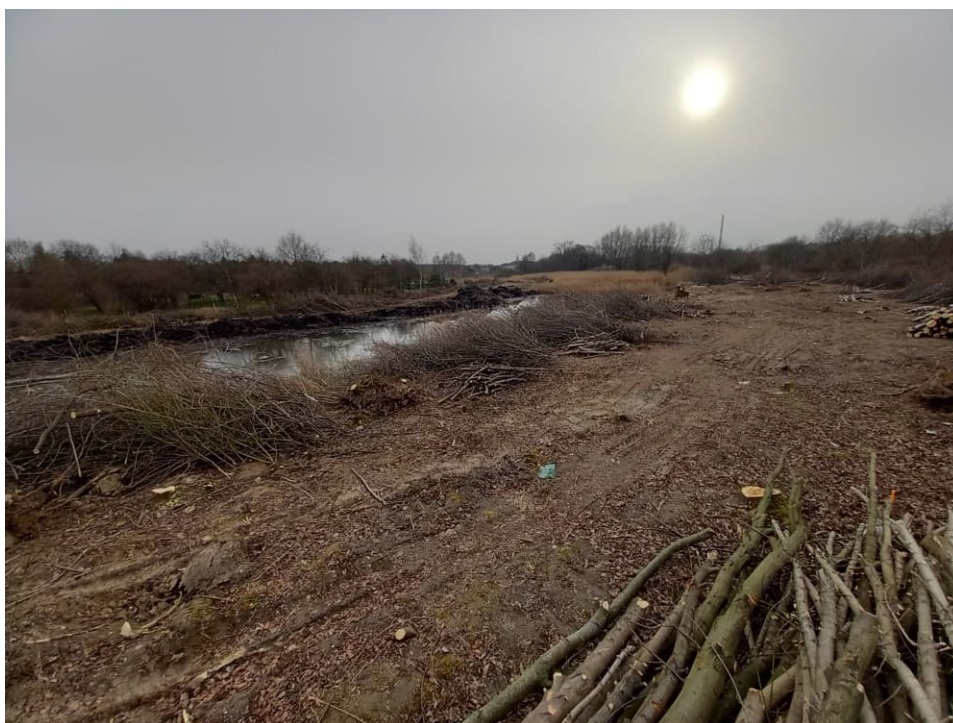
Fig. 10. Site condition in the first month of the works implementation period – redeveloped reservoir on the Ditch 2, western part, status in the third decade of March 2022 (view towards the west).

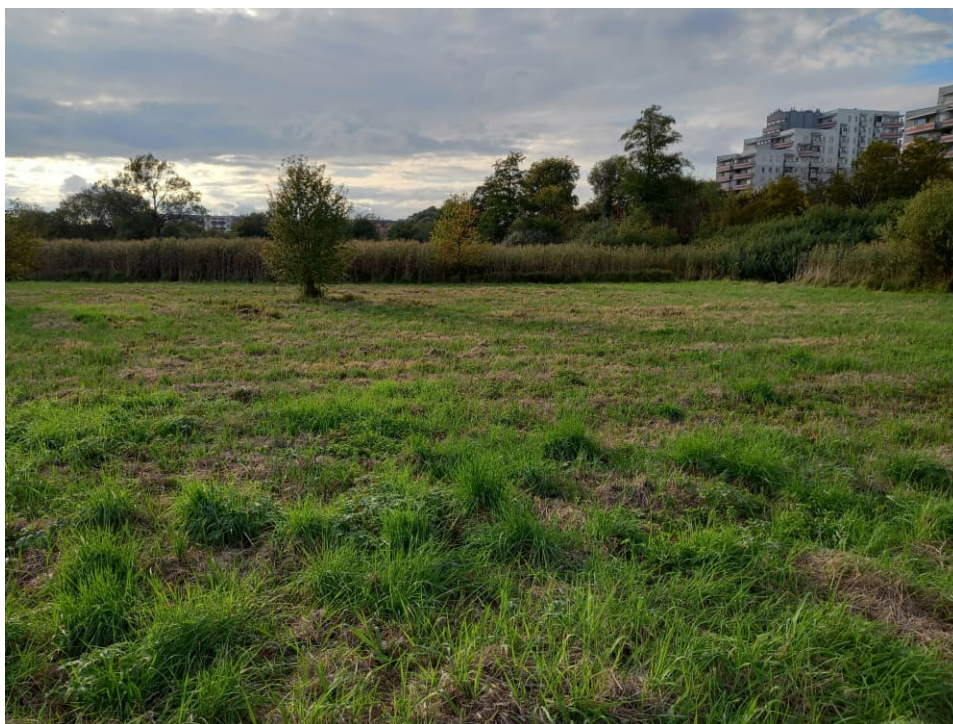
Fig. 11. Condition of the replacement planting area prior to the start of planting – plot no. 158 within the cadastral area of NH 54 in Cracow, status in the third decade of September 2022 (view towards the north-west).

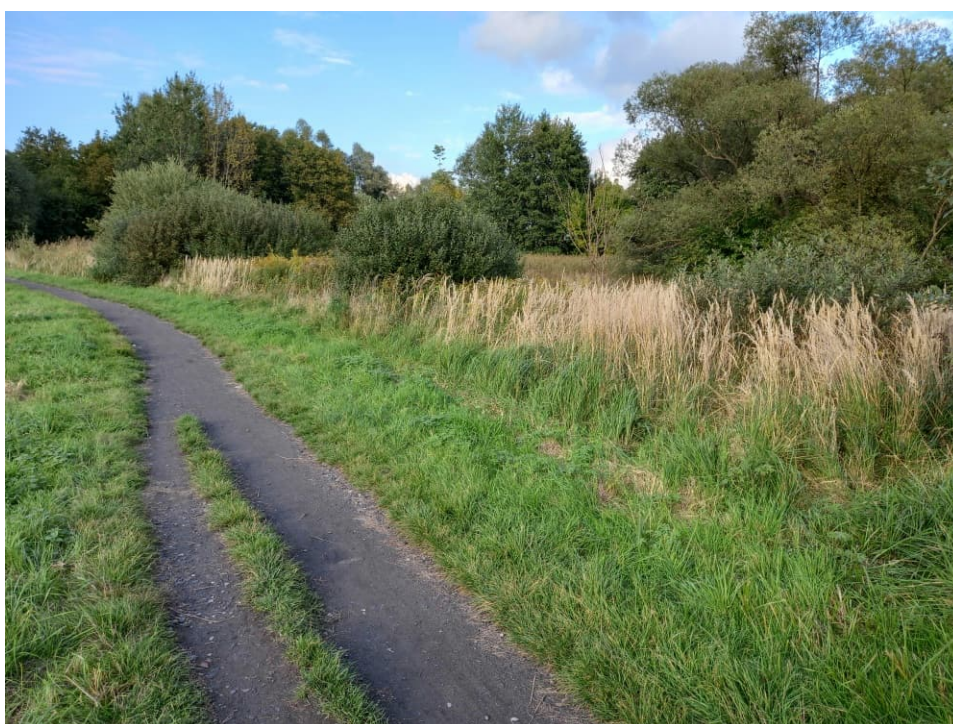
Fig. 12. Condition of the replacement planting area prior to the start of planting – plot no. 159 within the cadastral area of NH 54 in Cracow, status in the third decade of September 2022 (view towards the east).

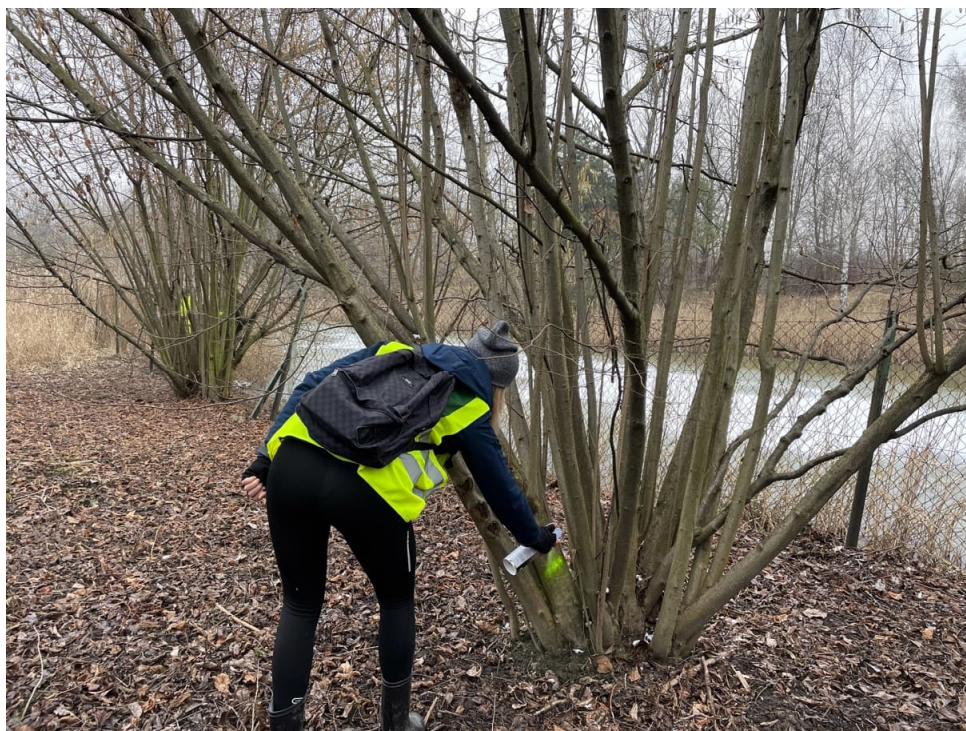
Fig. 13. Inspection of environmental supervision prior to the start of tree felling, status in the second half of March 2022 (view towards the west).

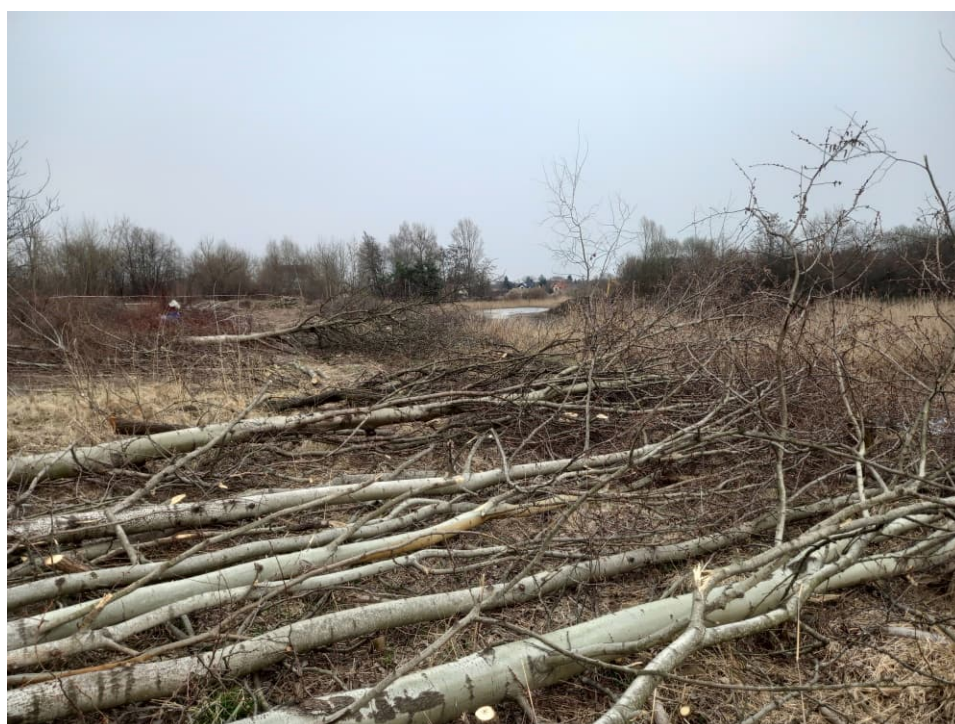
Fig. 14. Tree felling on the northern bank of the reservoir on the Ditch 2, status in the second half of March 2022 (view towards the east).

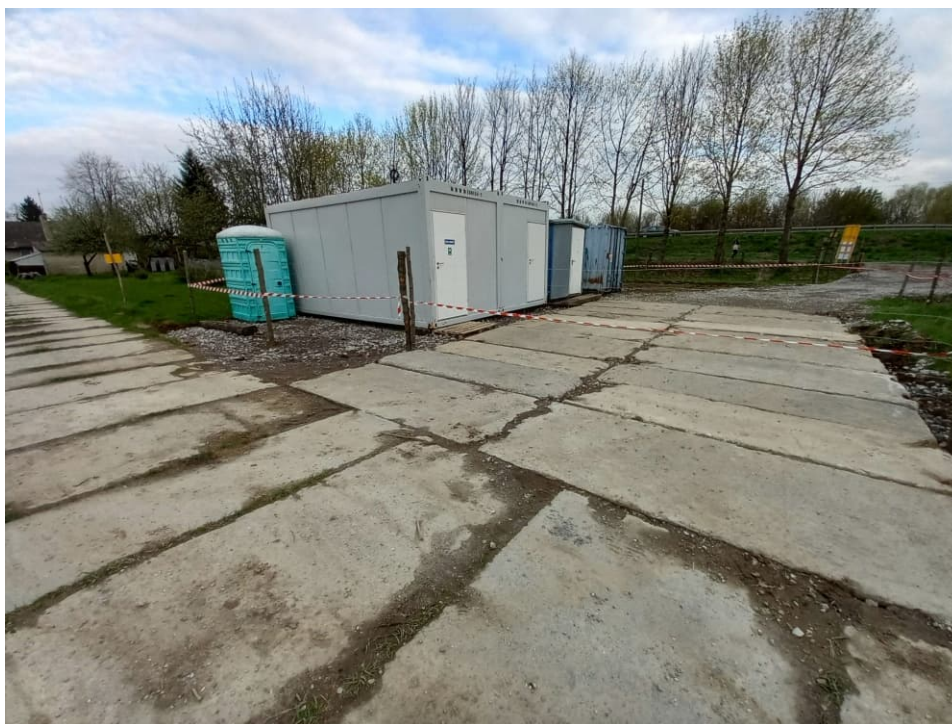
Fig. 15. Site facilities in the area beyond the left Vistula embankment, status in the third decade of April 2022 (view towards the south).

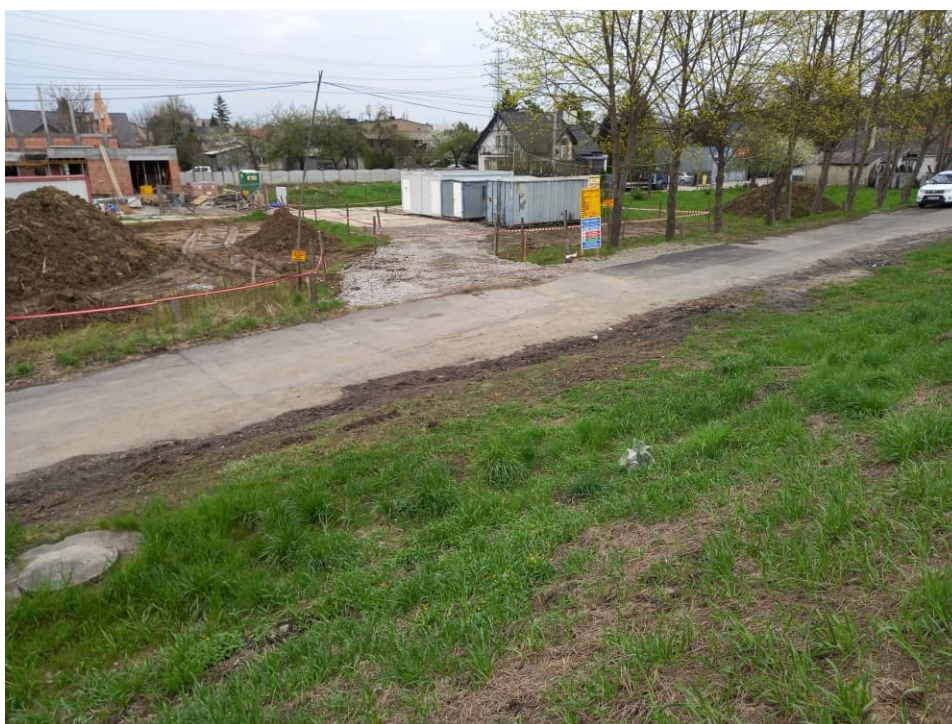
Fig. 16. Marking of the entrance to the construction site from the Zagloby Street, status in the third decade of April 2022 (view towards the north-east).

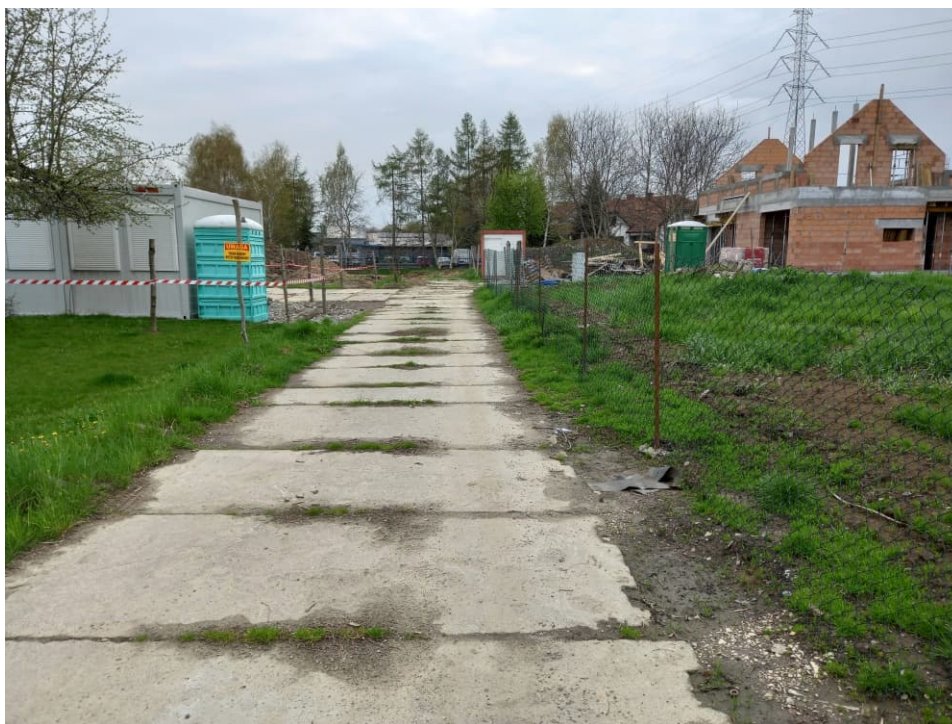
Fig. 17. Marking of the entrance to the construction site from the Klasztorna Street, status in the third decade of April 2022 (view towards the west).

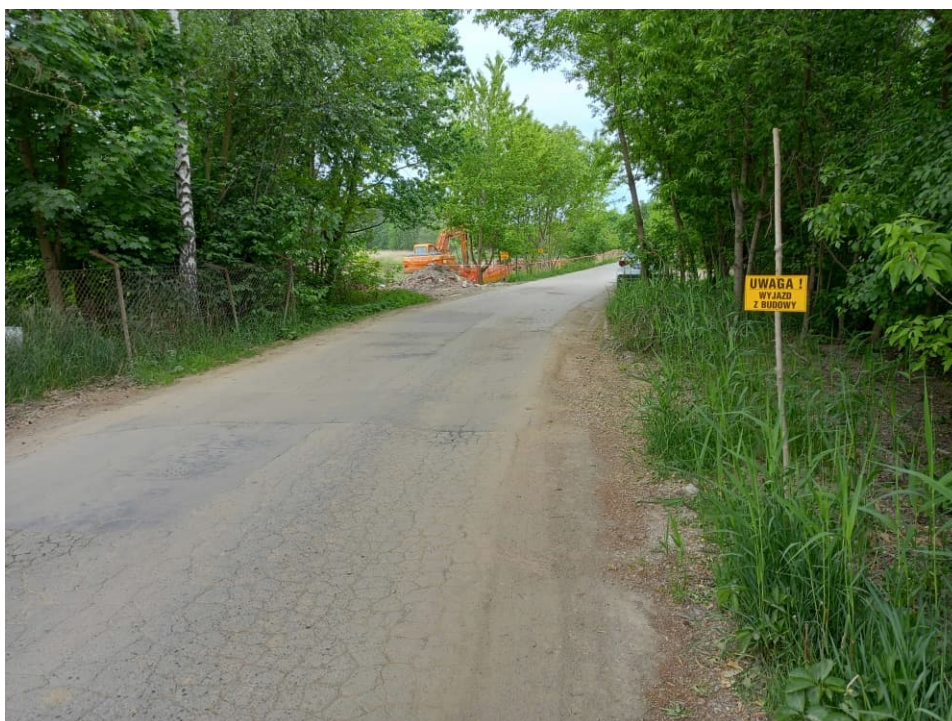
Fig. 18. Marking of the entrance to the construction site from the Odmetowa Street, status in the third decade of April 2022 (view towards the west).

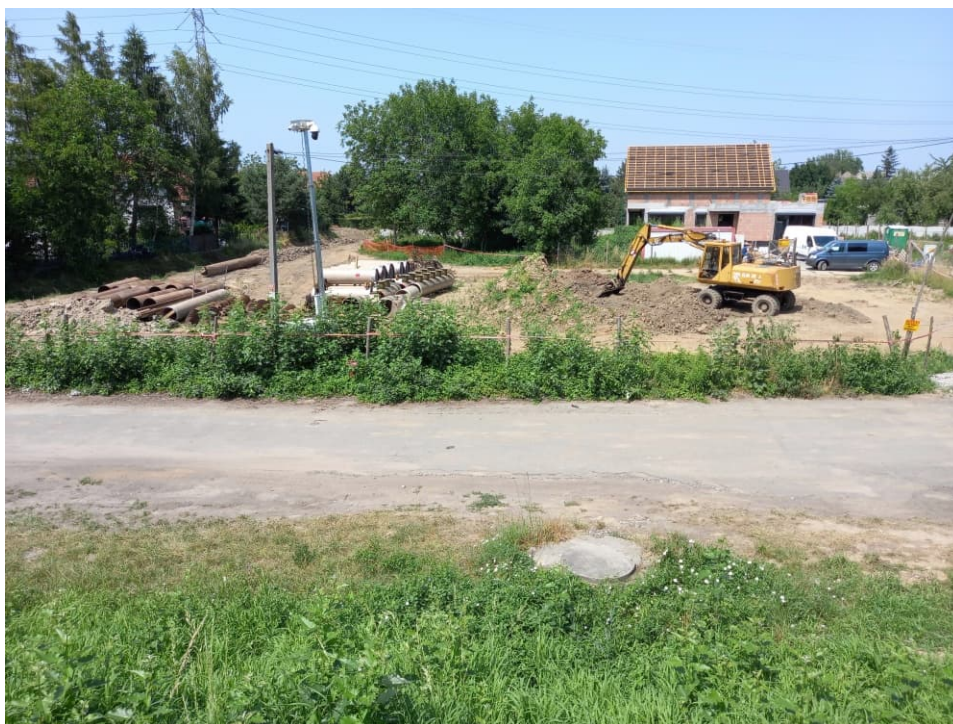
Fig. 19. Fencing of the construction site along the Zagloby Street, status in the third decade of June 2022 (view towards the north).

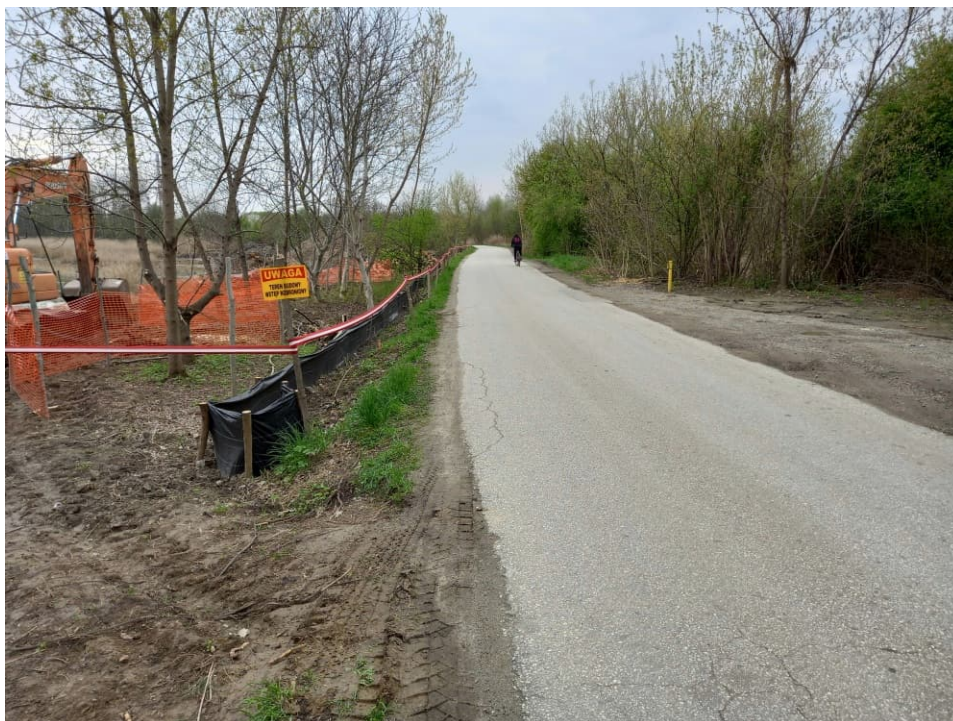
Fig. 20. Fencing of the construction site along the Odmetowa Street, status in the third decade of April 2022 (view towards the west).

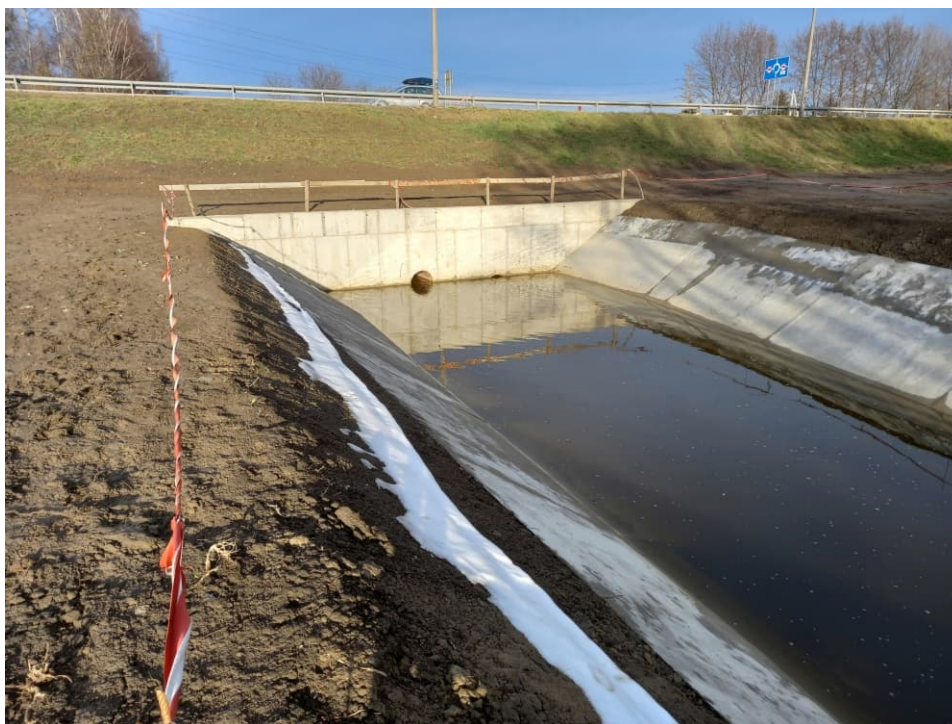
Fig. 21. Protection of hazardous sites on the construction area of embankment lock on the Ditch 2a within the embanked area of the Vistula River, status in the third decade of December 2022 (view towards the north).

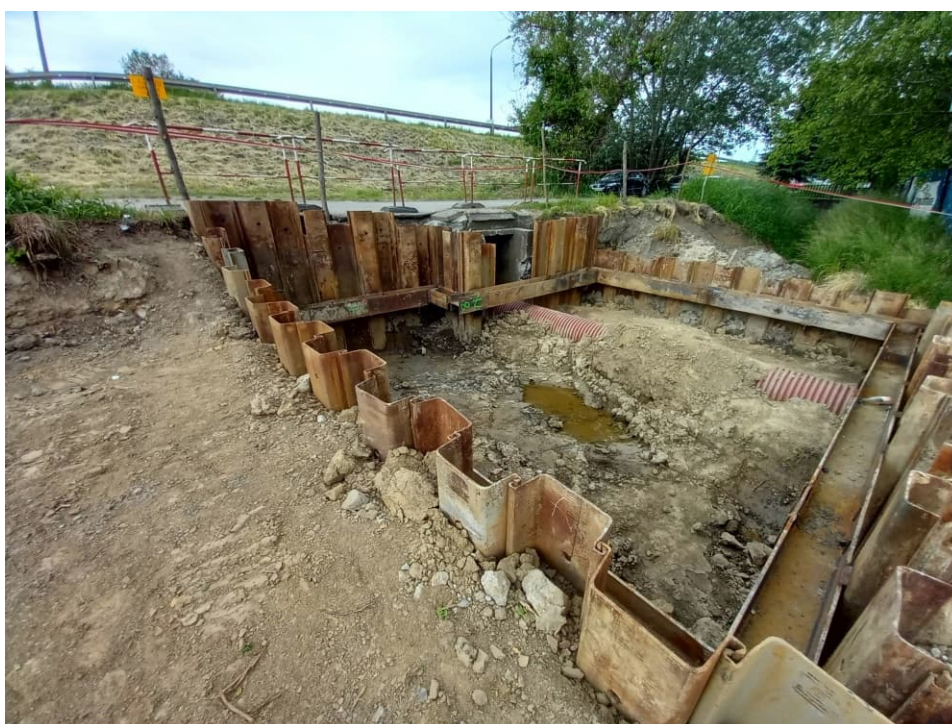
Fig. 22. Protection of hazardous sites on the construction area of embankment lock on the Ditch 2a within the area beyond the Vistula River embankment, status in the third decade of July 2022 (view towards the north).

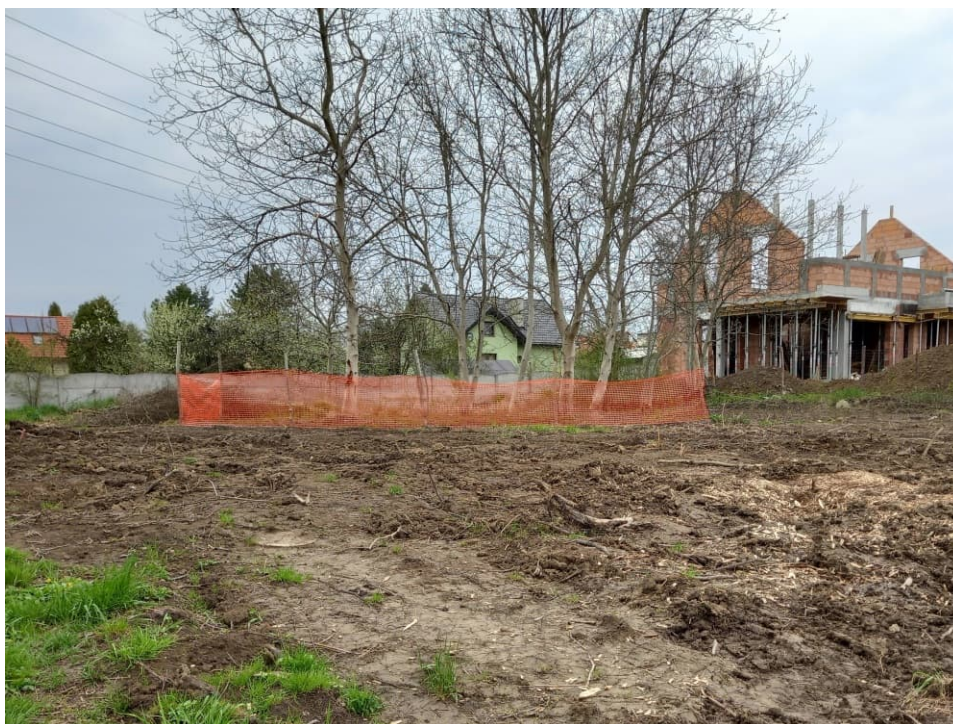
Fig. 23. Protection of trees not intended to felling
in the vicinity of construction area of site flood storage reservoir on the Ditch 2a,
status in the third decade of April 2022
(view towards the north).

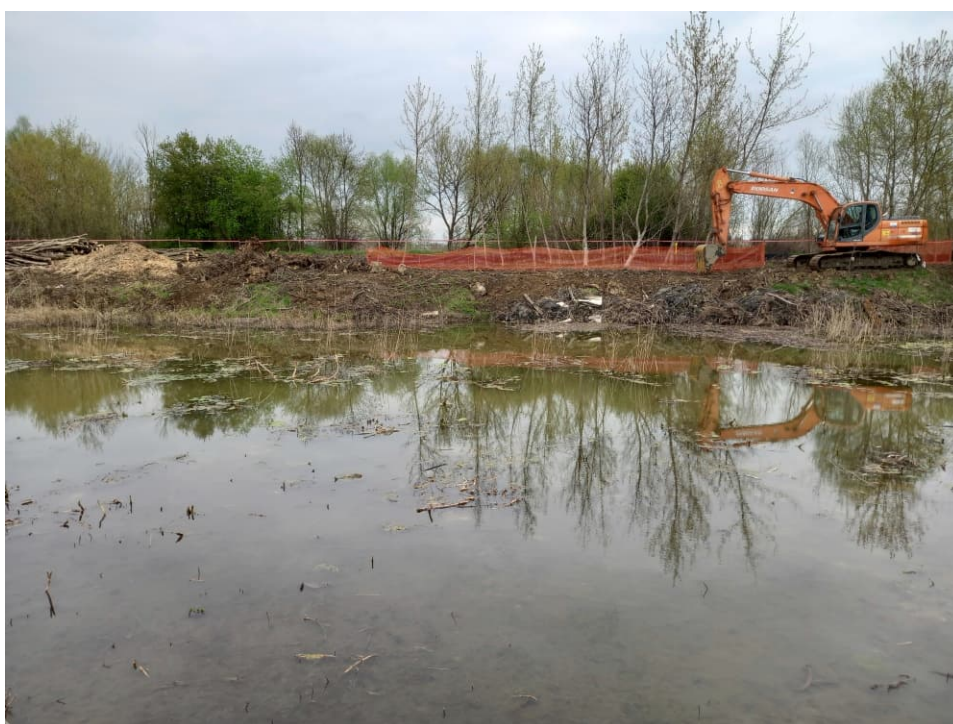
Fig. 24. Protection of trees not intended to felling
on the northern bank of redeveloped reservoir on the Ditch 2,
status in the third decade of April 2022
(view towards the north).

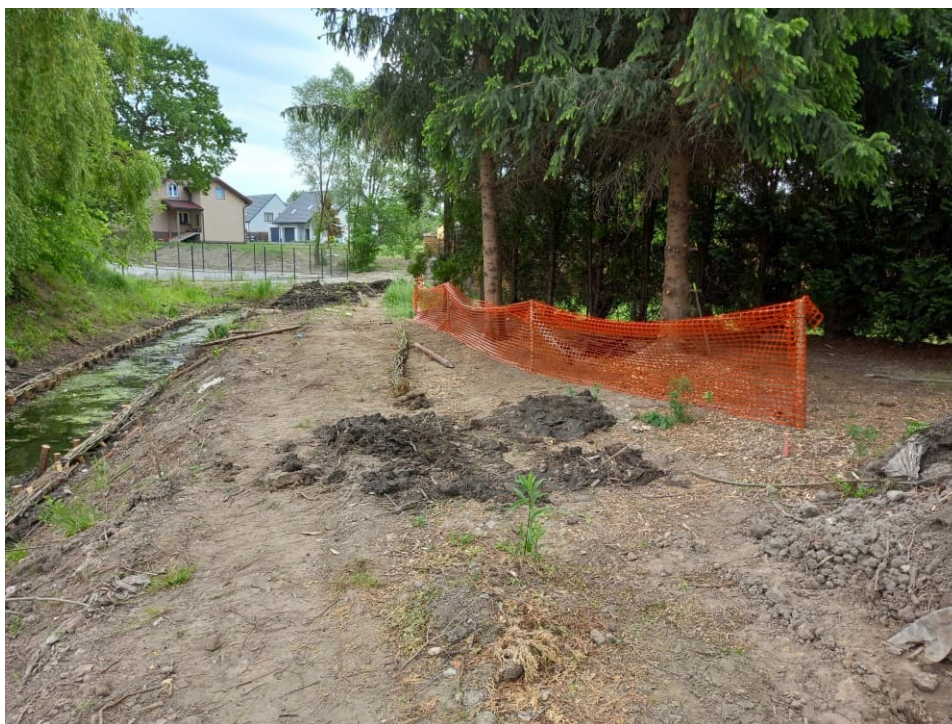
Fig. 25. Protection of trees not intended to felling
in the vicinity of construction area on the Ditch 2,
status in the third decade of May 2022
(view towards the east).

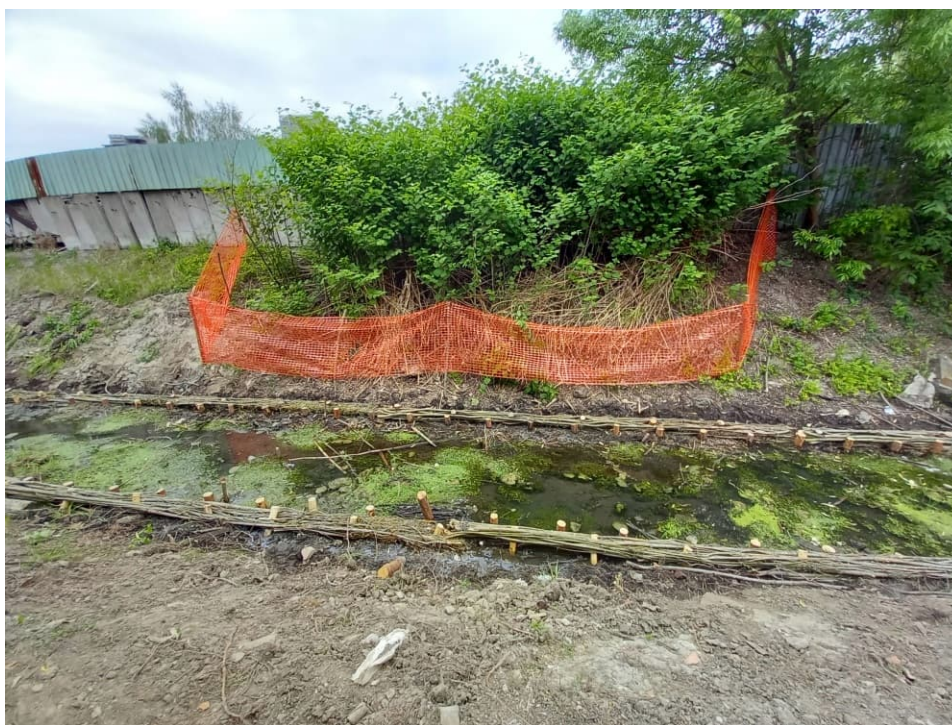
Fig. 26. Preventing the spread of foreign invasive plant species
– fencing off knotweed site on the northern bank of the Ditch 2,
status in the third decade of May 2022
(view towards the north).

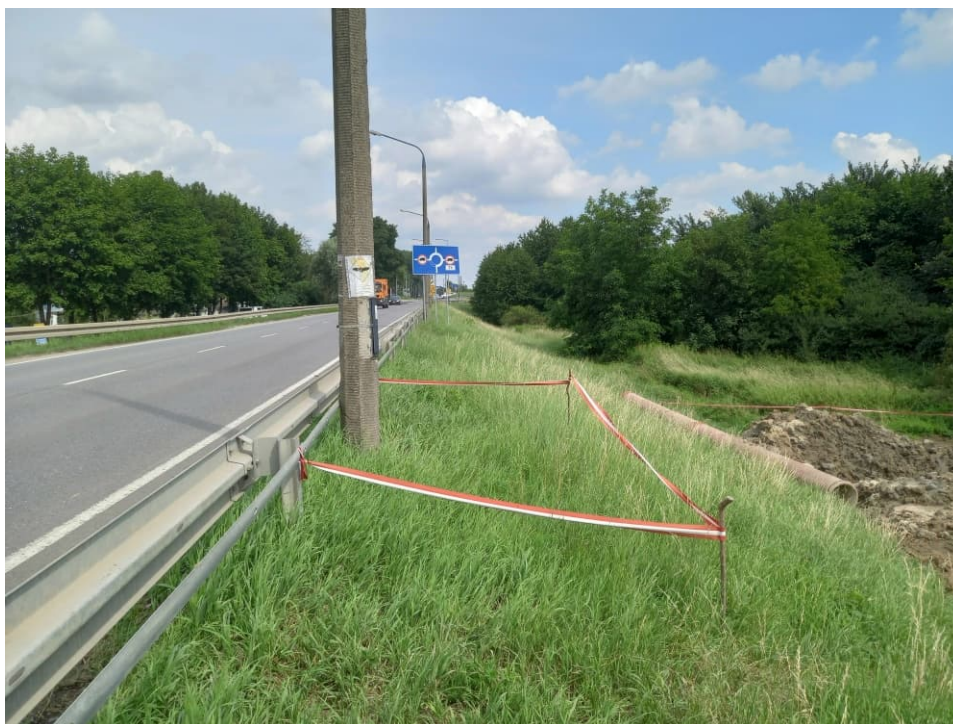
Fig. 27. Protection of bat site in a street lamp at the Podbipiety Street, status in the third decade of July 2022 (view towards the east).

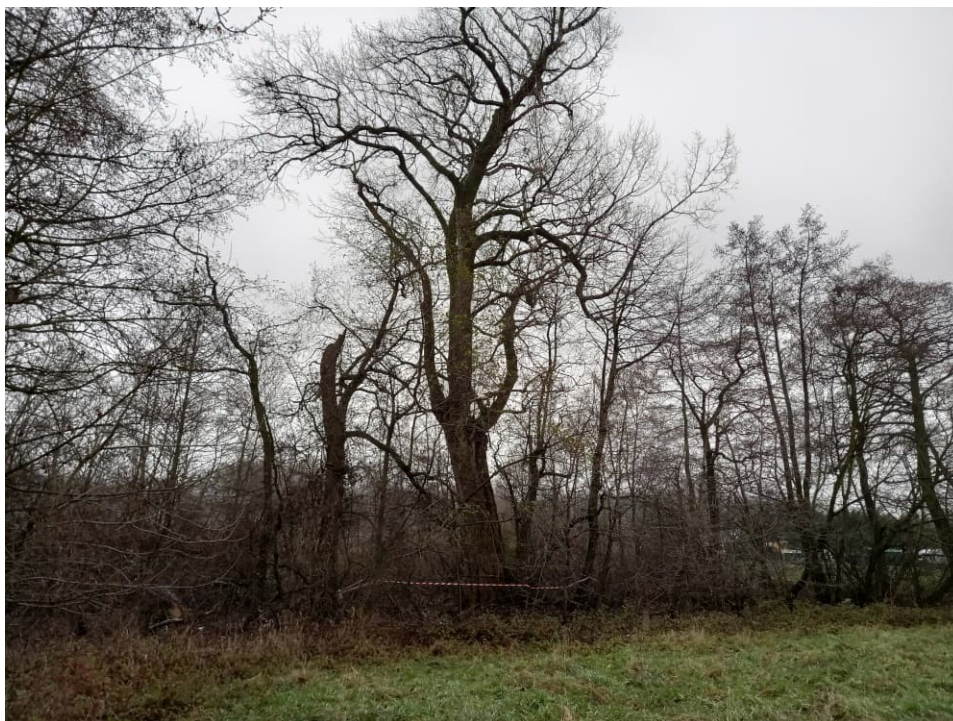
Fig. 28. Protection of bat site in an old poplar tree south-west of the reservoir on the Ditch 2, status in the third decade of November 2022 (view towards the south).

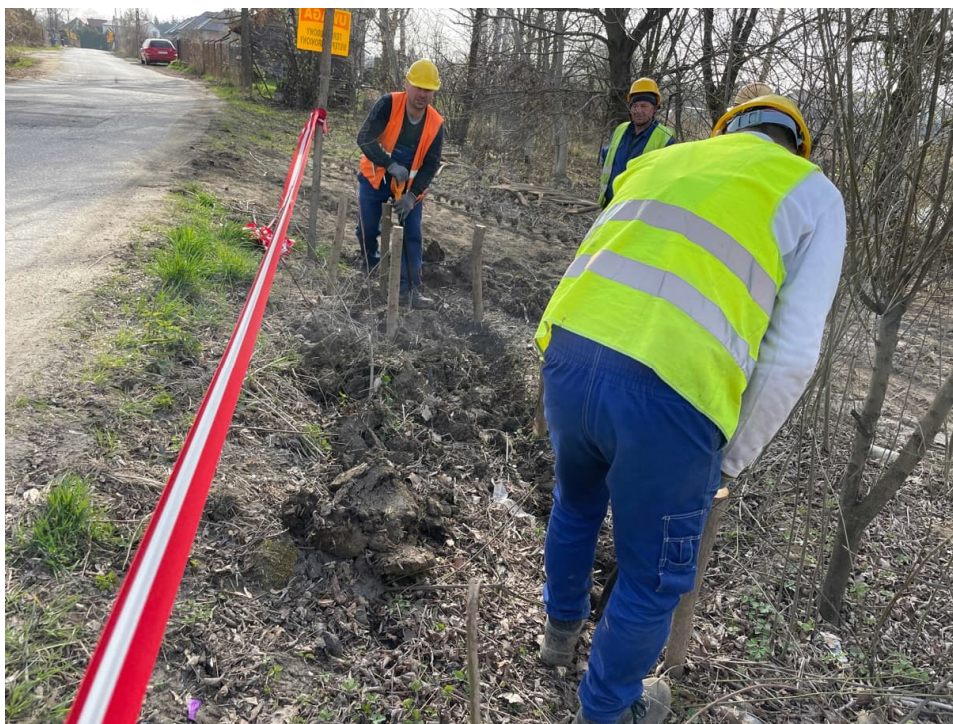
Fig. 29. Construction of herpetological fence on the northern bank of the redeveloped reservoir on the Ditch 2, status in the second half of April 2022 (view towards the east).

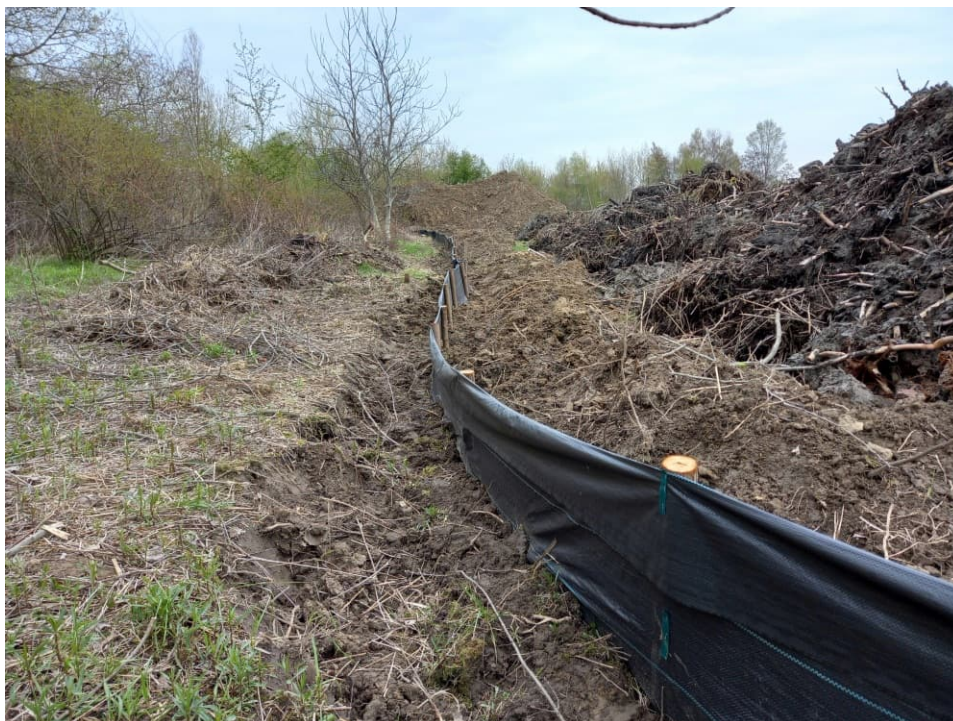
Fig. 30. Herpetological fence on the northern bank of the redeveloped reservoir on the Ditch 2, status in the third decade of April 2022 (view towards the east).

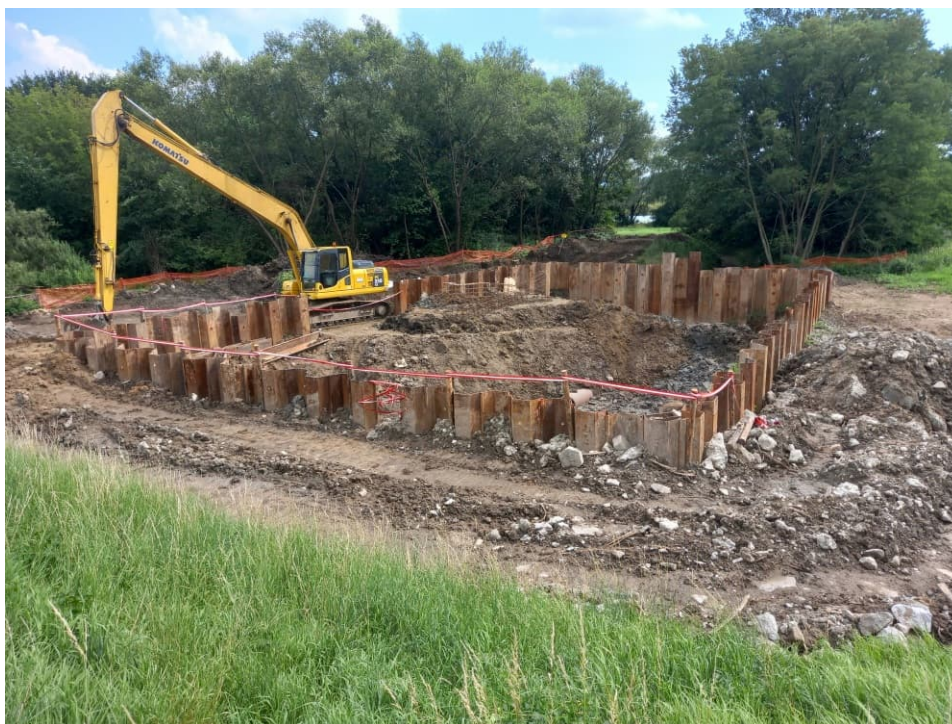
Fig. 31. Earthworks on the construction area of embankment lock on the Ditch 2a within the embanked area of the Vistula River, status in the third decade of July 2022 (view towards the south).
