PHOTO DOCUMENTATION

to the Final Report on implementation of measures determined in EMP
for the Contract 3A.6

Odra-Vistula Flood Management Project

OVFMP Subcomponent	3A Flood Protection of Upper Vistula Towns and Cracow
Contract Task	3A.6 Construction of a pumping station for mobile pumps to drain the Lesisko complex
Investor / Project Implementation Unit	State Water Holding Polish Waters Regional Water Management Authority in Cracow 22. Marszałka J. Piłsudskiego Street, 31-109 Cracow, Poland
Project Implementation Office (PIO)	Project Implementation Office in Cracow 22. Marszałka J. Piłsudskiego Street, 31-109 Cracow, Poland
Contractor of Works	Przedsiębiorstwo Budownictwa Wodno-Inżynieryjnego w Krakowie Sp. z o.o. 17. Bogucka Street, 30-020 Wieliczka, Poland
Engineer	AECOM Polska Sp. z o.o. Project Office: 1. Pokoju Alley, 31-548 Cracow, Poland

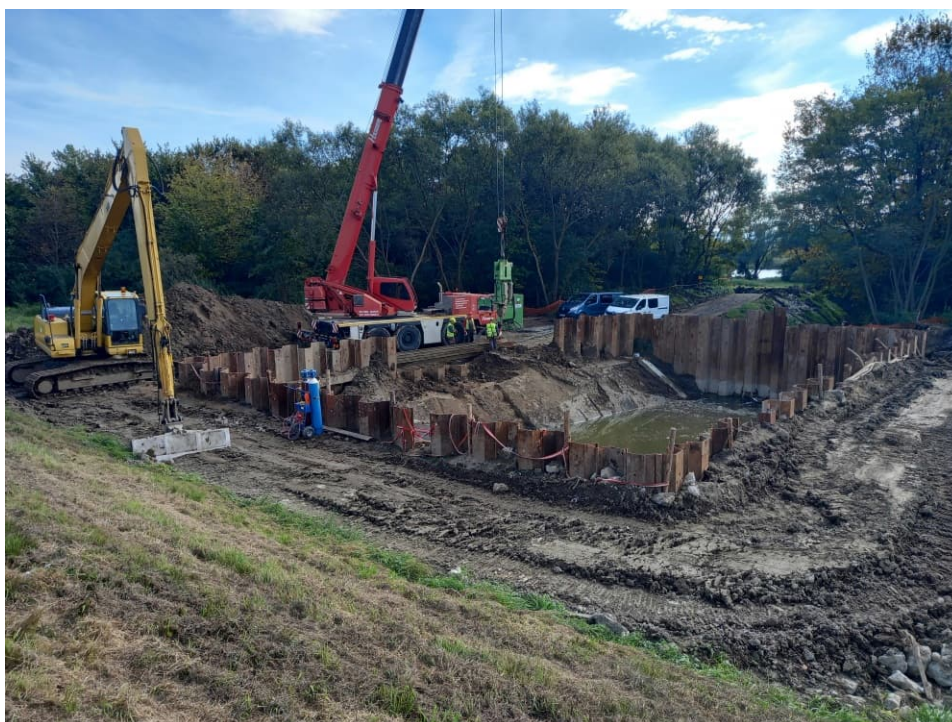
Fig. 32. Removal of sheet piling on the construction area of embankment lock on the Ditch 2a within the embanked area of the Vistula River, status in the third decade of September 2022 (view towards the south).

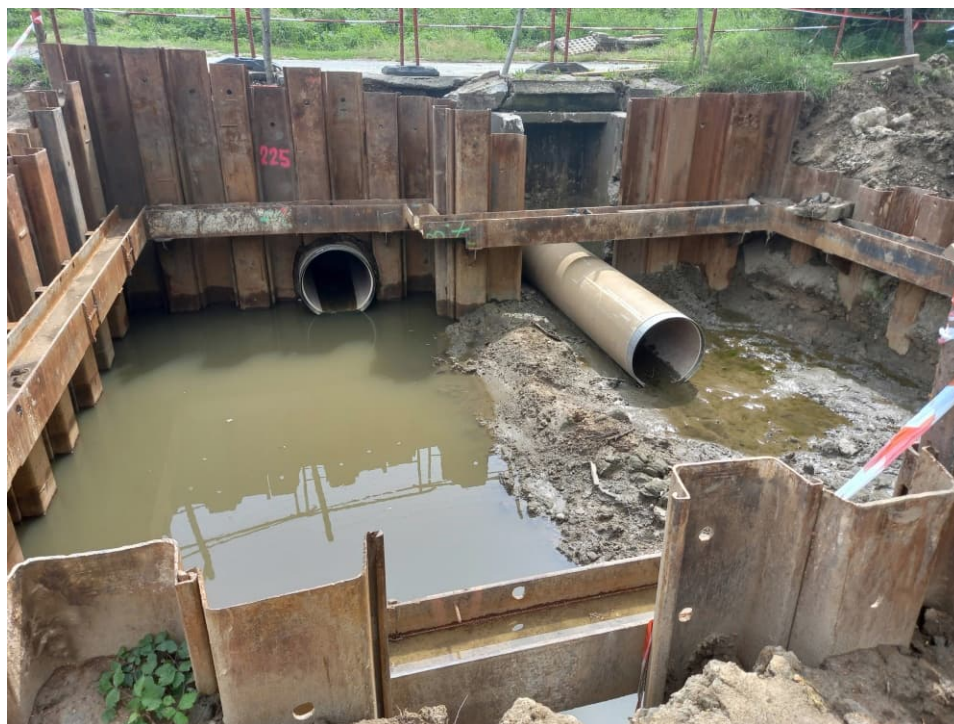
Fig. 33. Redeveloped gravity pipeline (right) and new pressure pipeline (left) on the construction area of embankment lock on the Ditch 2a, status in the third decade of July 2022 (view towards the south).

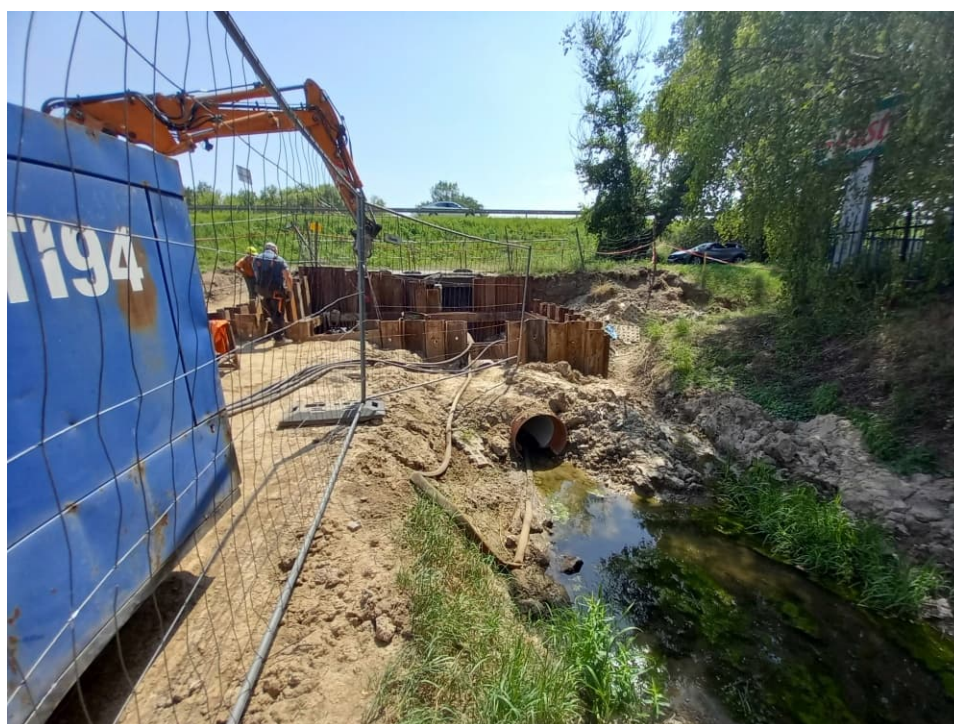
Fig. 34. Ensuring water flow in the Ditch 2a during works at the embankment lock, status in the third decade of June 2022 (view towards the south).

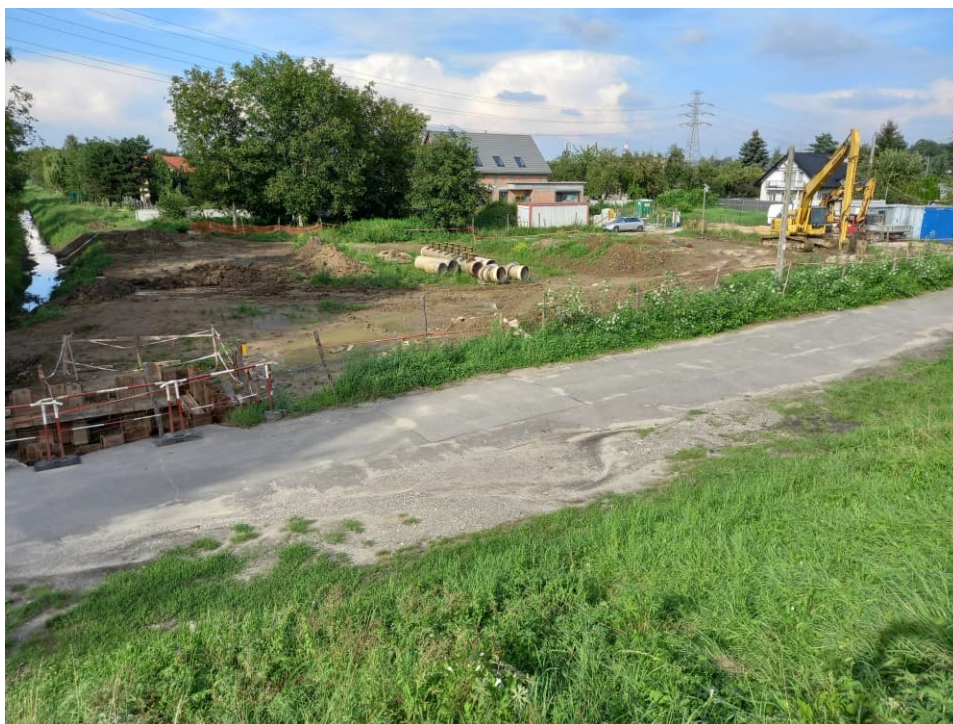
Fig. 35. Earthworks at the construction of flood storage reservoir on the Ditch 2a, status in the third decade of August 2022 (view towards the north).

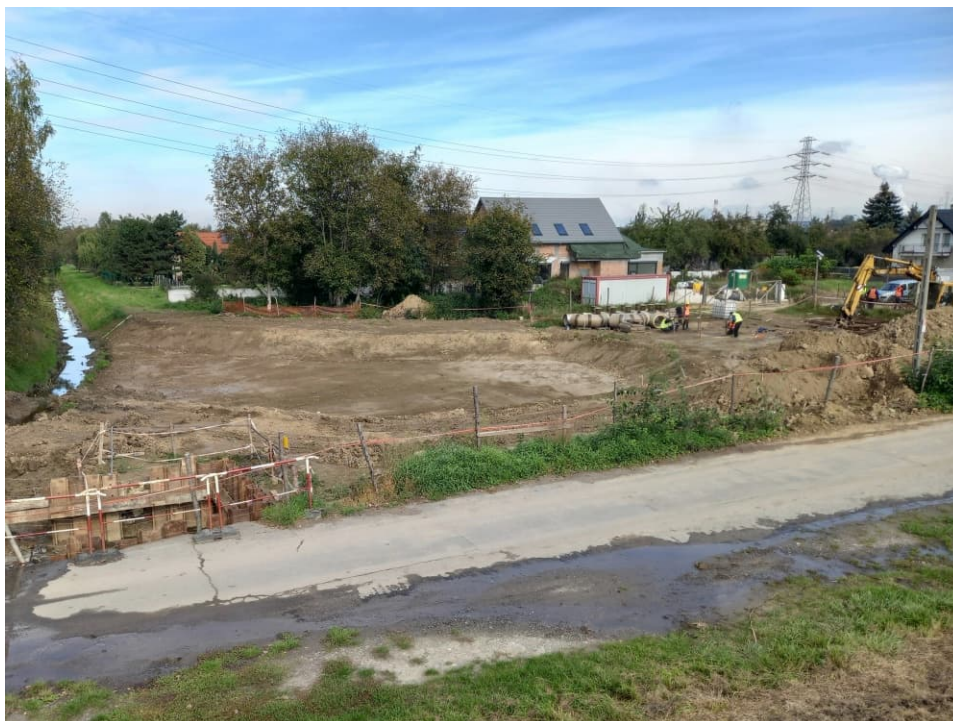
Fig. 36. Formation of slopes of flood storage reservoir on the Ditch 2a, status in the third decade of September 2022 (view towards the north).

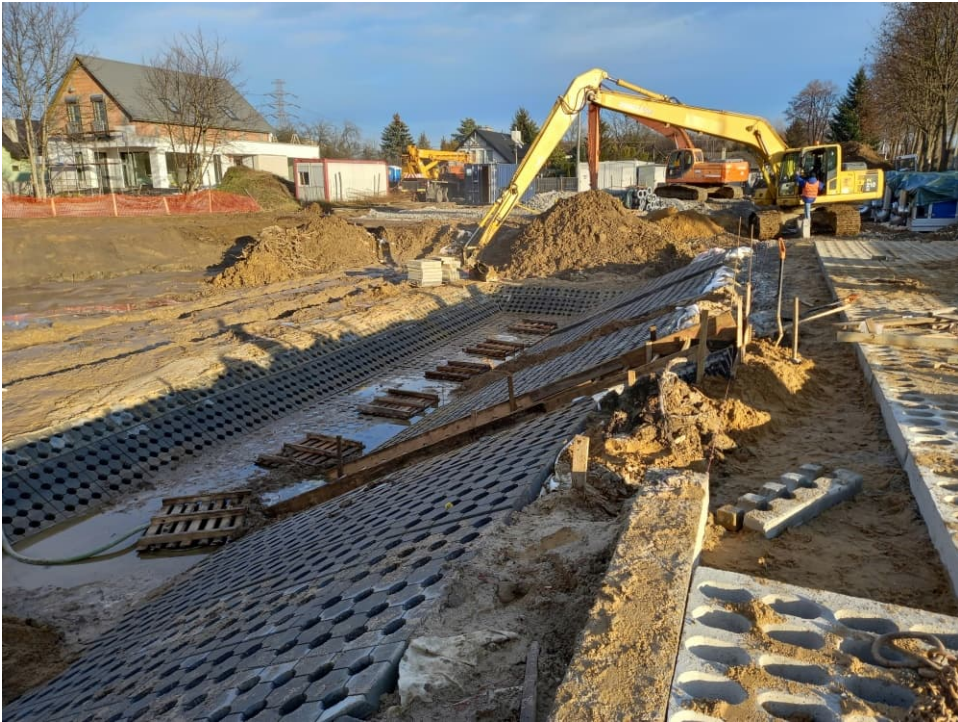
Fig. 37. Construction of a pumping station for mobile pumps on the Ditch 2a, status in the third decade of December 2022 (view towards the east).

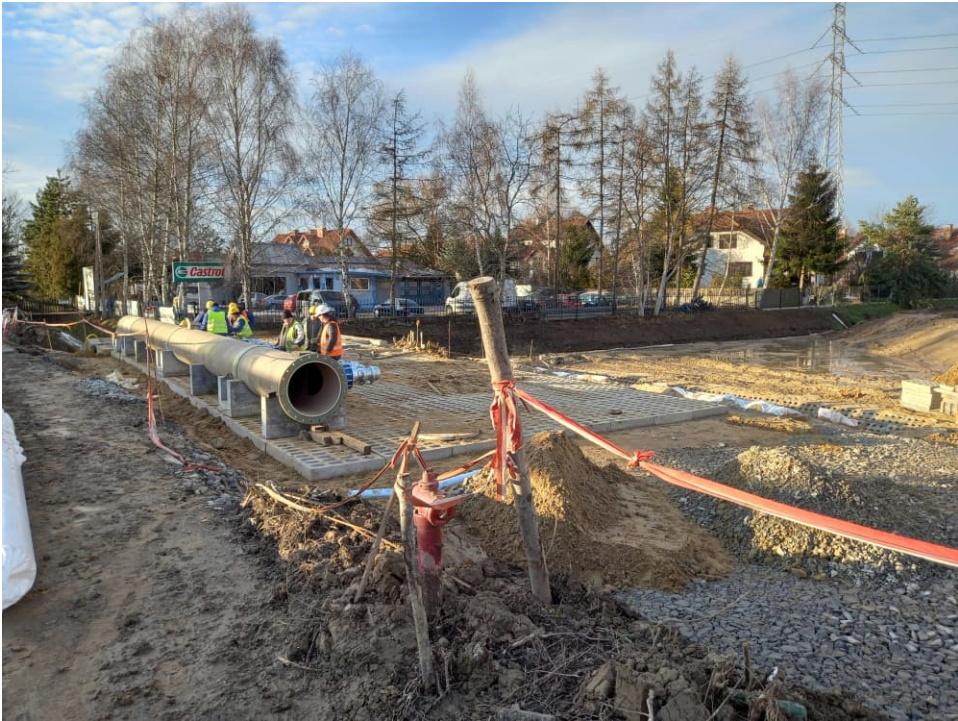
Fig. 38. Construction of a pumping station for mobile pumps on the Ditch 2a, status in the third decade of December 2022 (view towards the west).

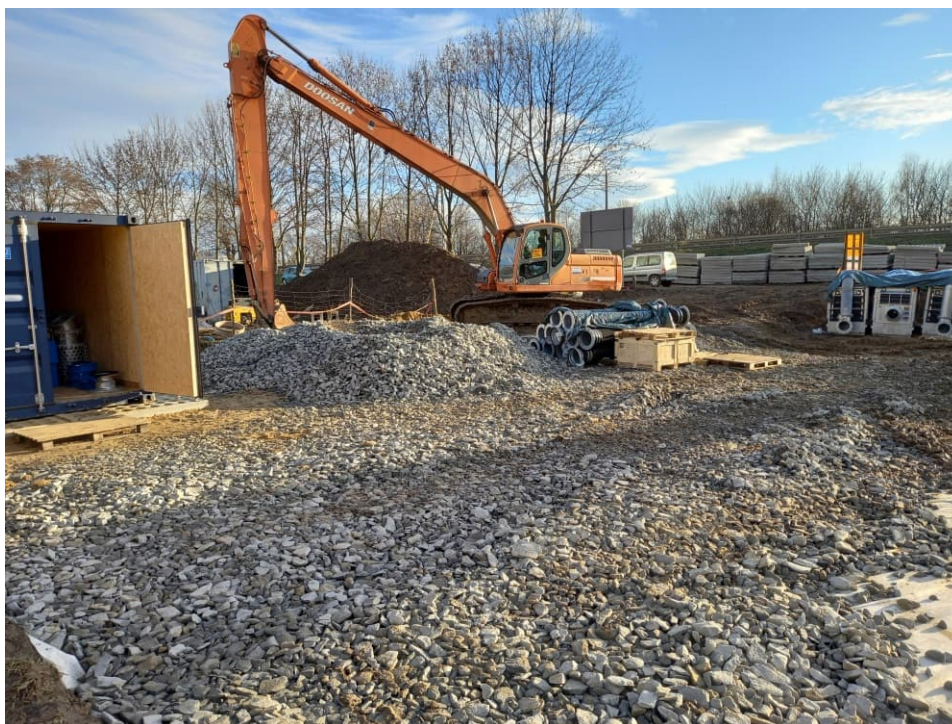
Fig. 39. Construction of a maneuvering yard
at pumping station for mobile pumps on the Ditch 2a,
status in the third decade of December 2022
(view towards the south-east).

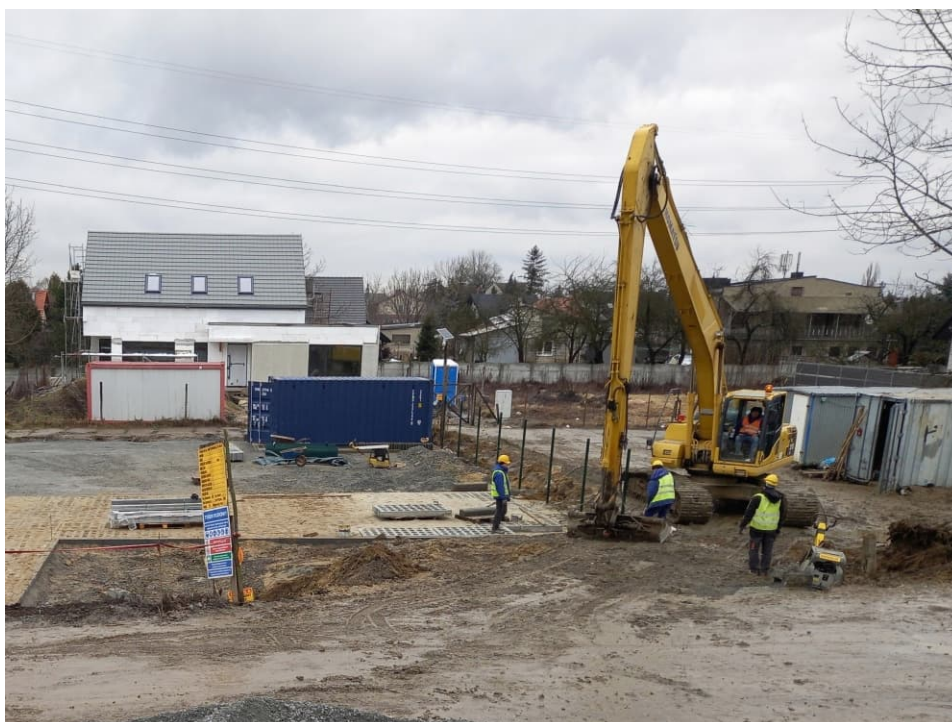
Fig. 40. Land reclamation in the vicinity of maneuvering yard and pumping station
for mobile pumps on the Ditch 2a,
status in the third decade of January 2023
(view towards the north).

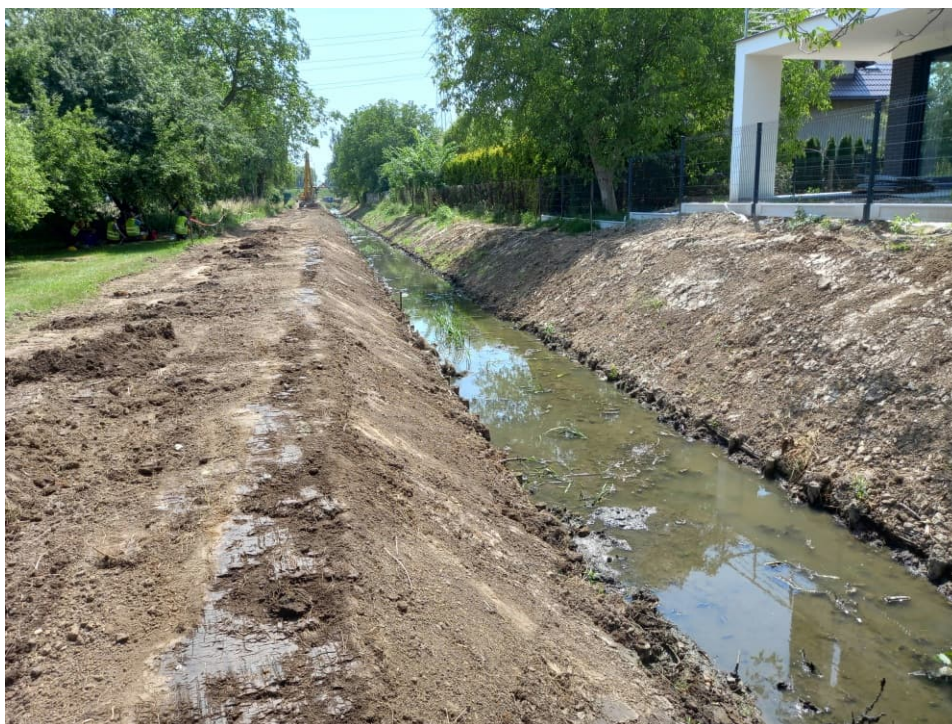
Fig. 41. Formation of bank slopes on the Ditch 2a, status in the third decade of June 2022 (view towards the south).

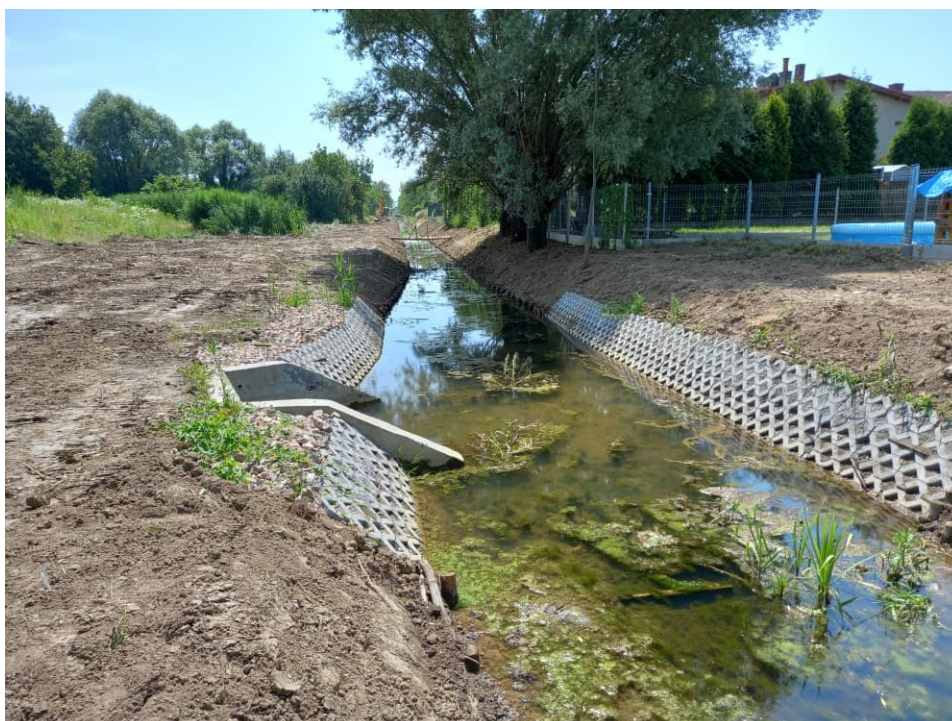
Fig. 42. Bank slopes insurance on the Ditch 2a, status in the third decade of September 2022 (view towards the south).

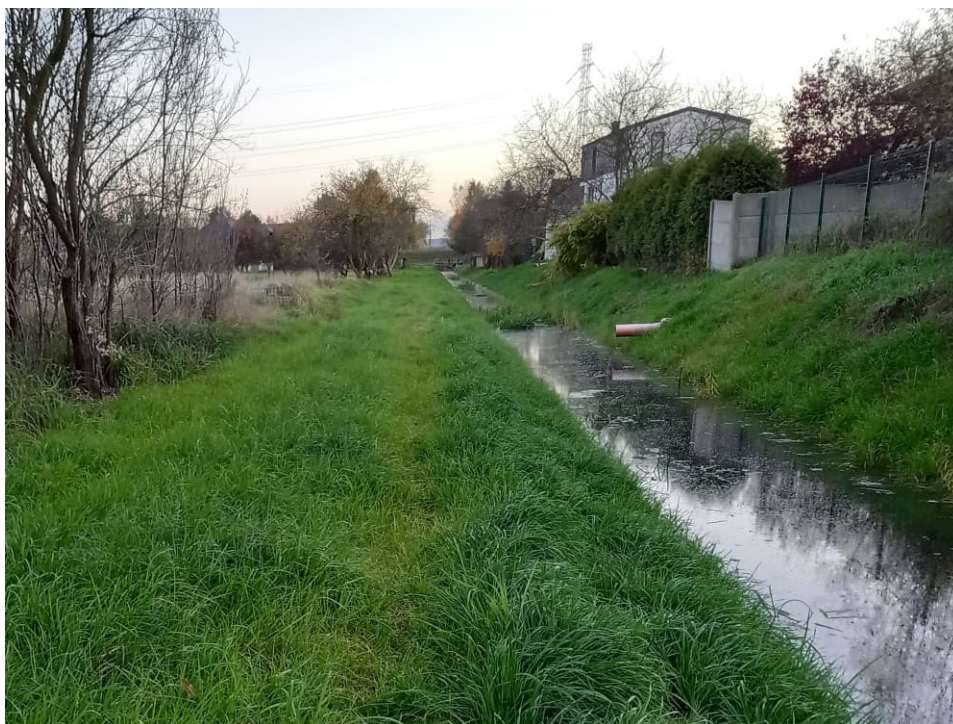
Fig. 43. Growth of grasses sown on the bank slopes on the Ditch 2a, status in the third decade of October 2022 (view towards the south).

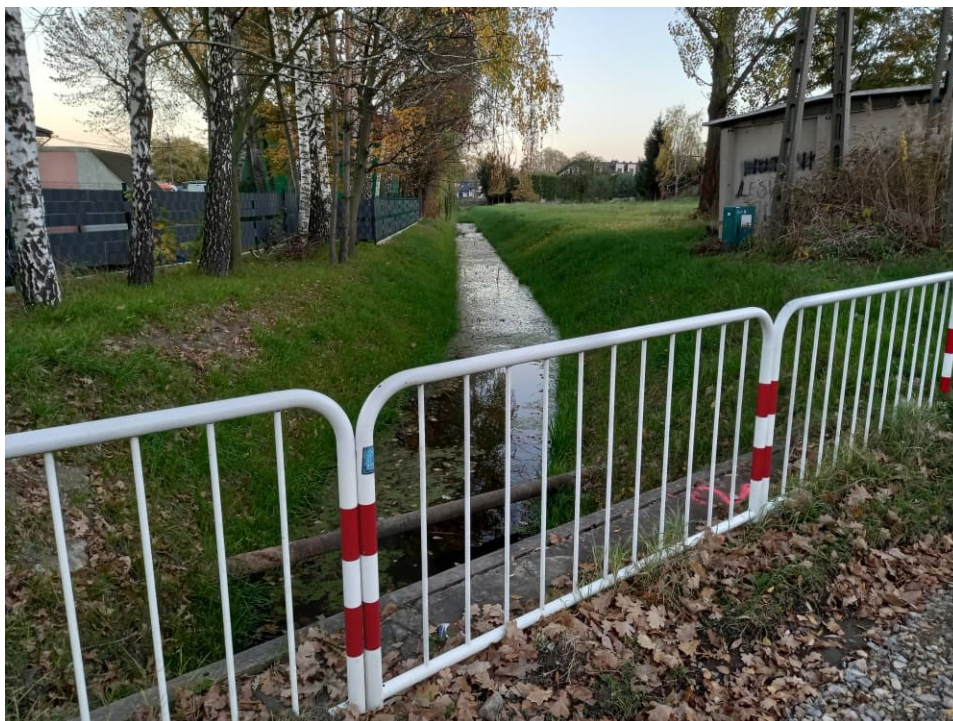
Fig. 44. Growth of grasses sown on the bank slopes on the Ditch 2, status in the third decade of October 2022 (view towards the east).

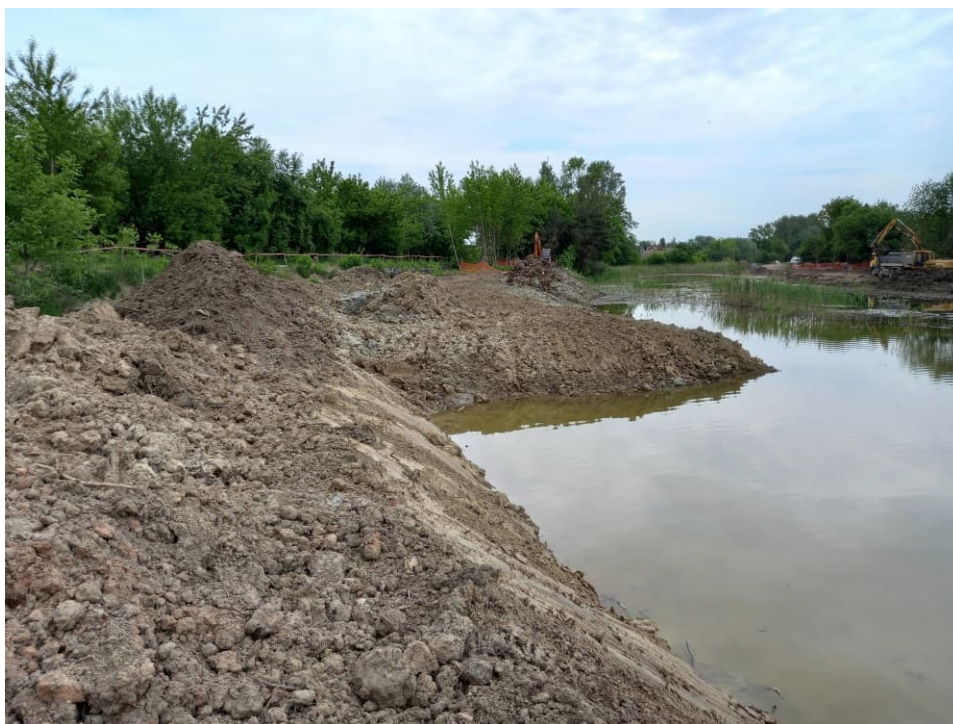
Fig. 45. Earthworks on the northern bank of the redeveloped reservoir on the Ditch 2, status in the third decade of May 2022 (view towards the east).

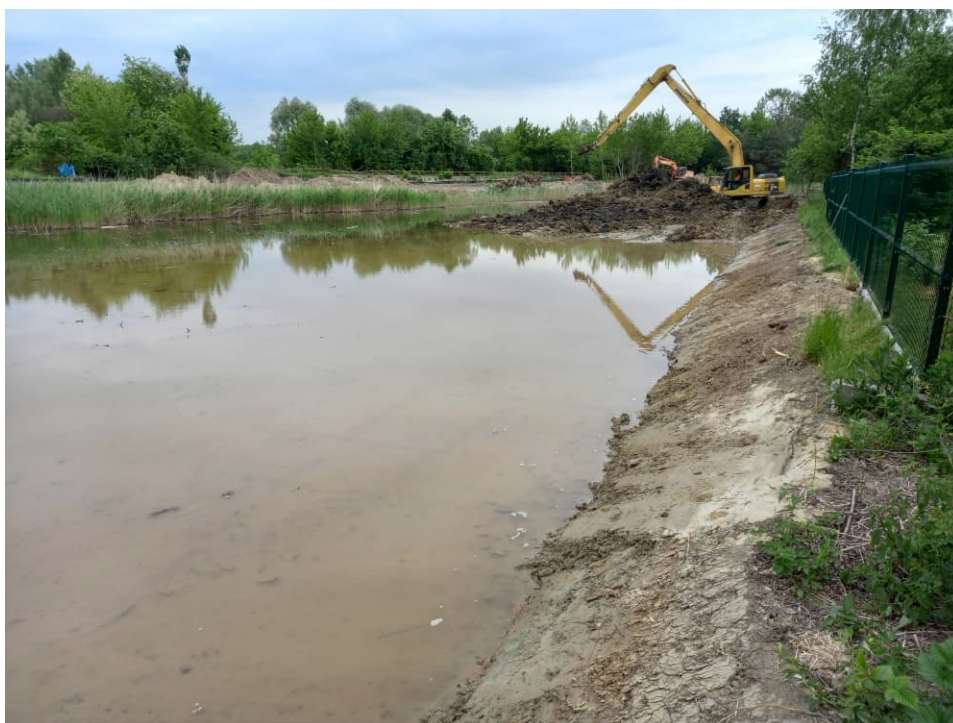
Fig. 46. Earthworks on the southern bank of the redeveloped reservoir on the Ditch 2, status in the third decade of May 2022 (view towards the east).

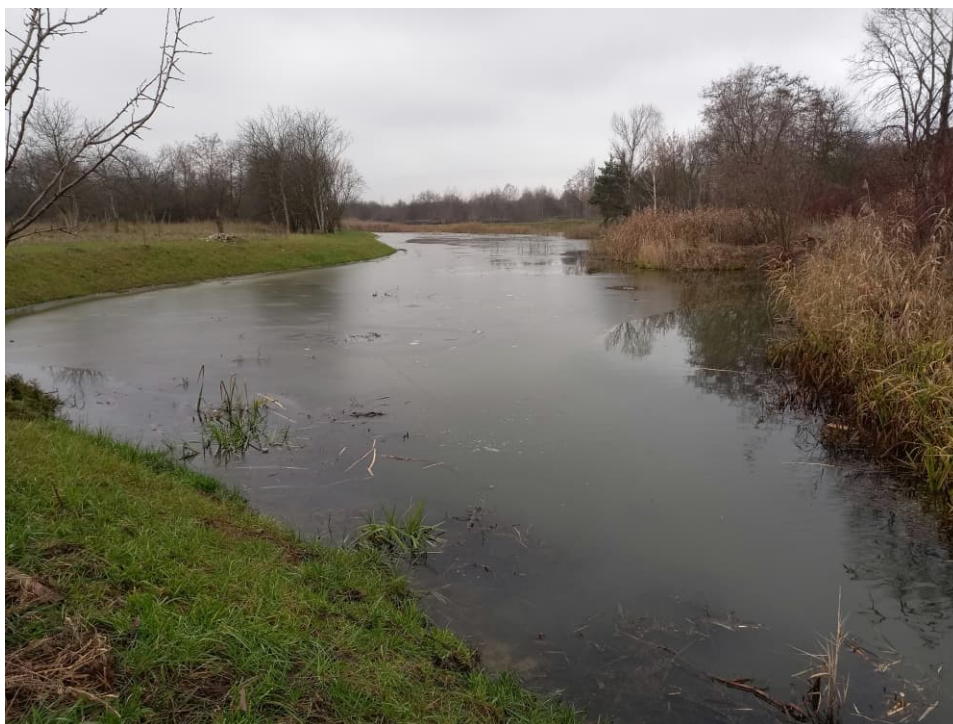
Fig. 47. Regeneration of vegetation
in the eastern part of the redeveloped reservoir on the Ditch 2,
status in the third decade of November 2022
(view towards the west).

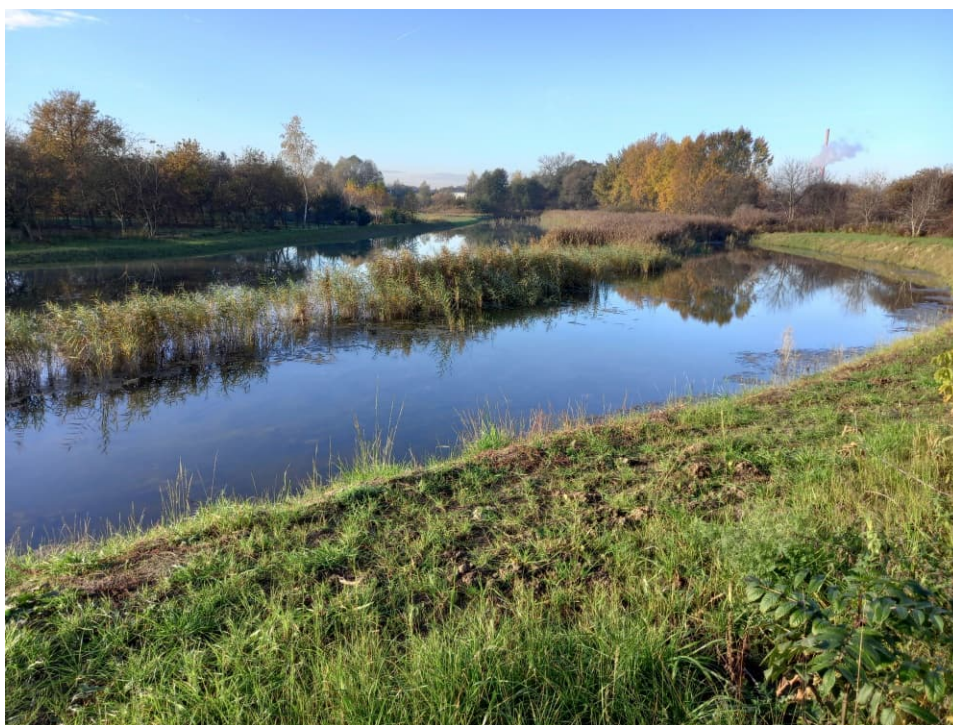
Fig. 48. Regeneration of vegetation
in the western part of the redeveloped reservoir on the Ditch 2,
status in the third decade of October 2022
(view towards the west).

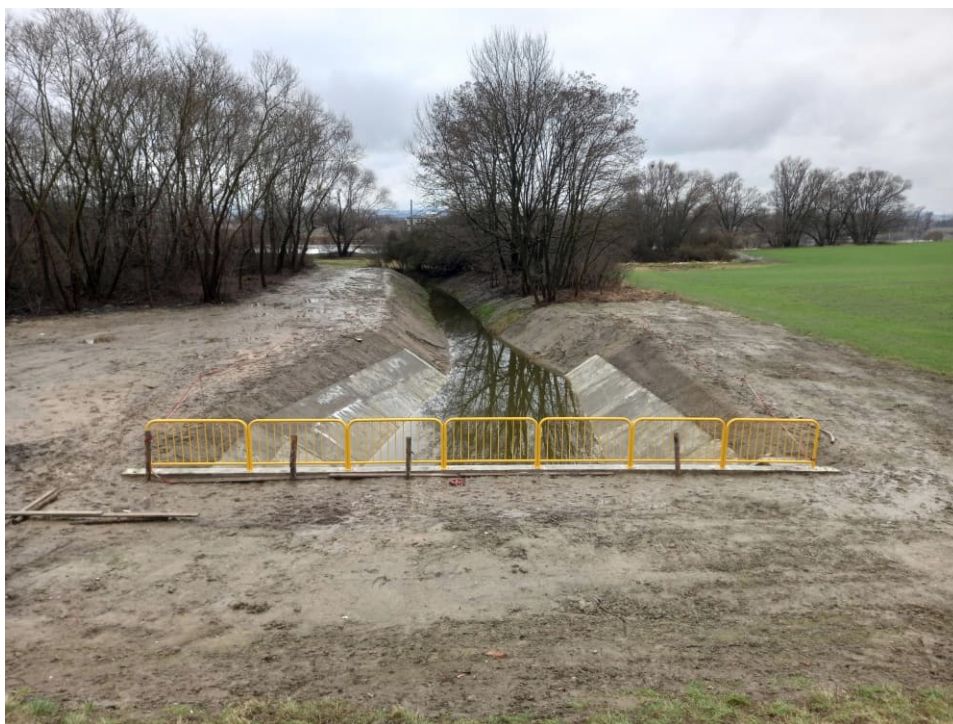
Fig. 49. Site condition in the last month of the works implementation period – construction area of an embankment lock on the Ditch 2a on the embanked area of the Vistula River, status in the third decade of January 2023 (view towards the south).

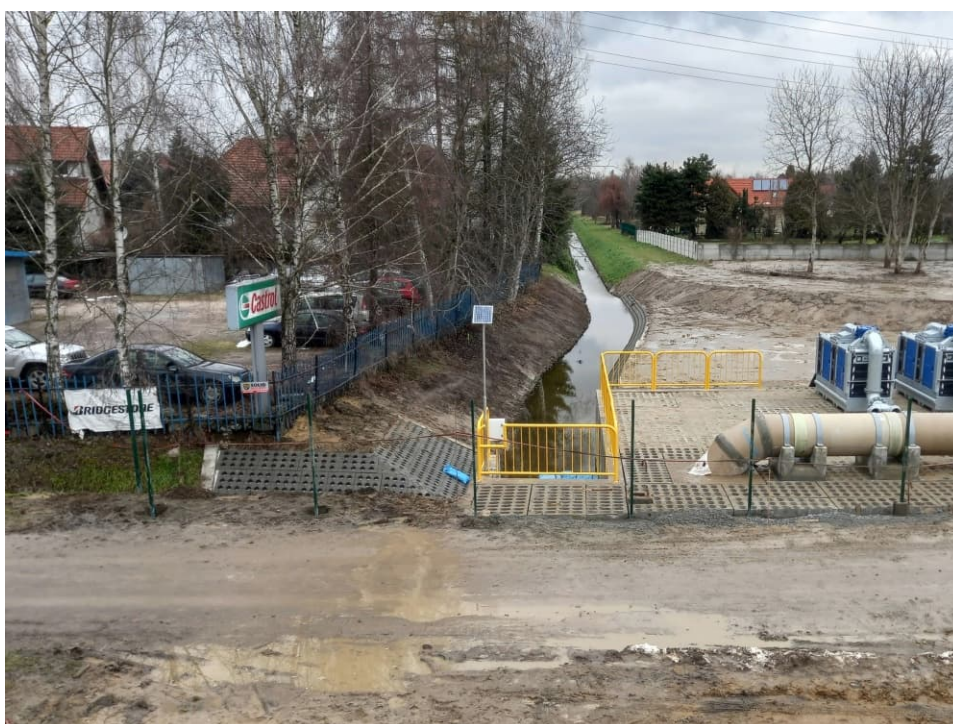
Fig. 50. Site condition in the last month of the works implementation period – construction area of an embankment lock on the Ditch 2a on the area beyond the Vistula River embankment, status in the third decade of January 2023 (view towards the north).

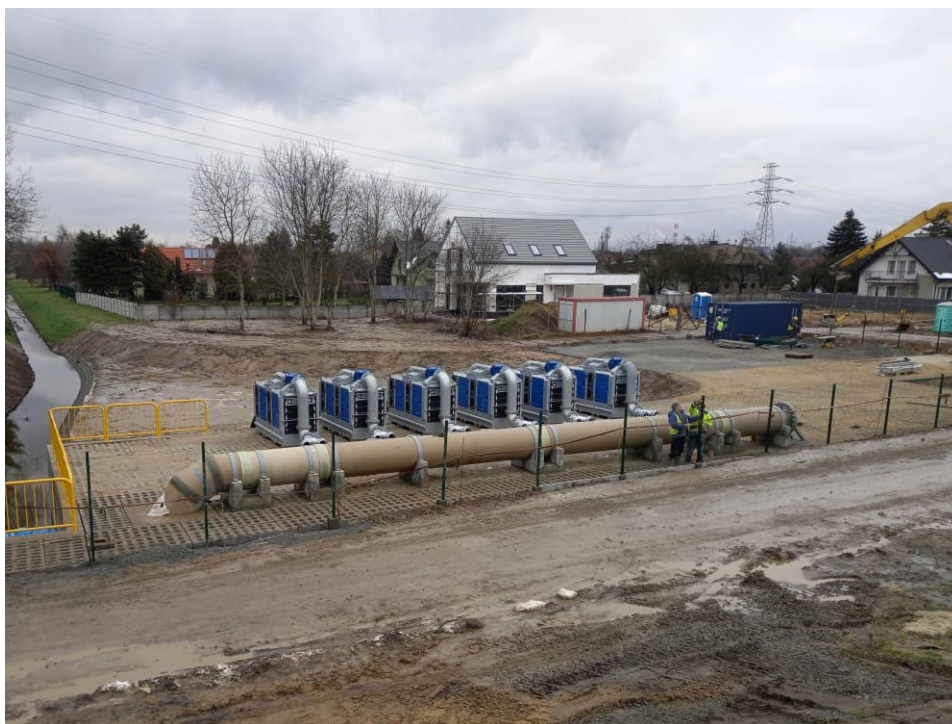
Fig. 51. Site condition in the last month of the works implementation period – construction area of a pumping station for mobile pumps and a site flood storage reservoir upstream of the embankment lock, status in the third decade of January 2023 (view towards the north).

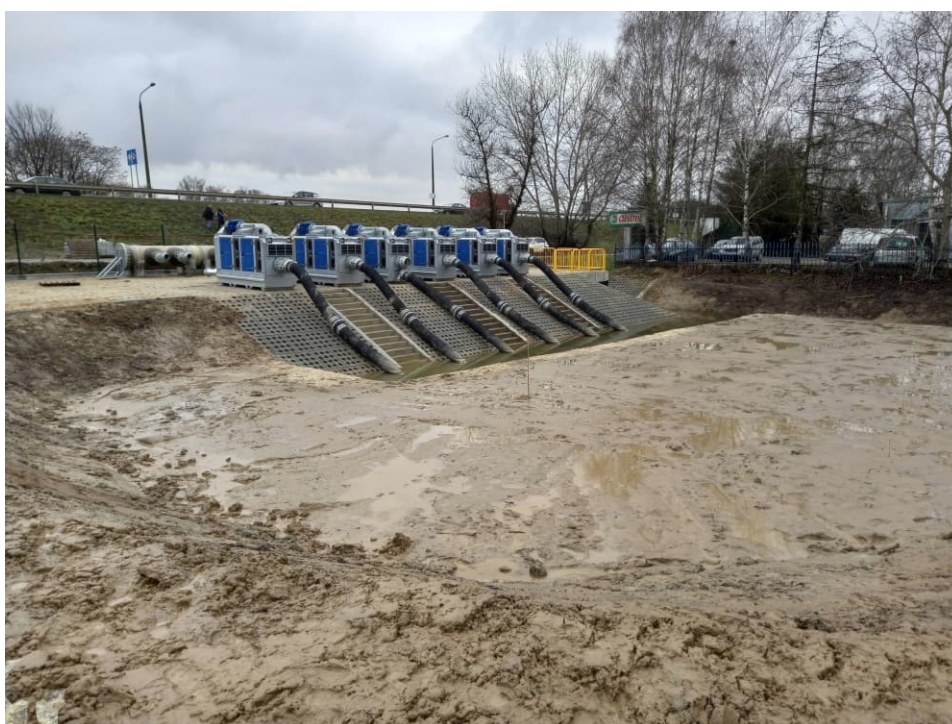
Fig. 52. Site condition in the last month of the works implementation period – construction area of a site flood storage reservoir upstream of the embankment lock and a pumping station for mobile pumps, status in the third decade of January 2023 (view towards the south).

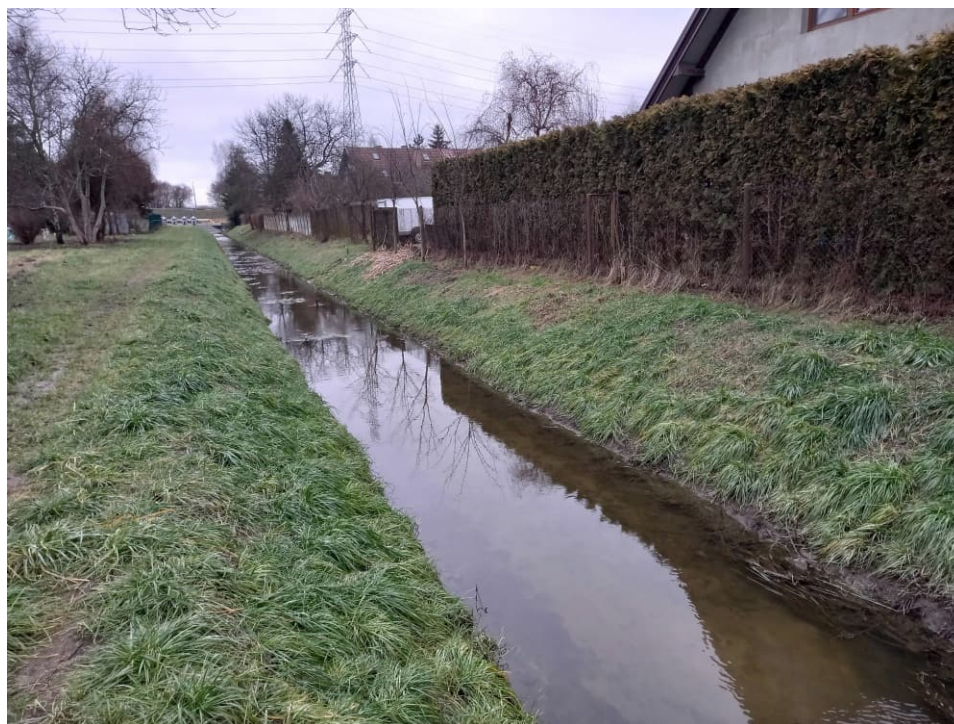
Fig. 53. Site condition in the last month of the works implementation period – redeveloped section of the Ditch 2a – downstream part, status in the third decade of January 2023 (view towards the south).

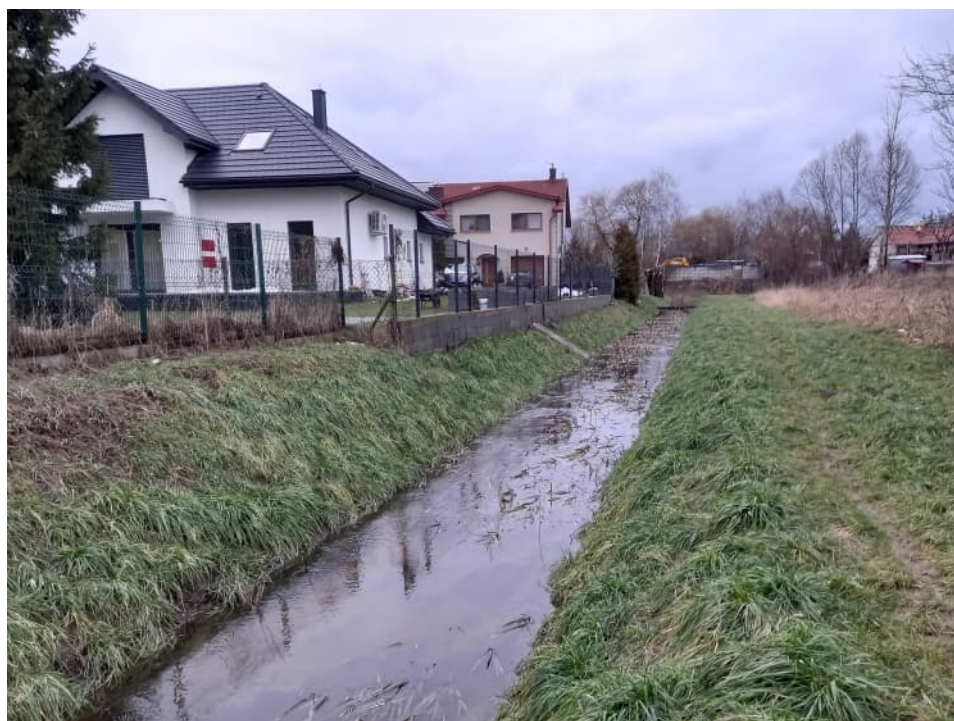
Fig. 54. Site condition in the last month of the works implementation period – redeveloped section of the Ditch 2a – upstream part, status in the third decade of January 2023 (view towards the north).

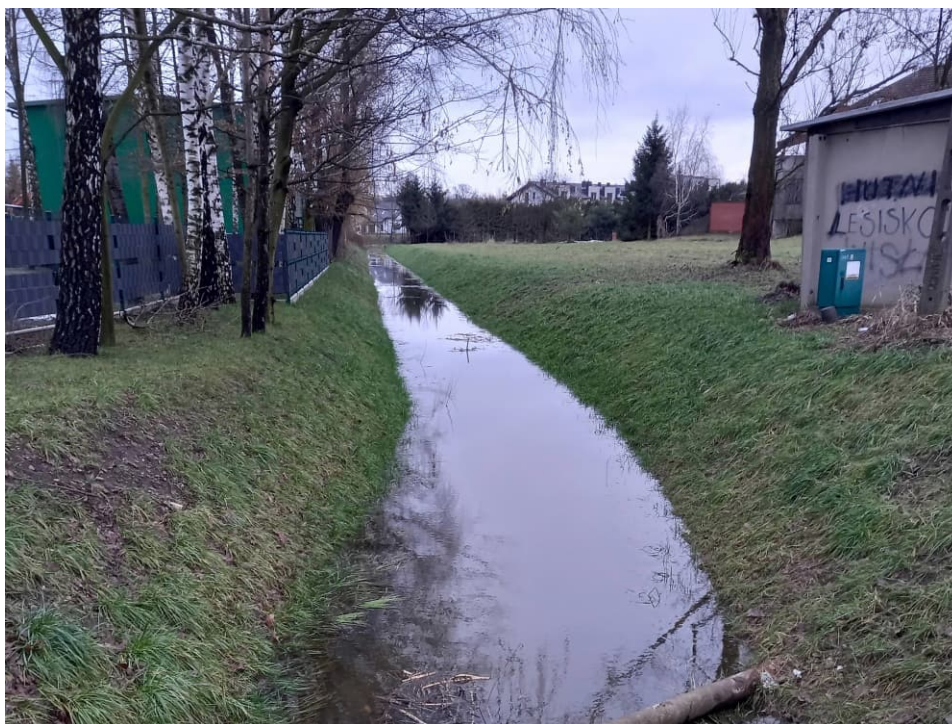
Fig. 55. Site condition in the last month of the works implementation period – redeveloped section of the Ditch 2 – downstream part, status in the third decade of January 2023 (view towards the east).

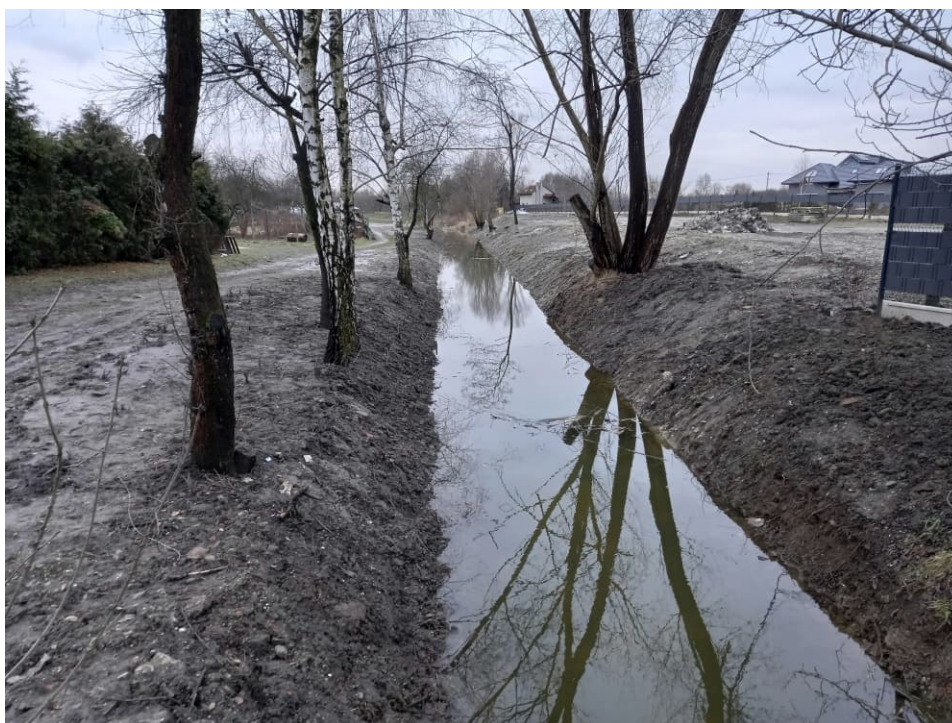
Fig. 56. Site condition in the last month of the works implementation period – redeveloped section of the Ditch 2 – upstream part, status in the third decade of January 2023 (view towards the west).

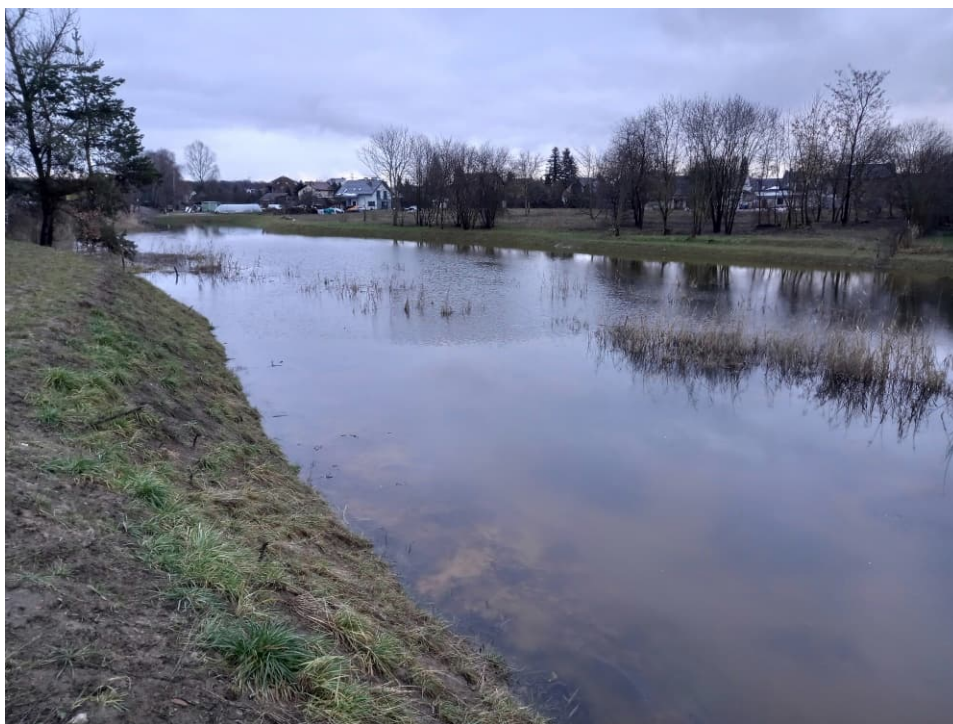
Fig. 57. Site condition in the last month of the works implementation period – redeveloped reservoir on the Ditch 2, eastern part, status in the third decade of January 2023 (view towards the east).

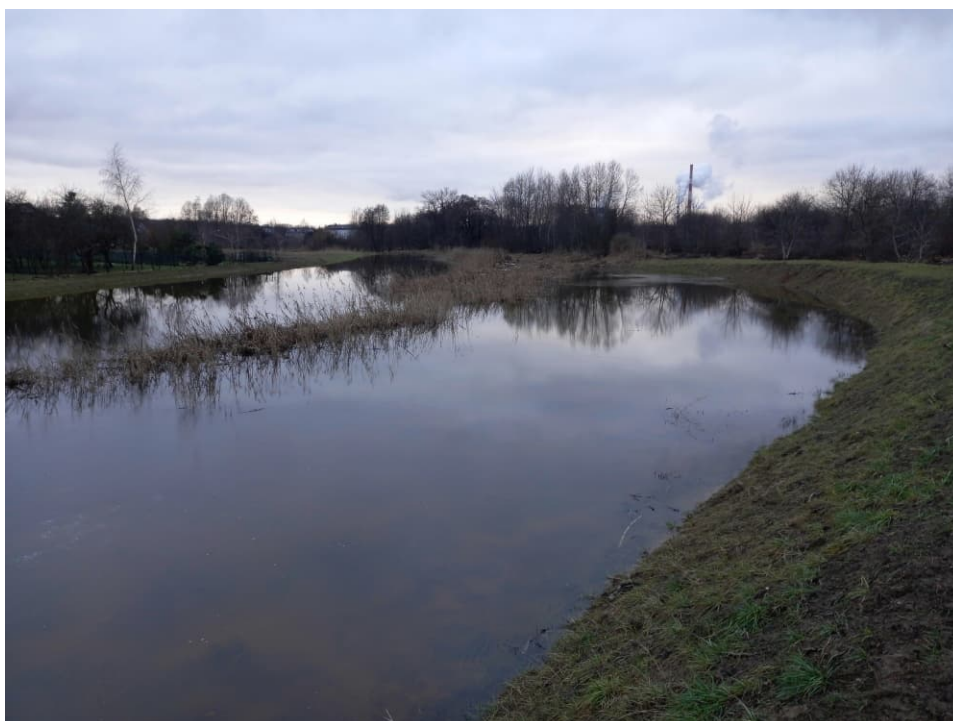
Fig. 58. Site condition in the last month of the works implementation period – redeveloped reservoir on the Ditch 2, western part, status in the third decade of January 2023 (view towards the west).

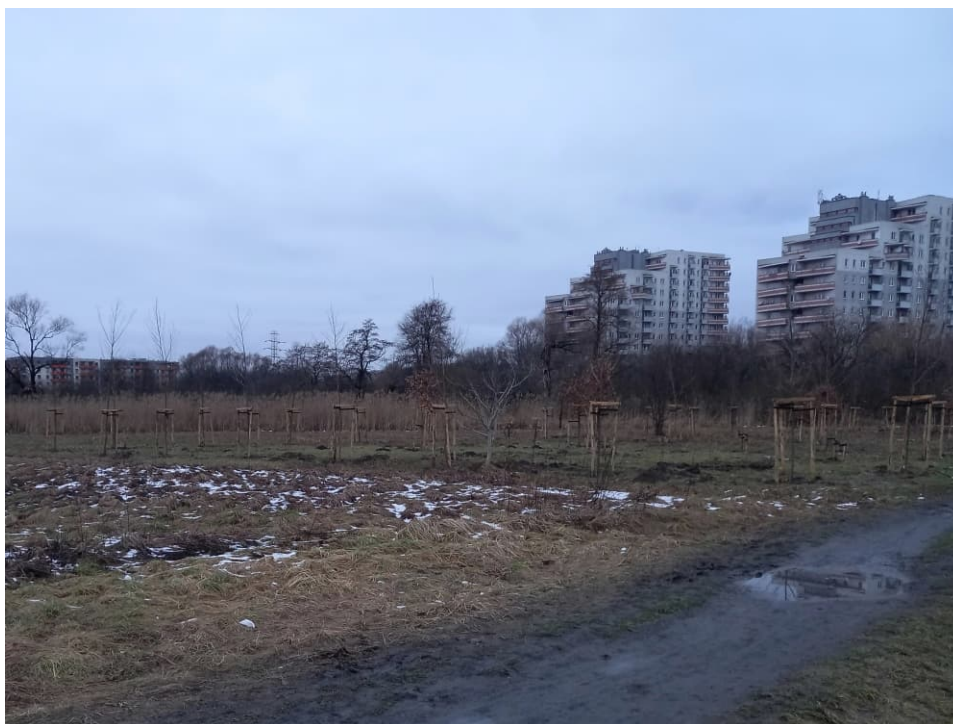
Fig. 59. Condition of the replacement planting area in the last month of the works implementation period – plot No. 158 within the cadastral area of NH 54 in Cracow, status in the third decade of January 2023 (view towards the north-west).

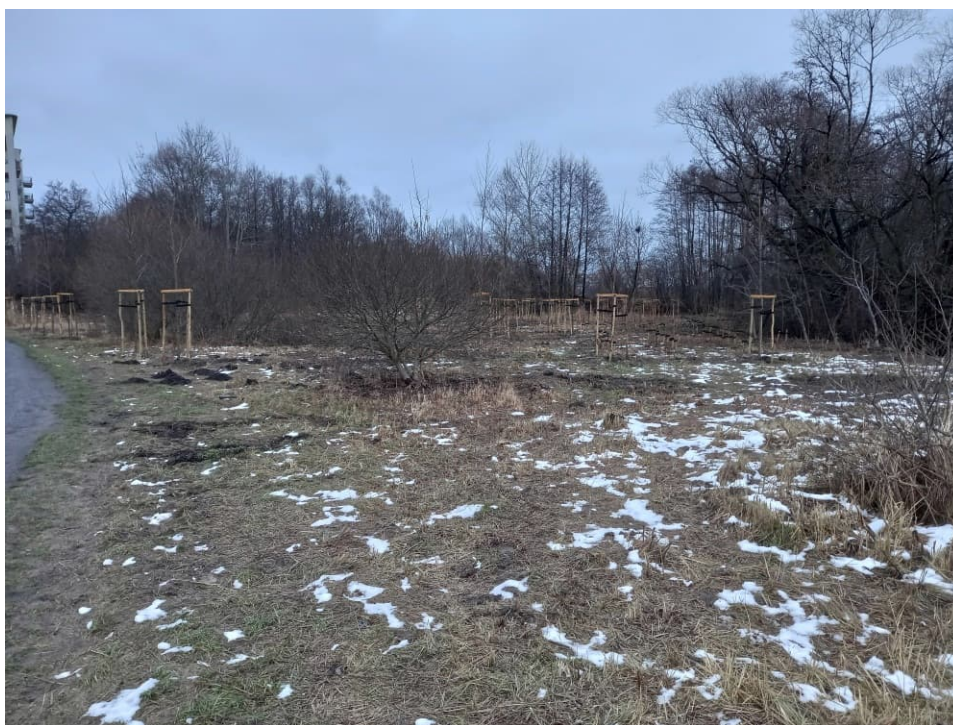
Fig. 60. Condition of the replacement planting area in the last month of the works implementation period – plot No. 159 within the cadastral area of NH 54 in Cracow, status in the third decade of January 2023 (view towards the east).
