PHOTO DOCUMENTATION for Task 3

Appendix no. 2a
to the Final Report on implementation of measures determined in EMP
for the Contract 3B.1/1

Odra-Vistula Flood Management Project

OVFMP Subcomponent	3B Protection of Sandomierz and Tarnobrzeg
Contract Task	3B.1/1 Flood Protection Sandomierz – completion of Tasks 3 and 4
Investor / Project Implementation Unit	State Water Holding Polish Waters Regional Water Management Authority in Cracow 22. Marszałka J. Piłsudskiego Street, 31-109 Cracow, Poland
Project Implementation Office (PIO)	Project Implementation Office in Cracow – branch in Kielce 5. Robotnicza Street, 25-662 Kielce, Poland
Contractor of Works	MELBUD Spółka Akcyjna 4. Składowa Street, 86-300 Grudziądz, Poland
Engineer	AECOM Polska Sp. z o.o. Project Office: 86A. Chwałki Street, 27-600 Sandomierz, Poland

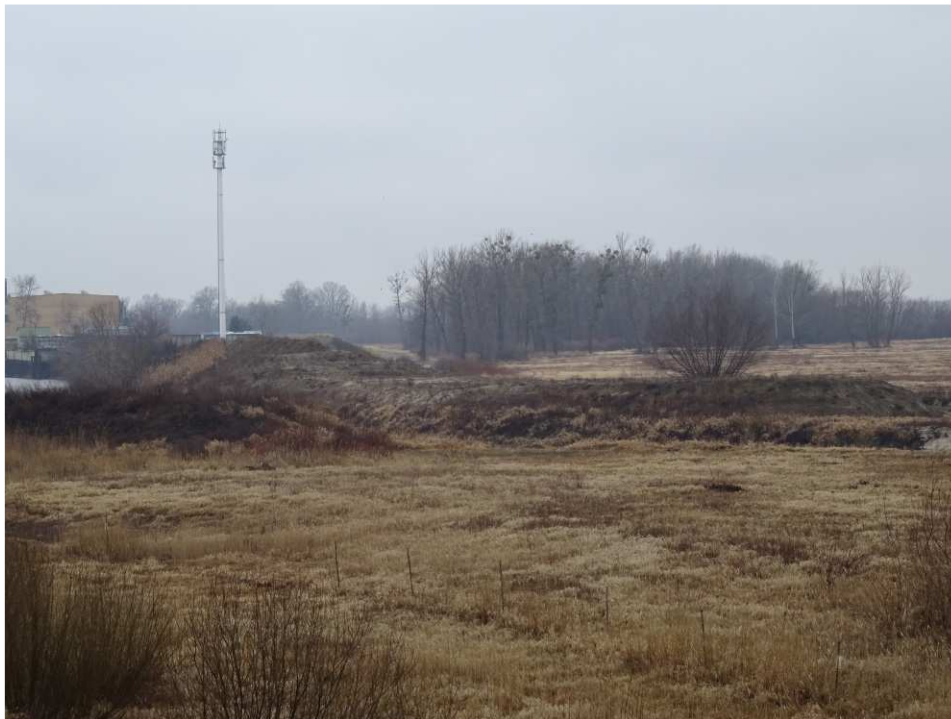
Fig. 1. Site condition in the first quarter of the works implementation period on Task 3 – planned flood gate on the port channel in Sandomierz, status in the third decade of February 2020 (view towards the west).

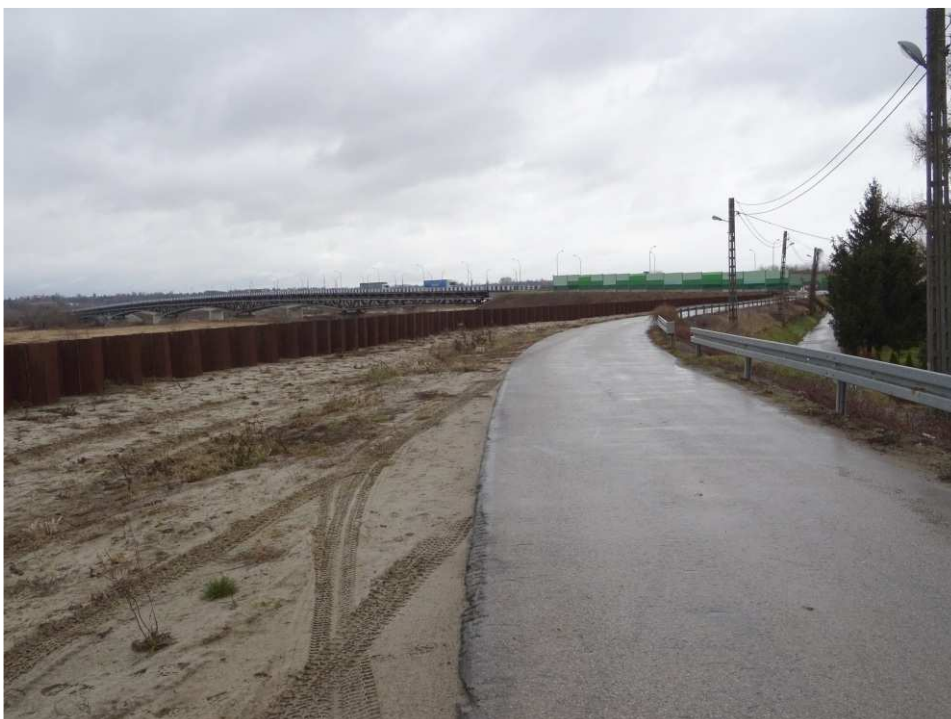
Fig. 2. Site condition in the first quarter of the works implementation period on Task 3 – band embankment within the artery of Mostowa Street, status in the second decade of February 2020 (view towards the north-east).

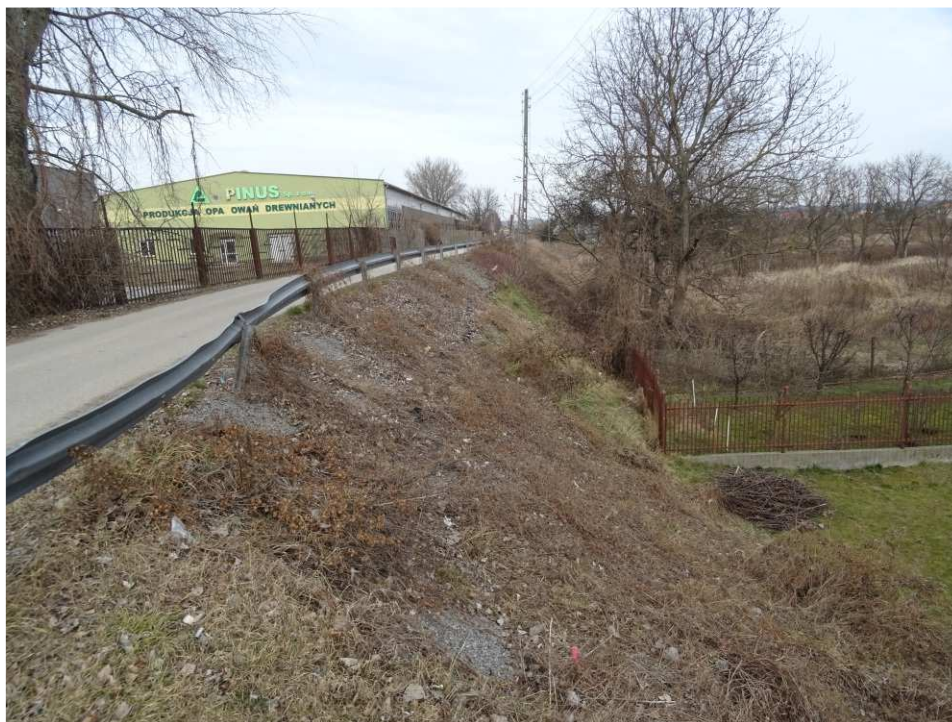
Fig. 3. Site condition in the first quarter of the works implementation period on Task 3 – band embankment within the artery of Mostowa Street, status in the second decade of February 2020 (view towards the north-east).

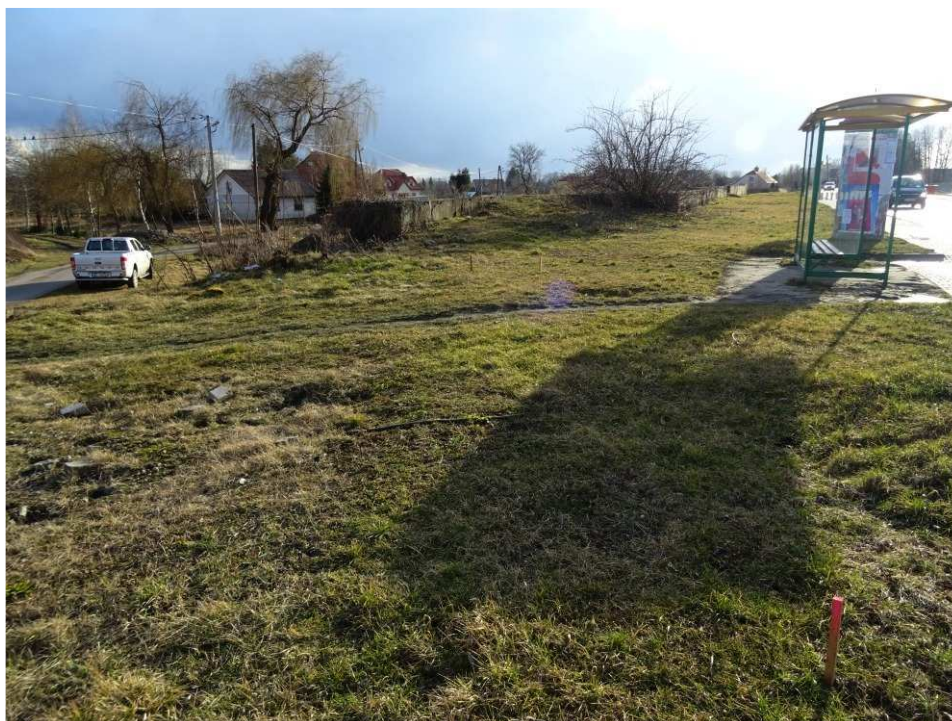
Fig. 4. Site condition in the first quarter of the works implementation period on Task 3 – band embankment within the artery of Portowa Street, status in the second decade of February 2020 (view towards the south-west).

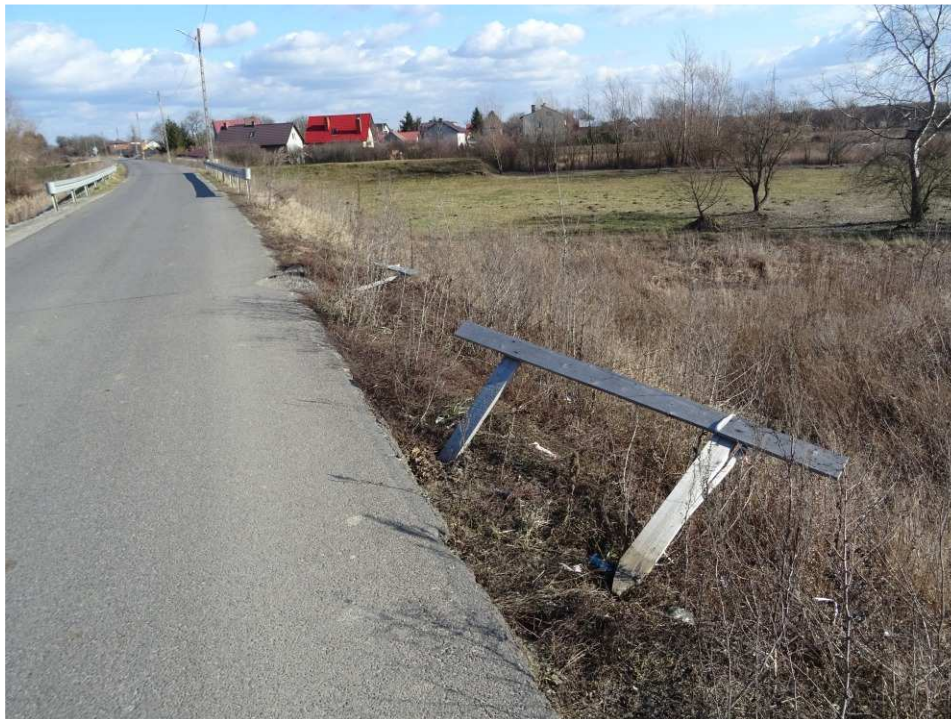
Fig. 5. Site condition in the first quarter of the works implementation period on Task 3 – band embankment within the artery of Zarzekowice Street, status in the second decade of February 2020 (view towards the north-east).

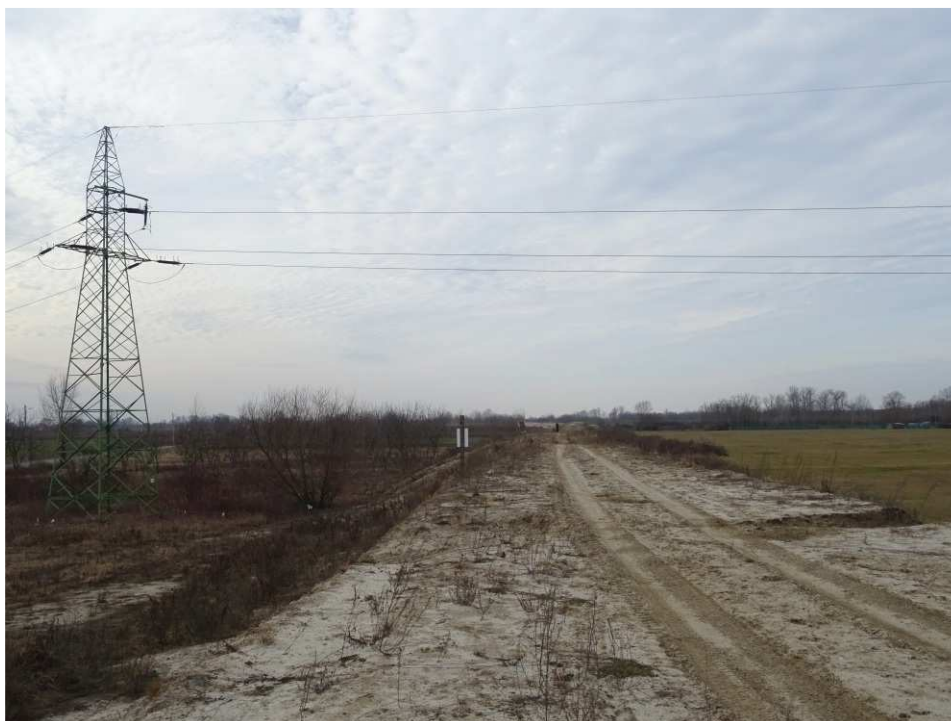
Fig. 6. Site condition in the first quarter of the works implementation period on Task 3 – band embankment between Zarzekowice Street and the right embankment of Vistula, status in the second decade of February 2020 (view towards the south-west).

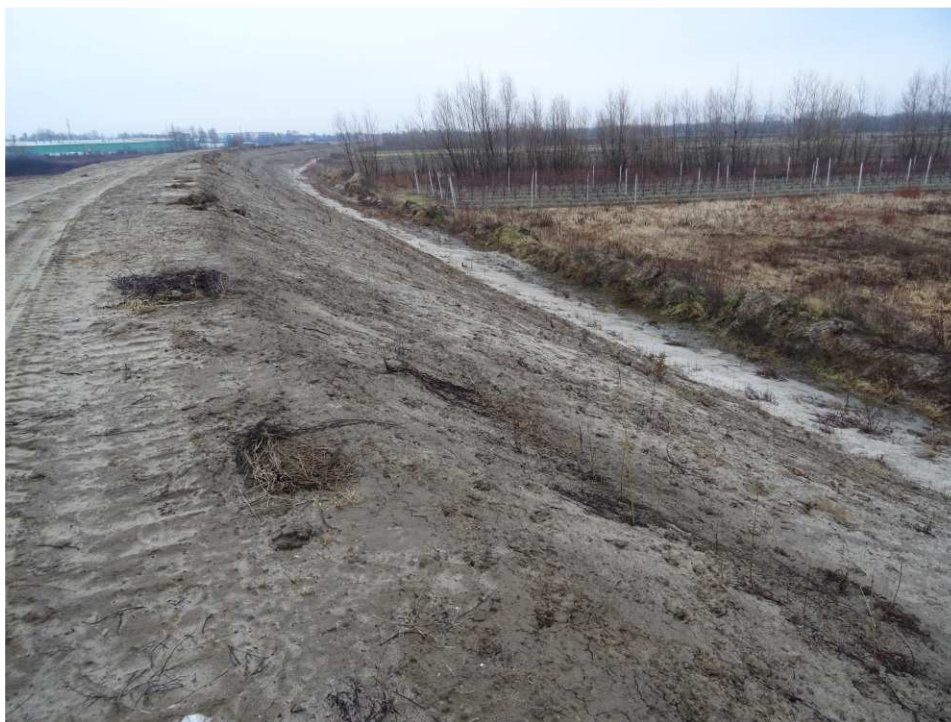
Fig. 7. Site condition in the first quarter of the works implementation period on Task 3 – band embankment between Zarzekowice Street and the right embankment of Vistula, status in the second decade of February 2020 (view towards the north-east).

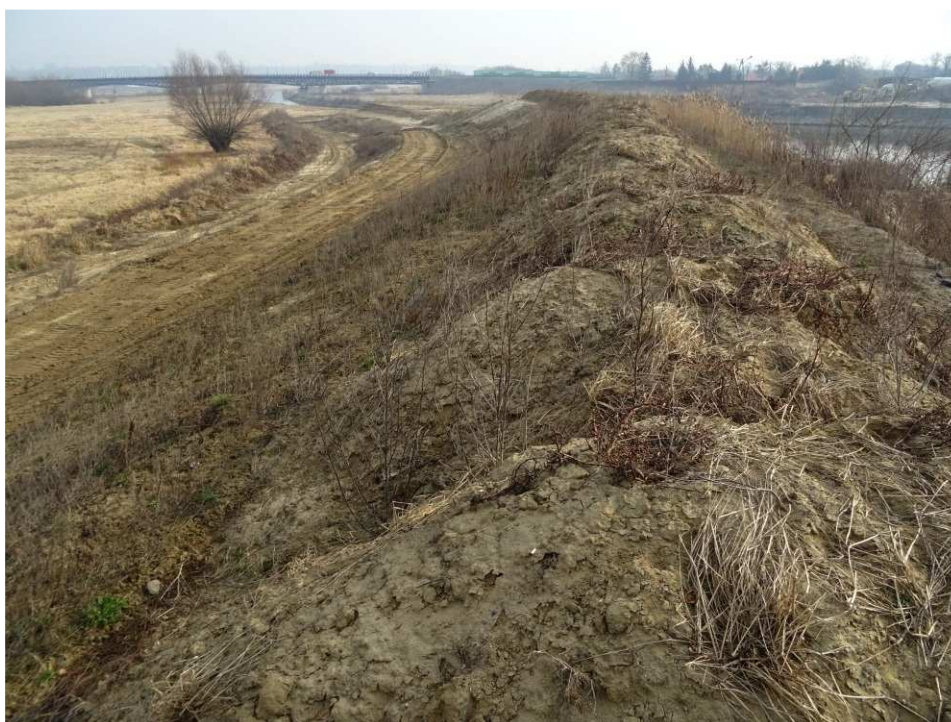
Fig. 8. Site condition in the first quarter of the works implementation period on Task 3 – right-bank Vistula embankment along the bank of the port channel, status in the second decade of March 2020 (view towards the north-east).

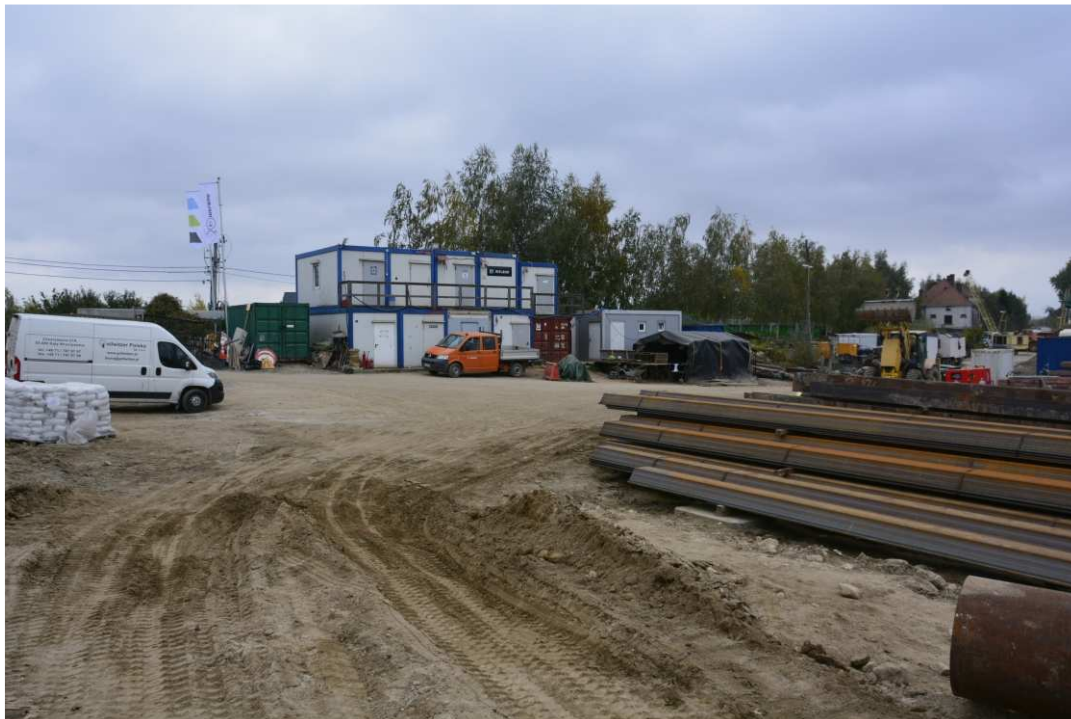
Fig. 9. Site facilities at the flood gate on the port channel in Sandomierz, status in the third decade of July 2020 (view towards the south-east).

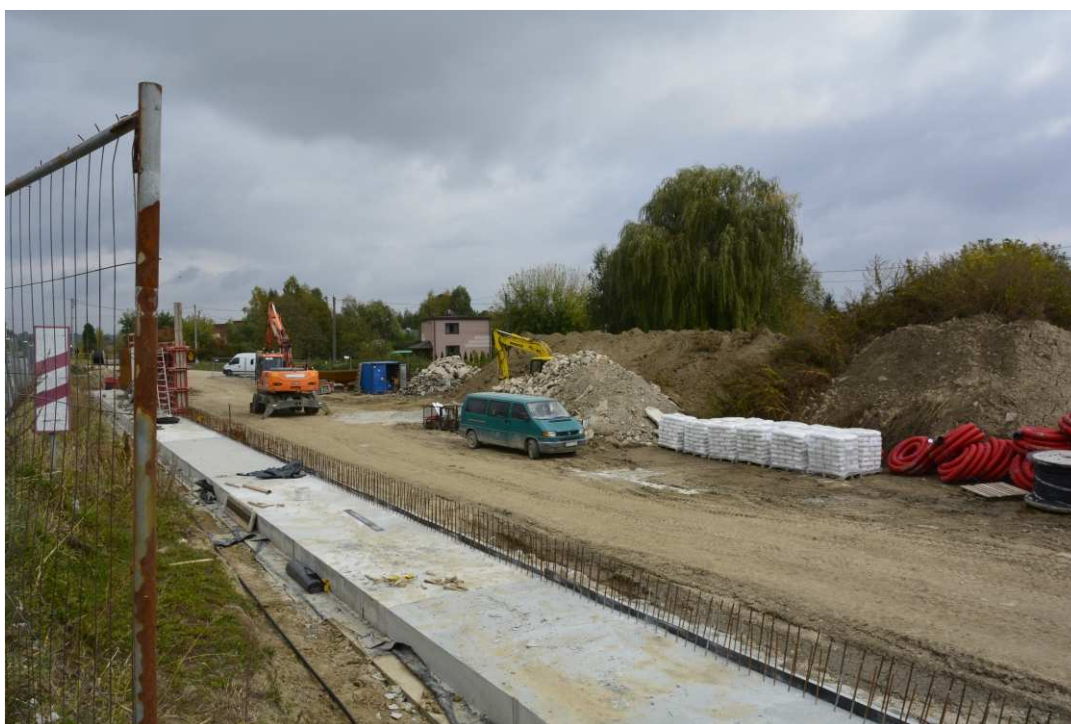
Fig. 10. Storage yard at the band embankment within the artery of Portowa Street, status in the second decade of October 2021 (view towards the north-east).

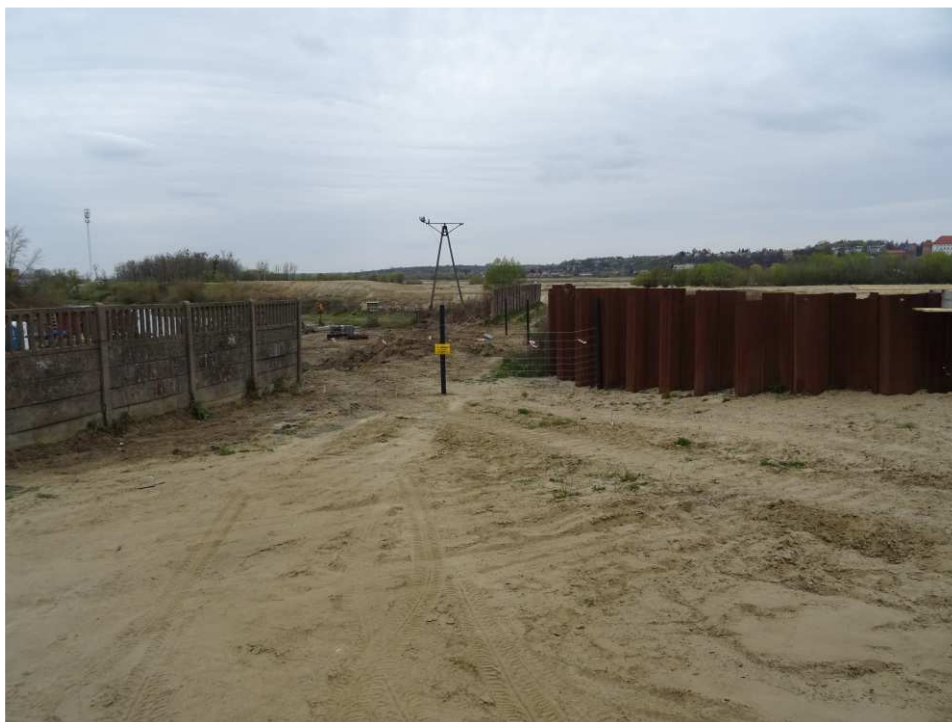
Fig. 11. Marking of the construction site
– flood gate on the port channel in Sandomierz,
status in the second decade of April 2020 (view towards the west).

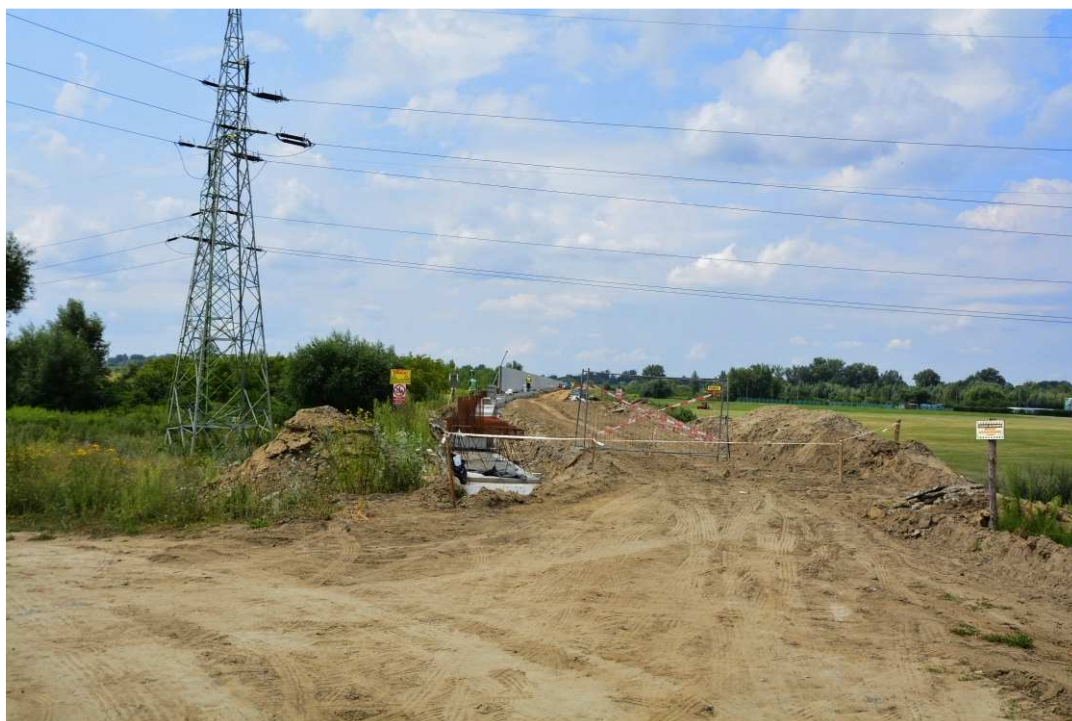
Fig. 12. Marking of the construction site
– band embankment between Zarzekowice Street and the right embankment
of Vistula, status in the third decade of July 2020 (view towards the south-west).

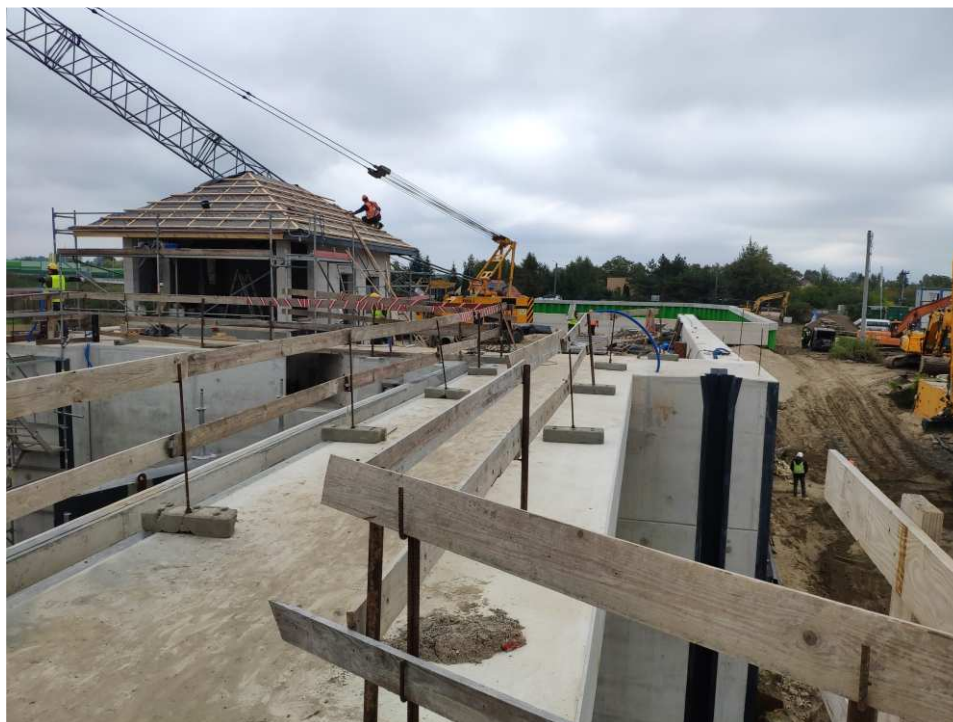
Fig. 13. Protection of hazardous sites
– flood gate on the port channel in Sandomierz,
status in the third decade of September 2022 (view towards the south-west).

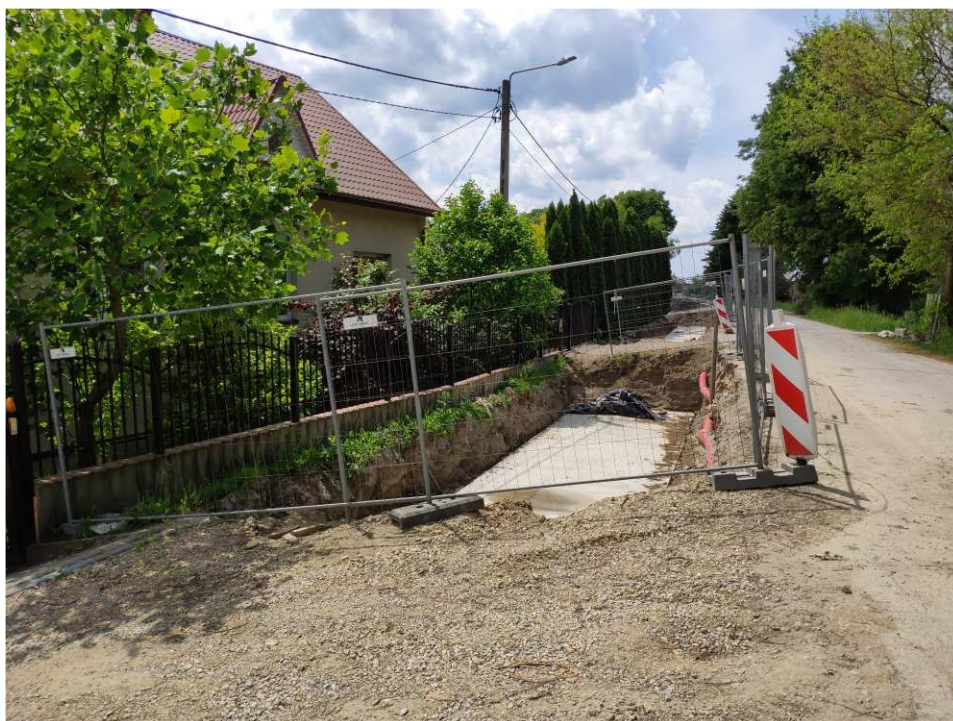
Fig. 14. Protection of hazardous sites
– band embankment within the artery of Zarzekowice Street,
status in the third decade of May 2022 (view towards the south-west).

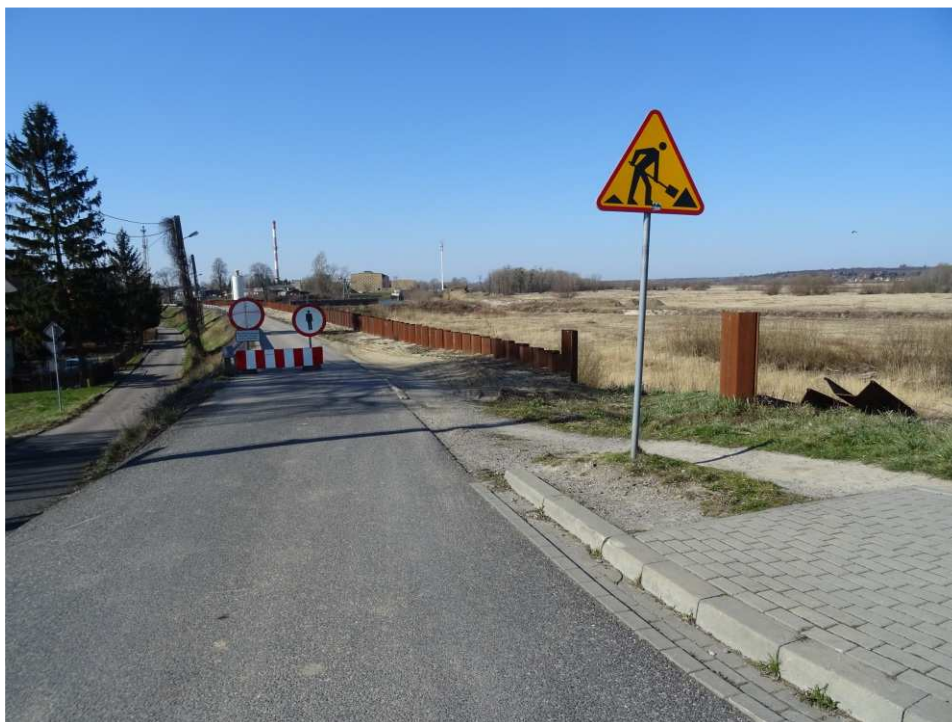
Fig. 15. Marking of public road near the exit from the construction site – band embankment within the artery of Mostowa Street, status in the third decade of March 2020 (view towards the south-west).

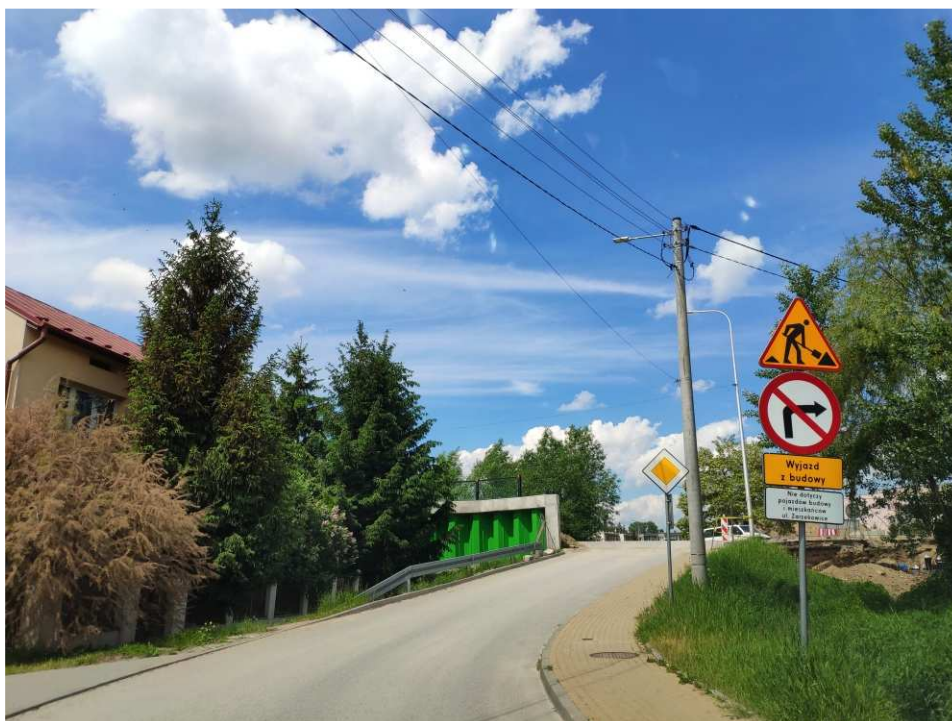
Fig. 16. Marking of public road near the exit from the construction site – band embankment within the artery of Zarzekowice Street, status in the third decade of May 2022 (view towards the south-west).

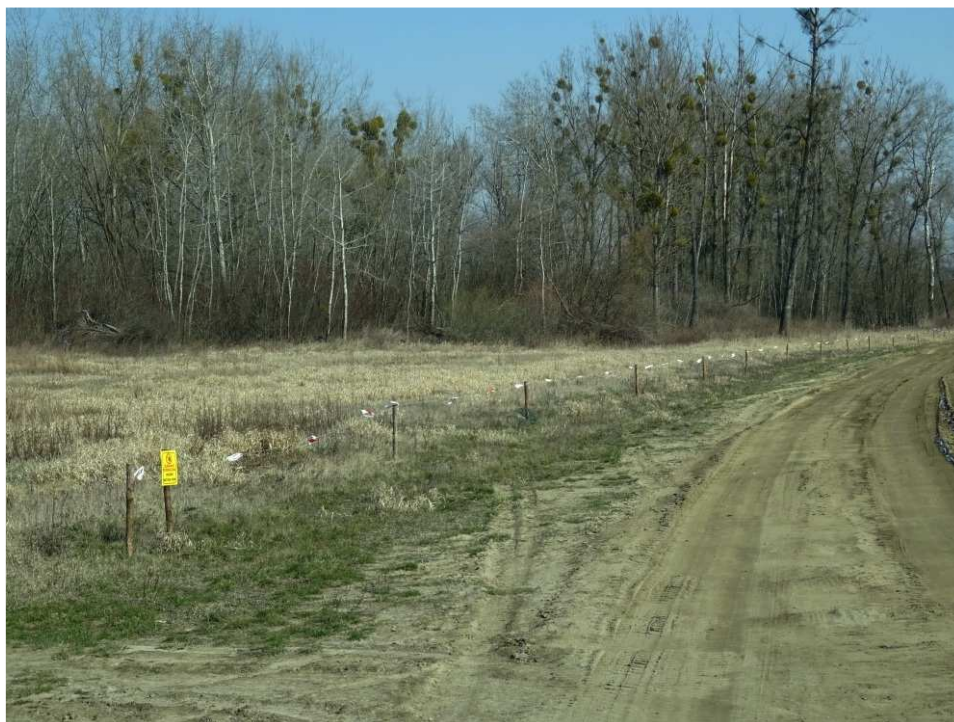
Fig. 17. Marking of Natura 2000 site
– access road to the work site on the right-bank Vistula embankment,
status in the third decade of March 2020 (view towards the north-east).

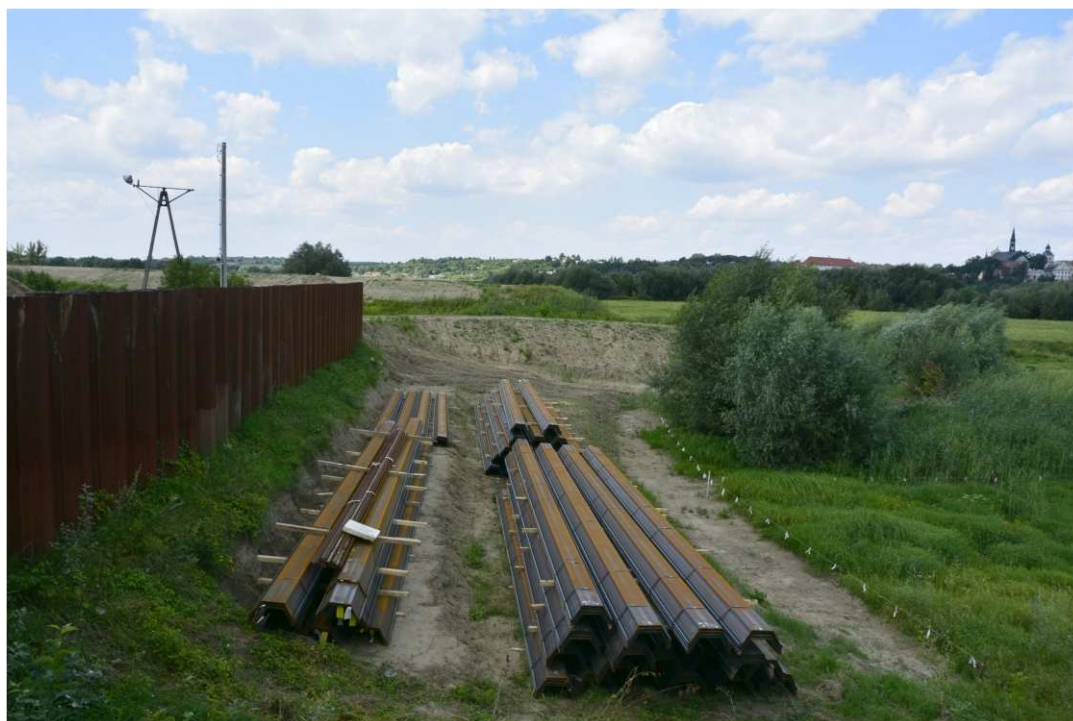
Fig. 18. Marking of Natura 2000 site
– flood gate on the port channel in Sandomierz,
status in the third decade of July 2021 (view towards the north-west).

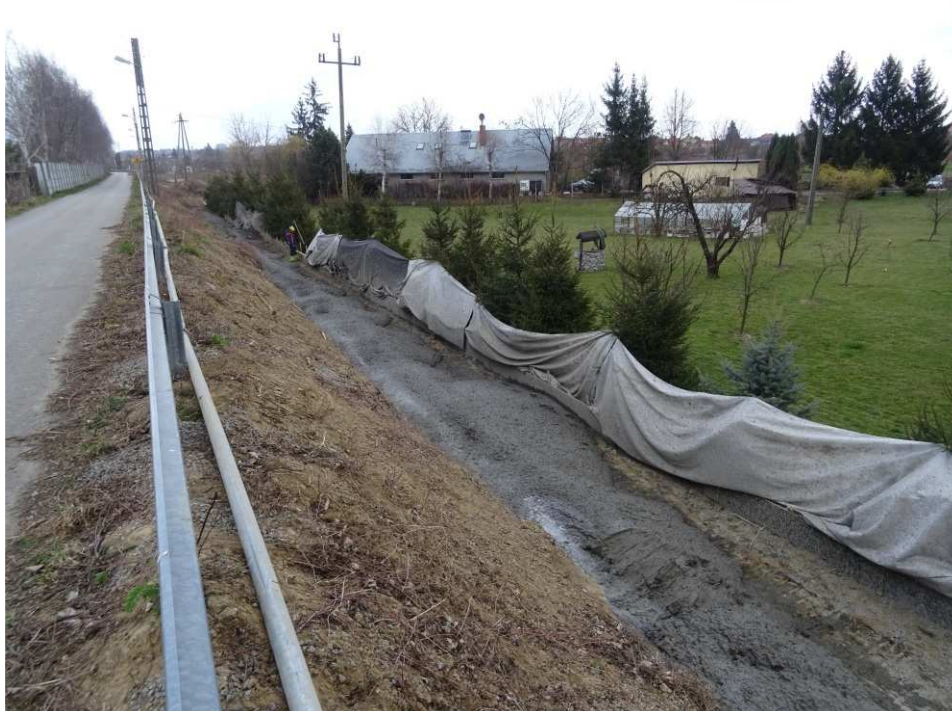
Fig. 19. Protection of trees and shrubs not intended to felling
– band embankment within the artery of Mostowa Street,
status in the third decade of March 2020 (view towards the north-east).

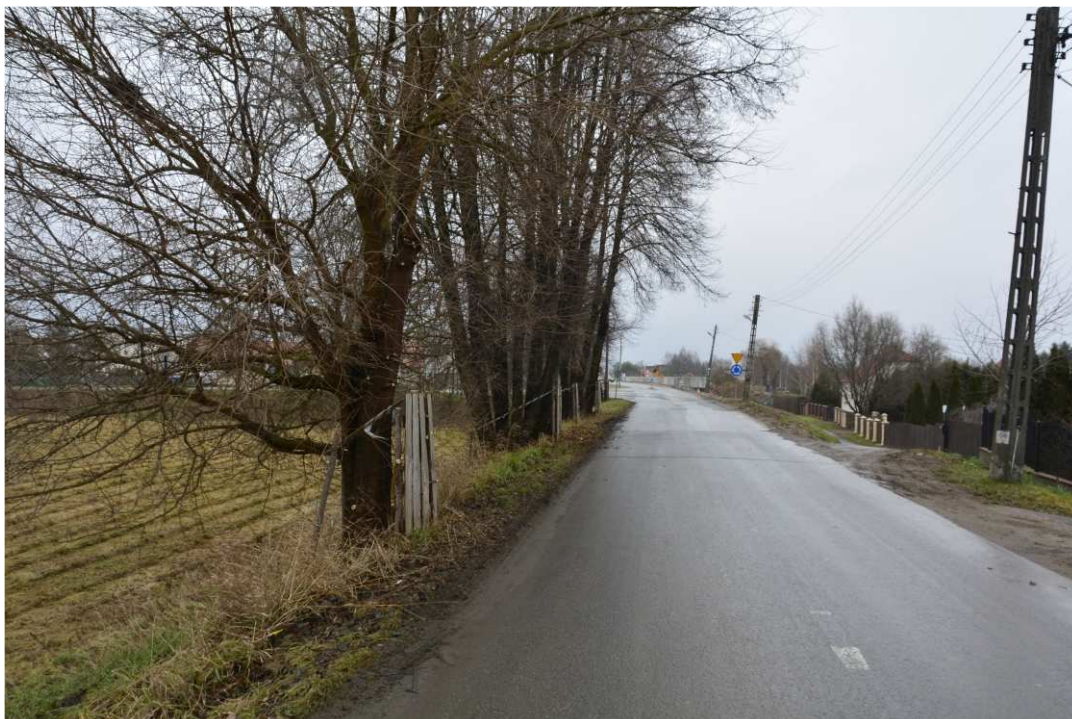
Fig. 20. Protection of trees and shrubs not intended to felling
– band embankment within the artery of Zarzekowice Street,
status in the second decade of December 2021 (view towards the north-east).

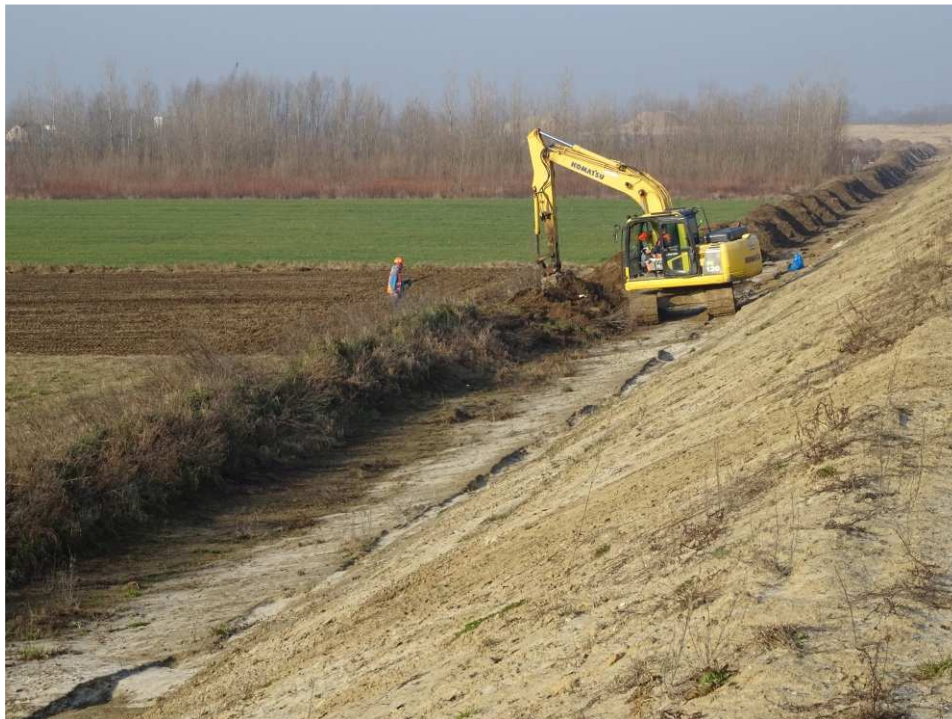
Fig. 21. Protection of top-soil piles
– band embankment between Zarzekowice Street and the right embankment of Vistula, status in the second decade of March 2020 (view towards the south-west).

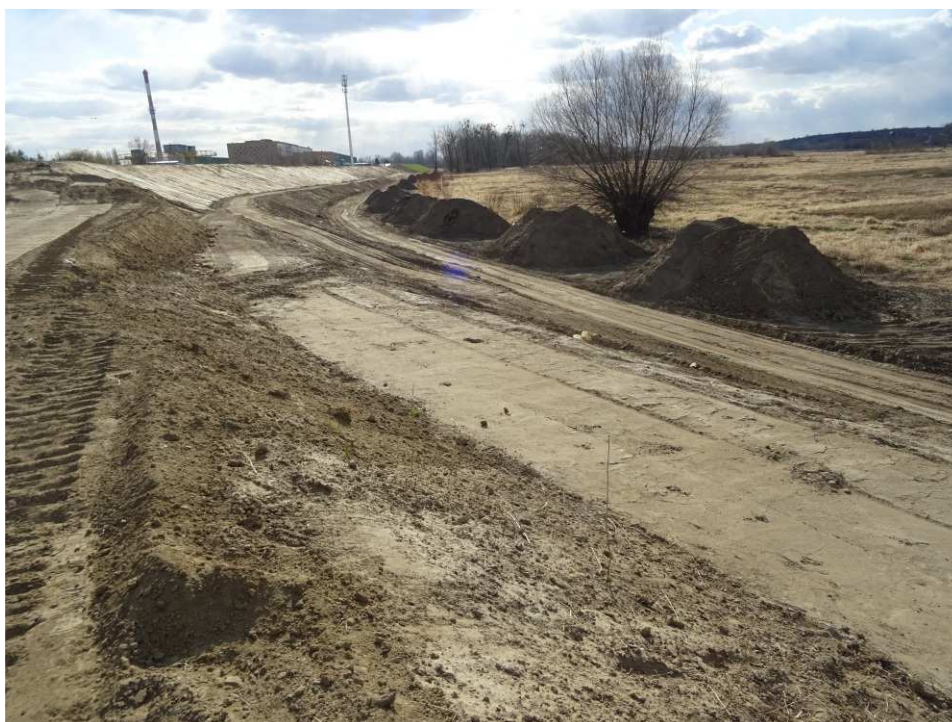
Fig. 22. Protection of top-soil piles
– right-bank Vistula embankment along the bank of the port channel, status in the third decade of March 2020 (view towards the south-west).

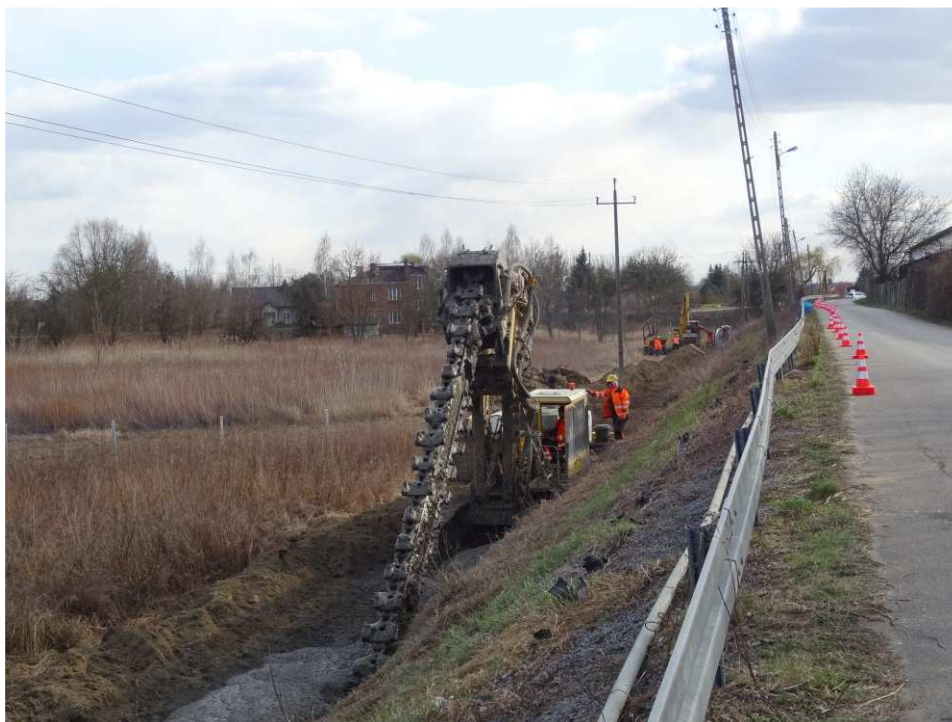
Fig. 23. Construction of a cement-bentonite barrier
– band embankment within the artery of Mostowa Street,
status in the third decade of March 2020 (view towards the south-west).

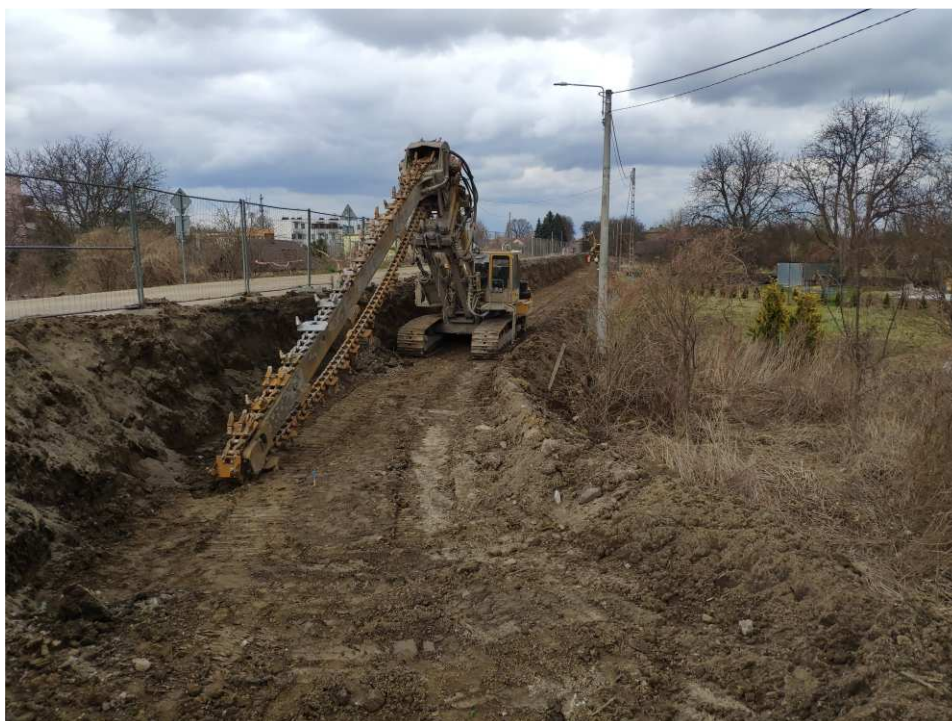
Fig. 24. Construction of a cement-bentonite barrier
– band embankment within the artery of Zarzekowice Street,
status in the first decade of April 2022 (view towards the north-east).

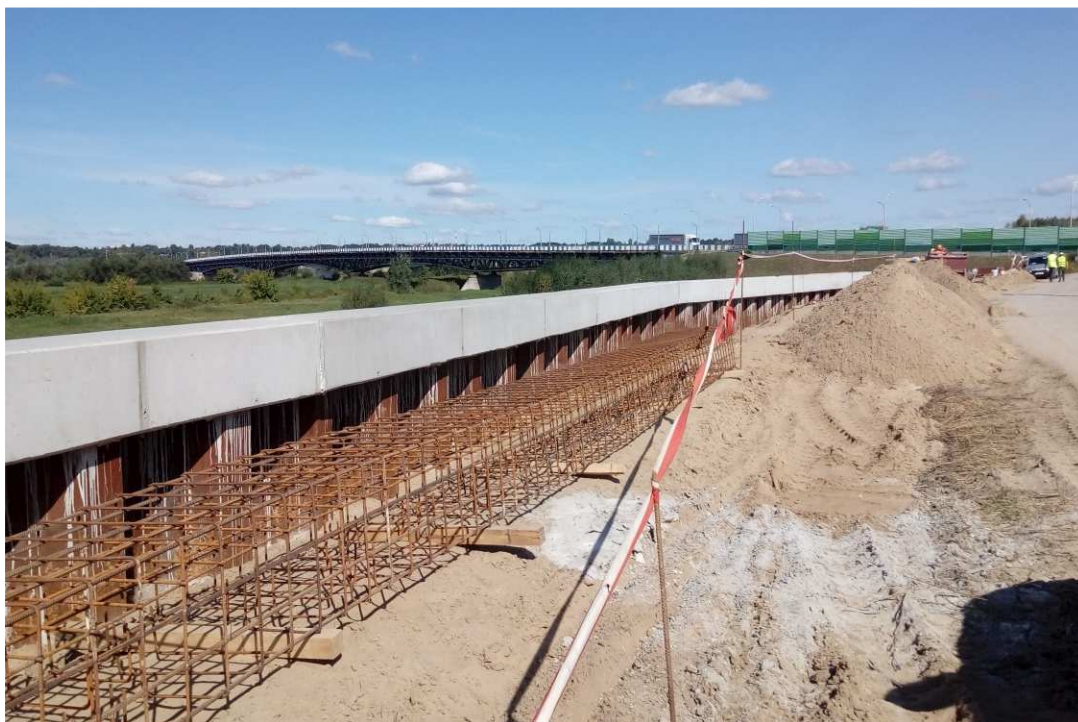
Fig. 25. Construction of a retaining wall made of steel sheet piles – band embankment within the artery of Mostowa Street, status in the second decade of September 2020 (view towards the north-east).

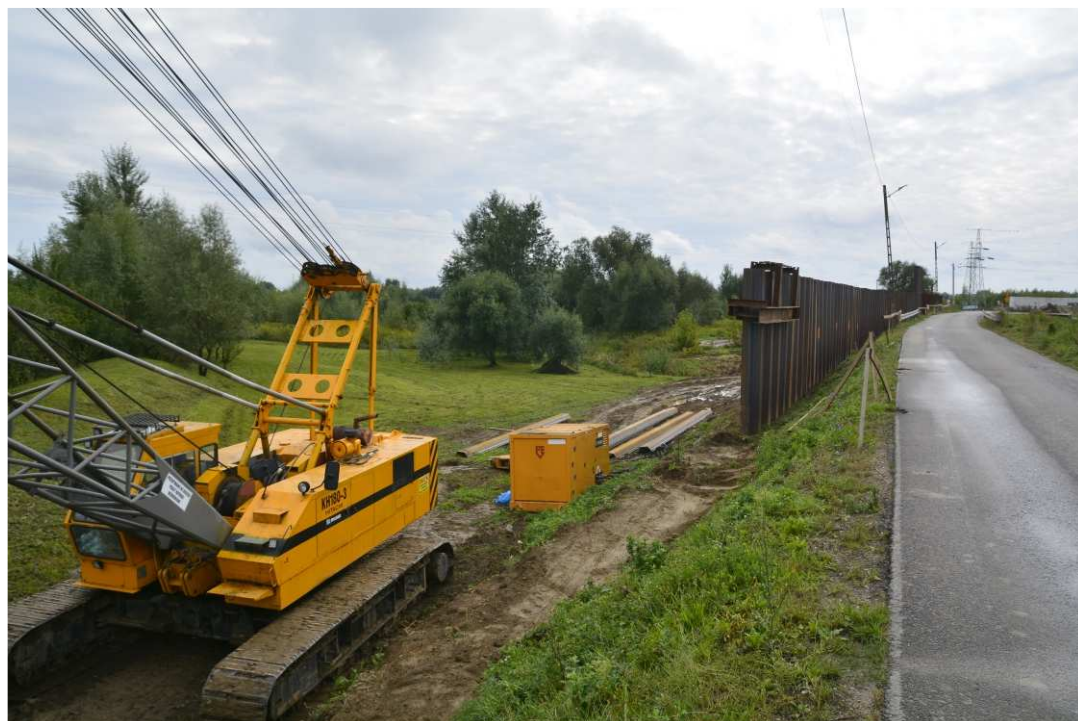
Fig. 26. Construction of a retaining wall made of steel sheet piles – band embankment within the artery of Zarzekowice Street, status in the first decade of September 2020 (view towards the south-west).

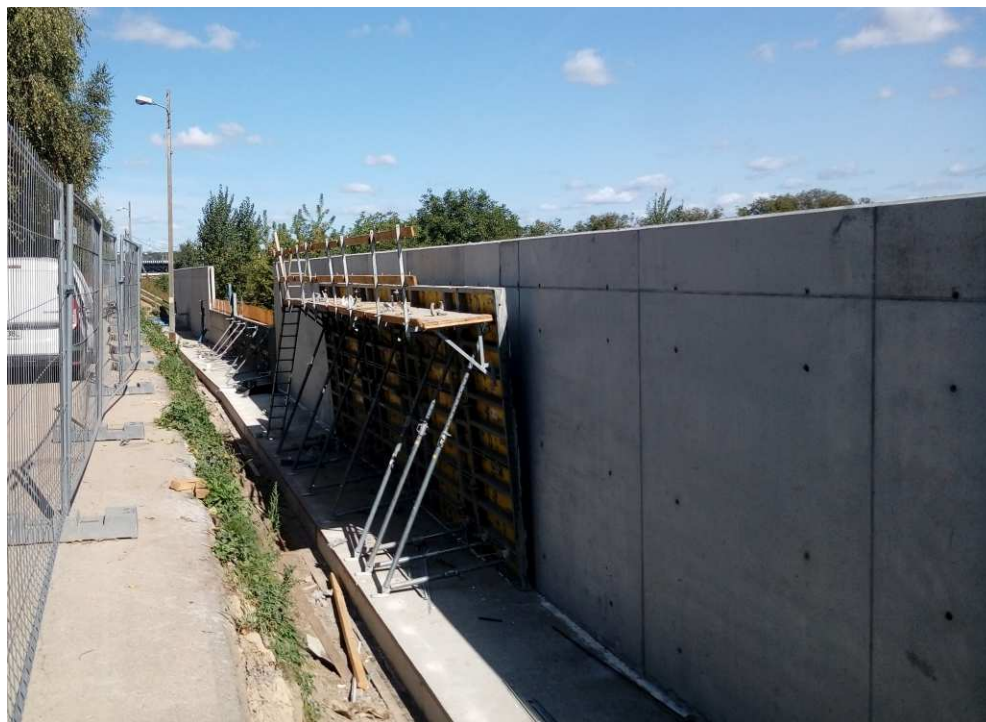
Fig. 27. Construction of a reinforced concrete retaining wall – band embankment within the artery of Mostowa Street, status in the second decade of September 2020 (view towards the north-east).

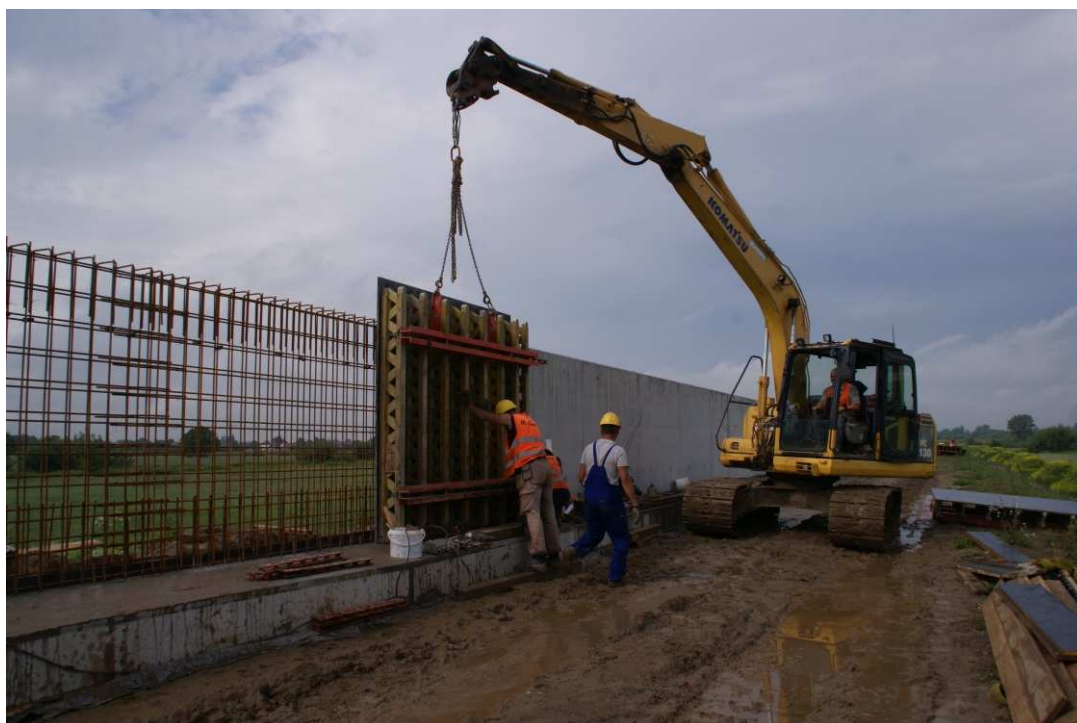
Fig. 28. Construction of a reinforced concrete retaining wall – band embankment between Zarzekowice Street and the right embankment of Vistula, status in the third decade of June 2020 (view towards the south-west).

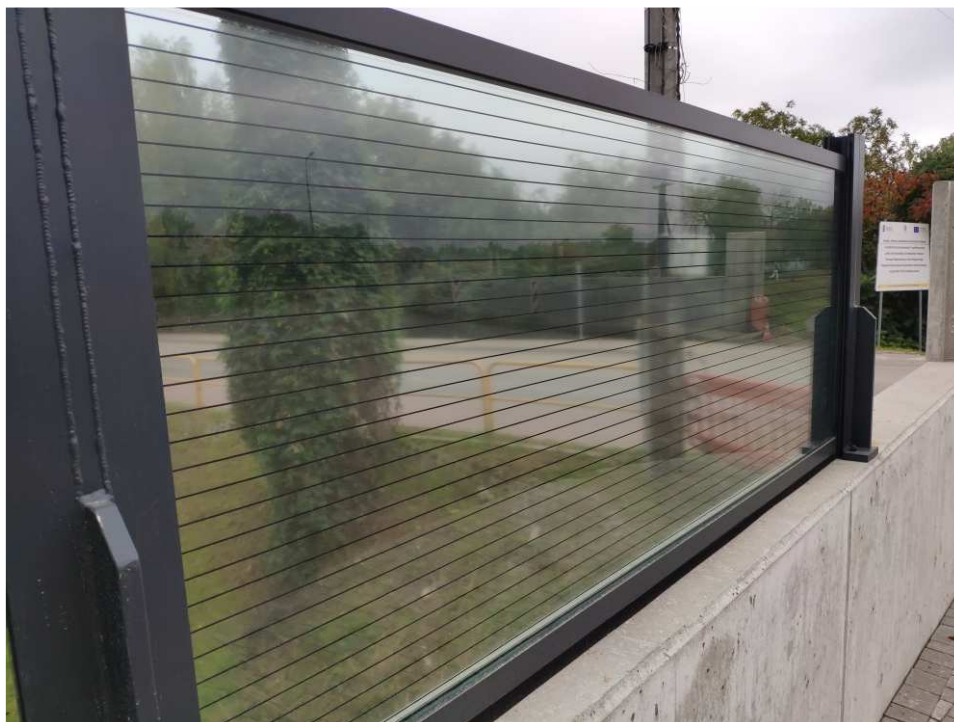
Fig. 29. Protection against birds crashing against the glass
– band embankment within the artery of Mostowa Street,
status in the third decade of September 2022 (view towards the south-west).

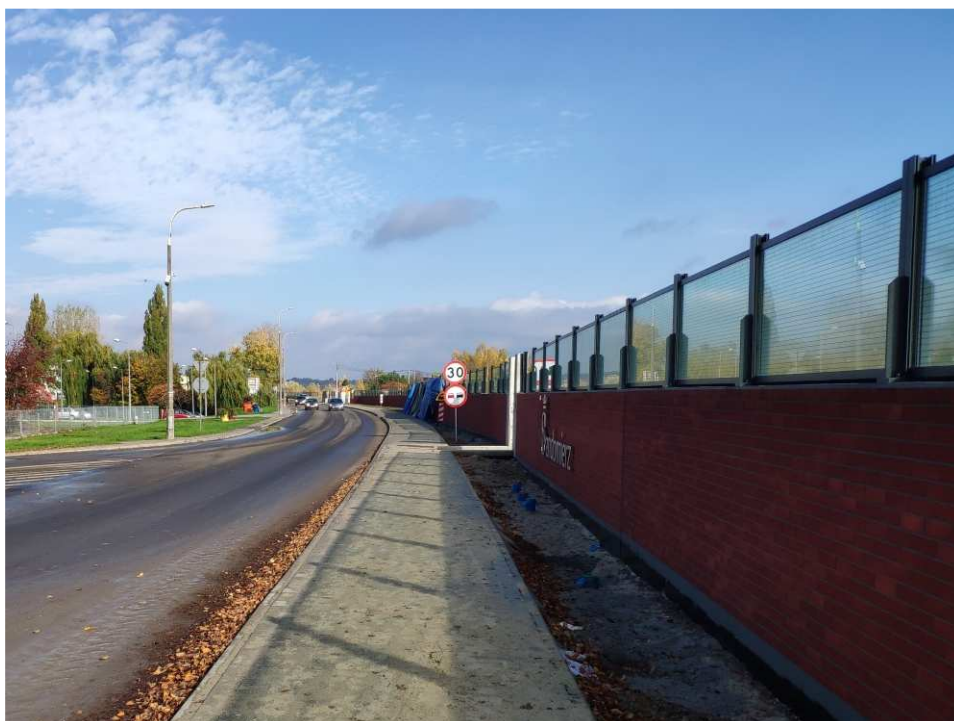
Fig. 30. Protection against birds crashing against the glass
– band embankment within the artery of Zarzekowice Street,
status in the third decade of October 2022 (view towards the north-east).
