PHOTO DOCUMENTATION for Task 3

Appendix no. 2a
to the Final Report on implementation of measures determined in EMP
for the Contract 3B.1/1

Odra-Vistula Flood Management Project

OVFMP Subcomponent	3B Protection of Sandomierz and Tarnobrzeg
Contract Task	3B.1/1 Flood Protection Sandomierz – completion of Tasks 3 and 4
Investor / Project Implementation Unit	State Water Holding Polish Waters Regional Water Management Authority in Cracow 22. Marszałka J. Piłsudskiego Street, 31-109 Cracow, Poland
Project Implementation Office (PIO)	Project Implementation Office in Cracow – branch in Kielce 5. Robotnicza Street, 25-662 Kielce, Poland
Contractor of Works	MELBUD Spółka Akcyjna 4. Składowa Street, 86-300 Grudziądz, Poland
Engineer	AECOM Polska Sp. z o.o. Project Office: 86A. Chwałki Street, 27-600 Sandomierz, Poland

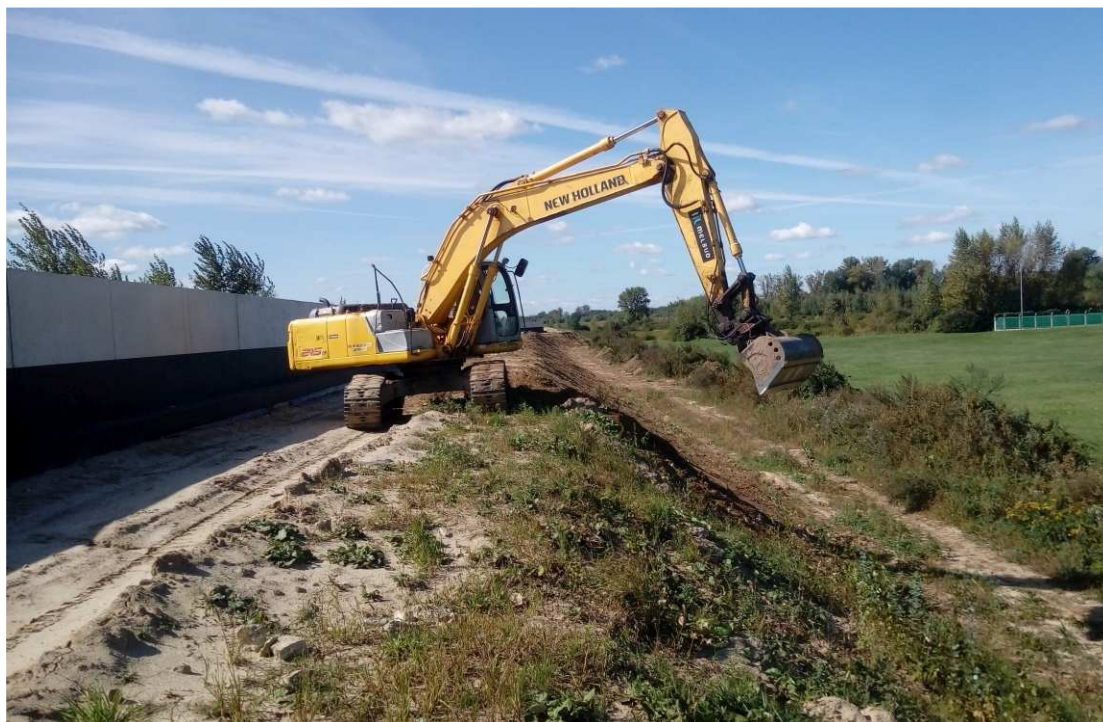
Fig. 31. Shaping the slopes of the flood embankment
– band embankment between Zarzekowice Street and the right embankment of Vistula, status in the second decade of September 2020 (view towards the south-west).

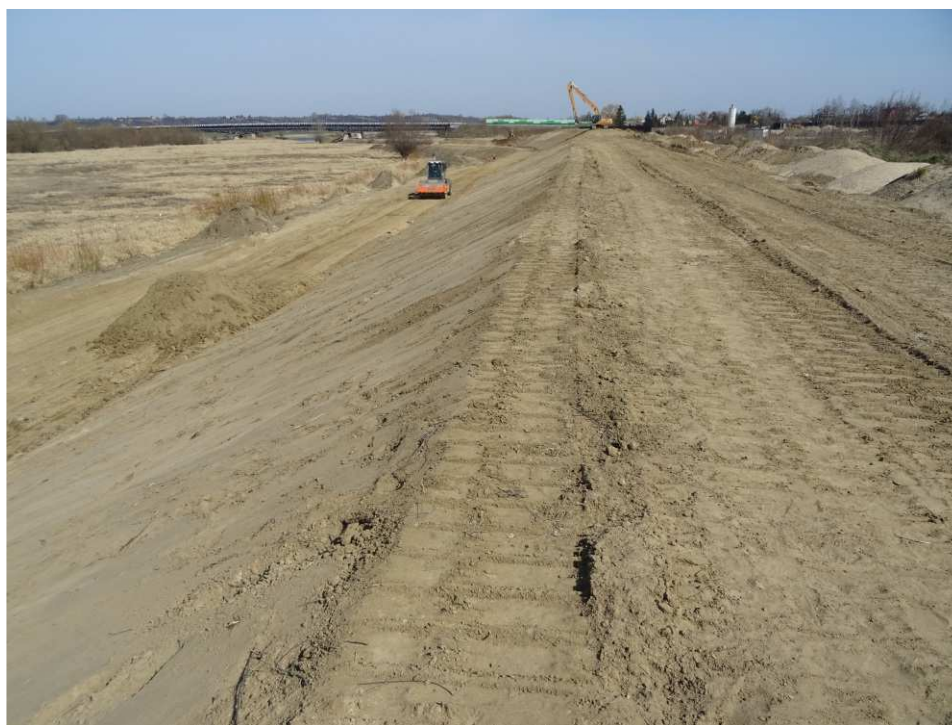
Fig. 32. Shaping the slopes of the flood embankment
– right-bank Vistula embankment along the bank of the port channel, status in the third decade of March 2020 (view towards the north-east).

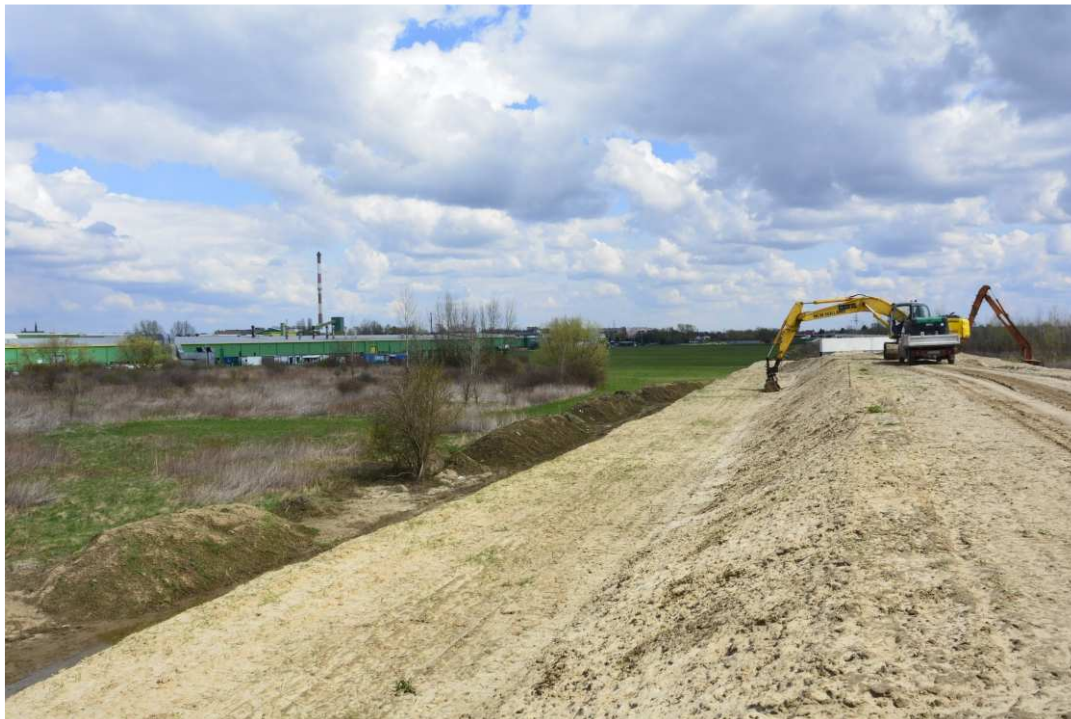
Fig. 33. Compaction of the body of the flood embankment
– band embankment between Zarzekowice Street and the right embankment of Vistula, status in the third decade of April 2021 (view towards the north-east).

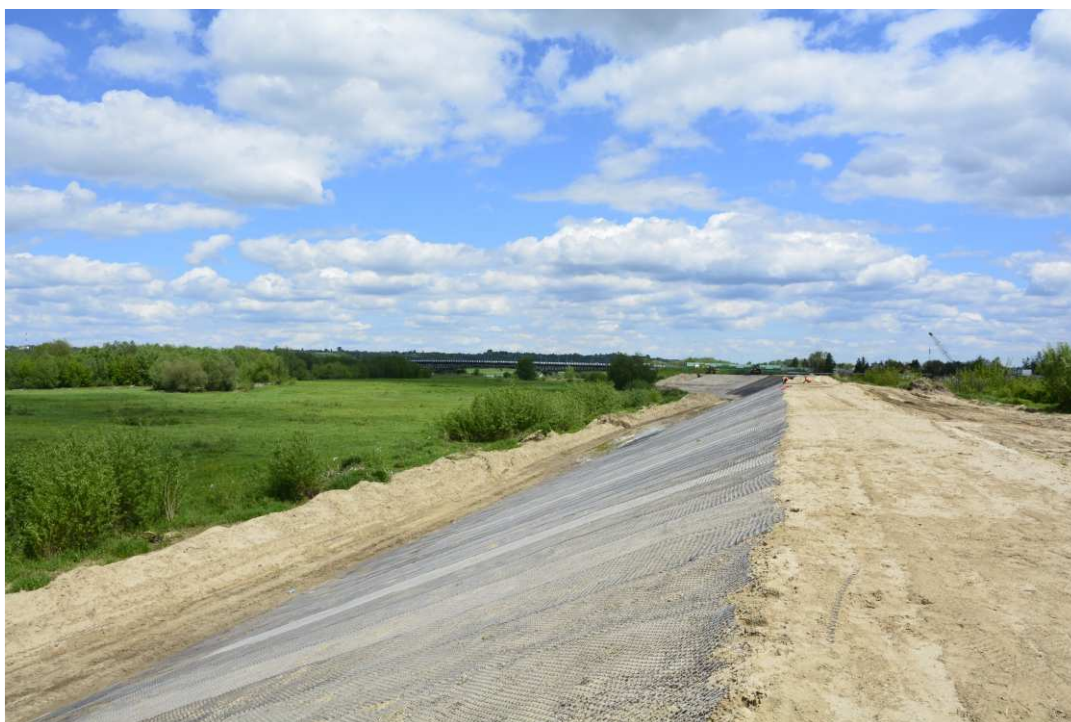
Fig. 34. Securing the slope of the flood embankment with a net against beavers
– right-bank Vistula embankment along the bank of the port channel, status in the second decade of May 2021 (view towards the north-east).

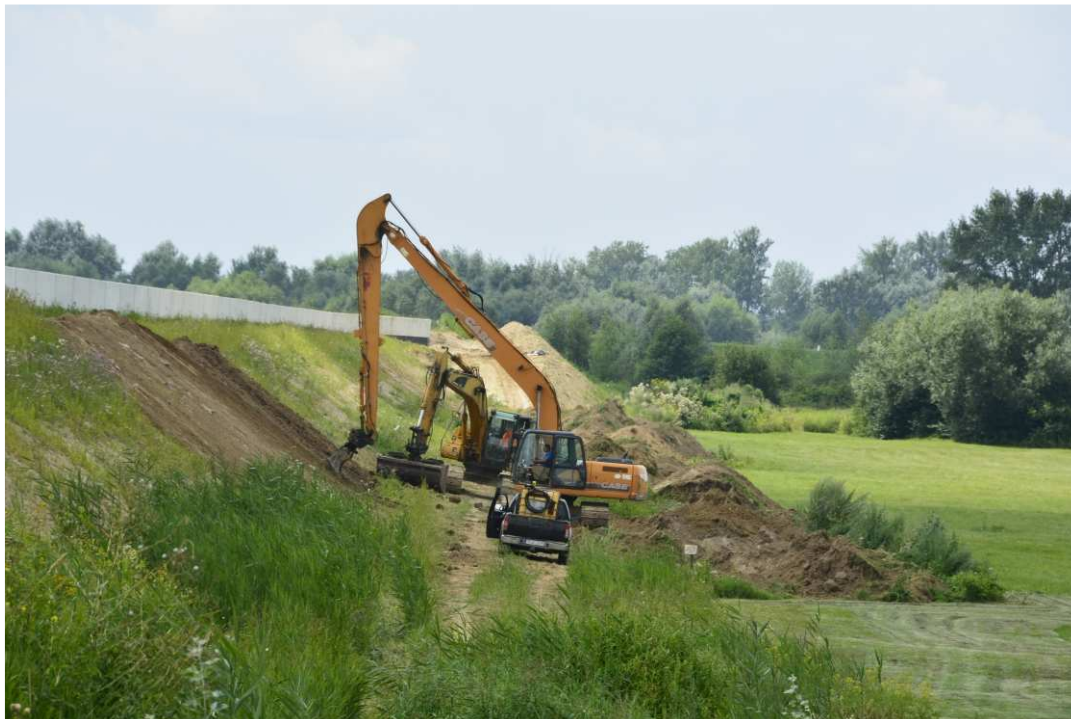
Fig. 35. Covering slopes of the flood embankment with a top-soil layer – band embankment between Zarzekowice Street and the right embankment of Vistula, status in the second decade of July 2021 (view towards the south-west).

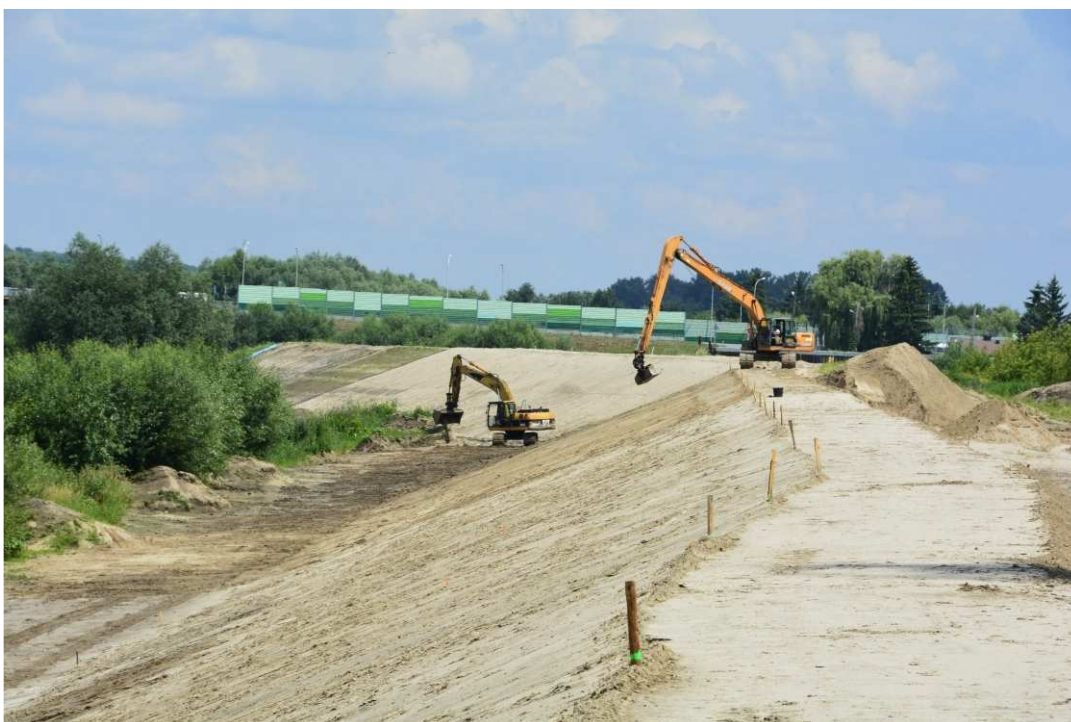
Fig. 36. Covering slopes of the flood embankment with a top-soil layer – right-bank Vistula embankment along the bank of the port channel, status in the first decade of July 2021 (view towards the north-east).

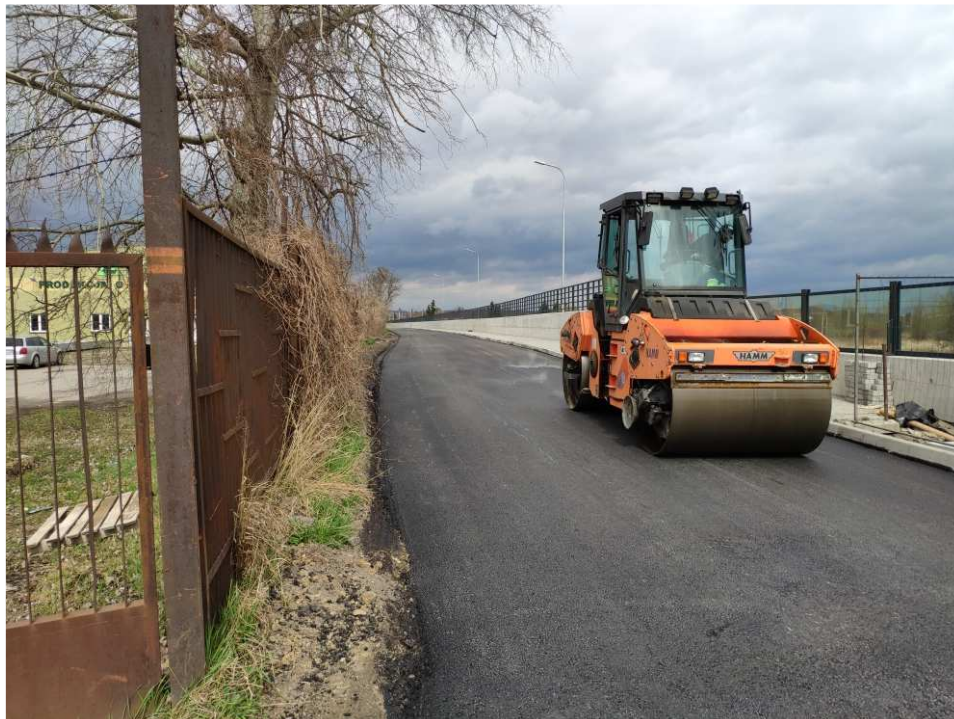
Fig. 37. Construction of a road on the band embankment
– band embankment within the artery of Mostowa Street,
status in the first decade of April 2022 (view towards the north-east).

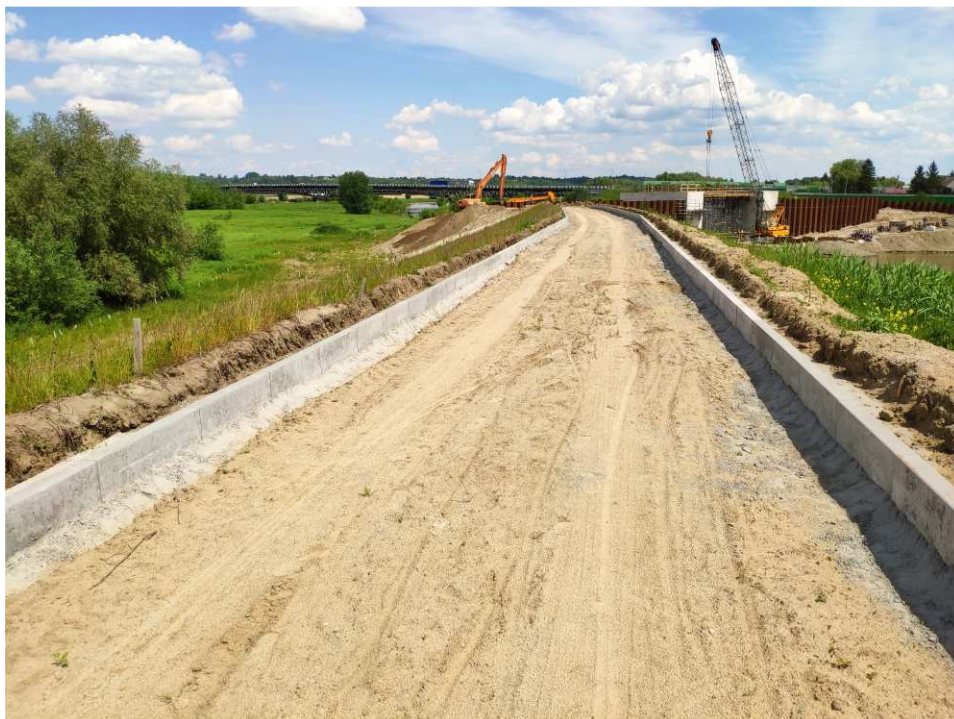
Fig. 38. Construction of a road on the crown of the flood embankment
– right-bank Vistula embankment along the bank of the port channel,
status in the third decade of May 2022 (view towards the north-east).

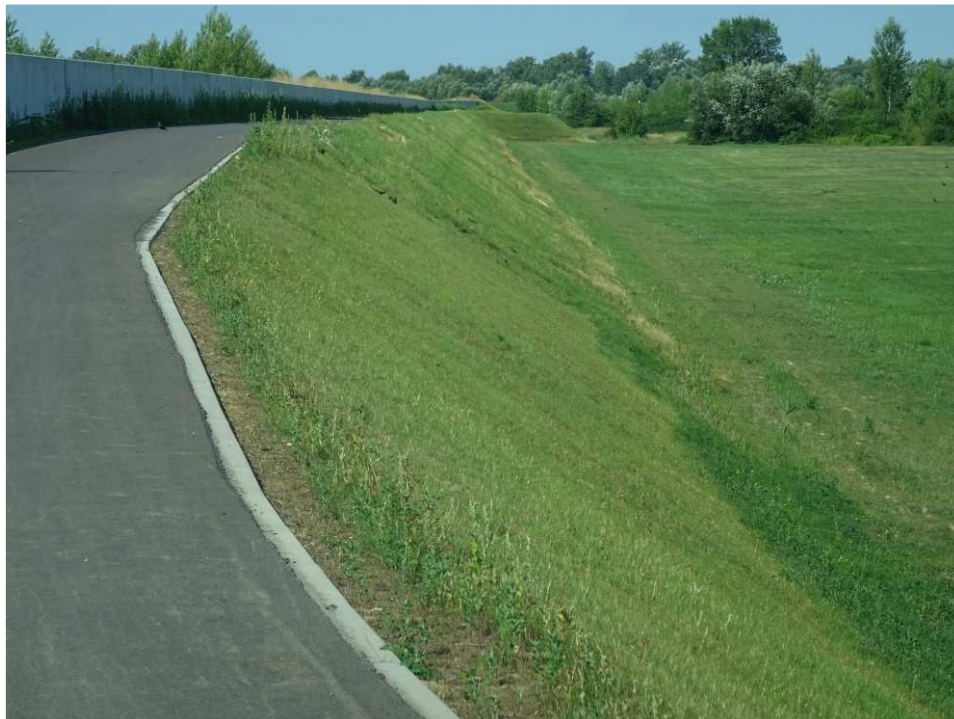
Fig. 39. Growth of grasses sown on the slope of the flood embankment
– band embankment between Zarzekowice Street and the right embankment
of Vistula, status in the third decade of July 2022 (view towards the south-west).

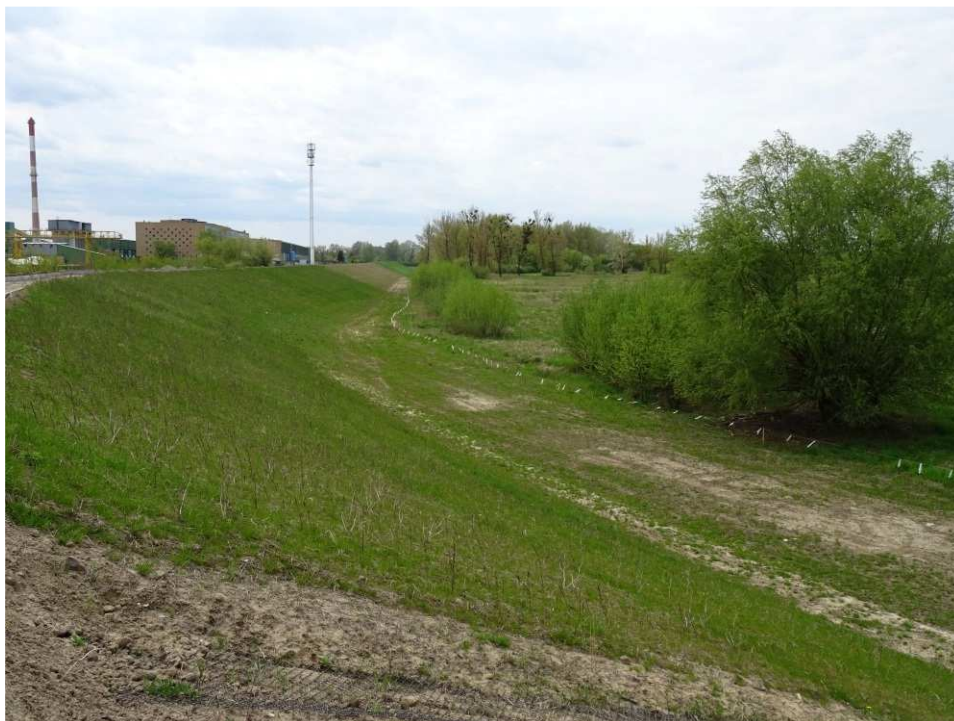
Fig. 40. Growth of grasses sown on the slope of the flood embankment
– right-bank Vistula embankment along the bank of the port channel,
status in the first decade of May 2022 (view towards the south-west).

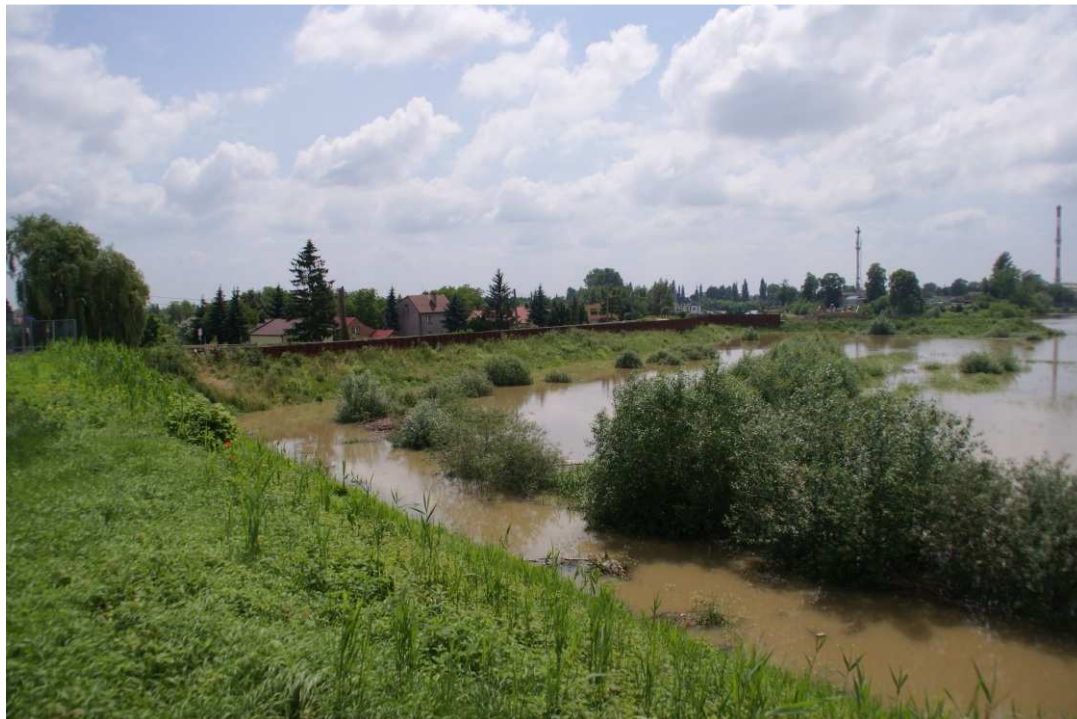
Fig. 41. Flooding from Vistula in the area of works
– band embankment within the artery of Mostowa Street,
status in the third decade of June 2020 (view towards the south-west).

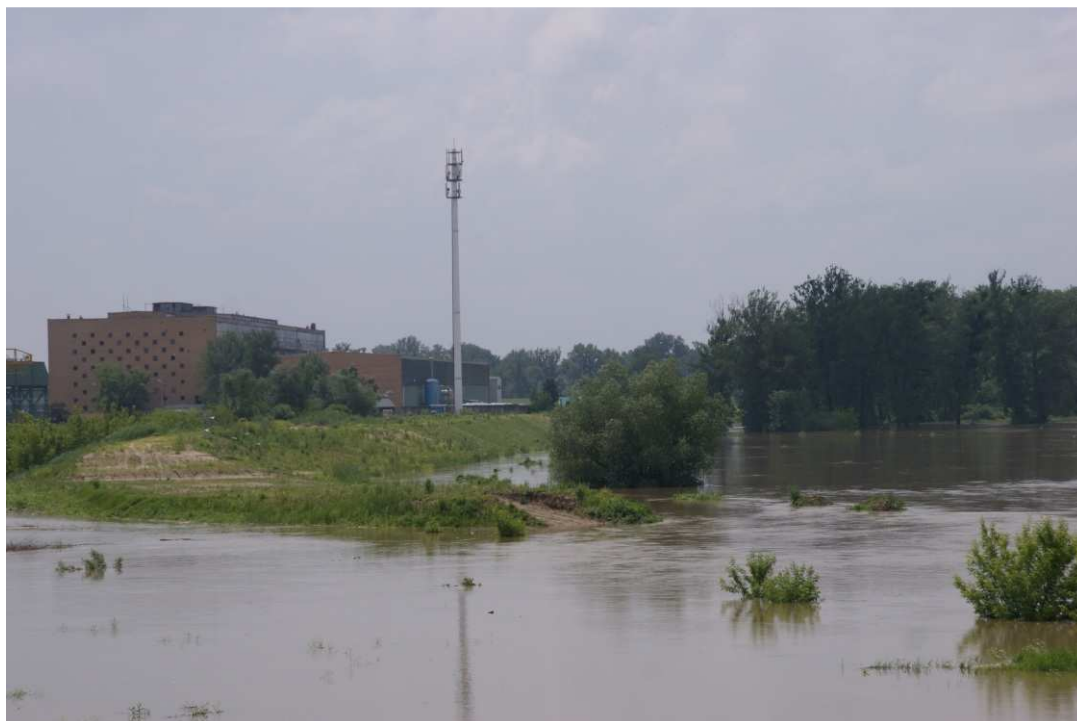
Fig. 42. Flooding from Vistula in the area of works
– right-bank Vistula embankment along the bank of the port channel,
status in the third decade of June 2020 (view towards the south-west).

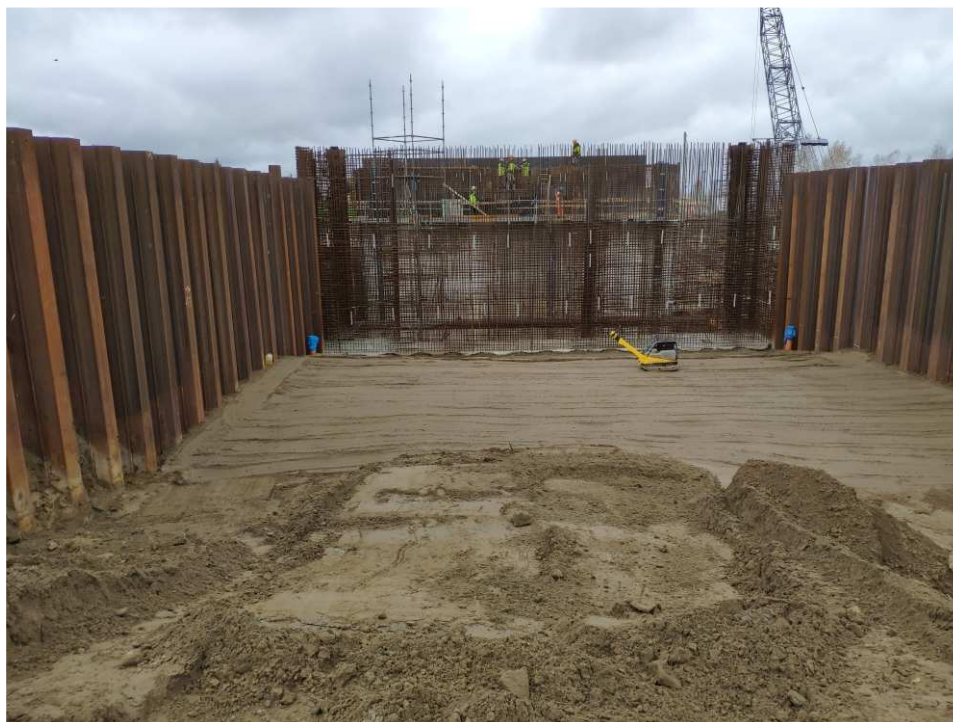
Fig. 43. Construction of a flood gate on the port channel in Sandomierz, status in the third decade of April 2022 (view towards the south-east).

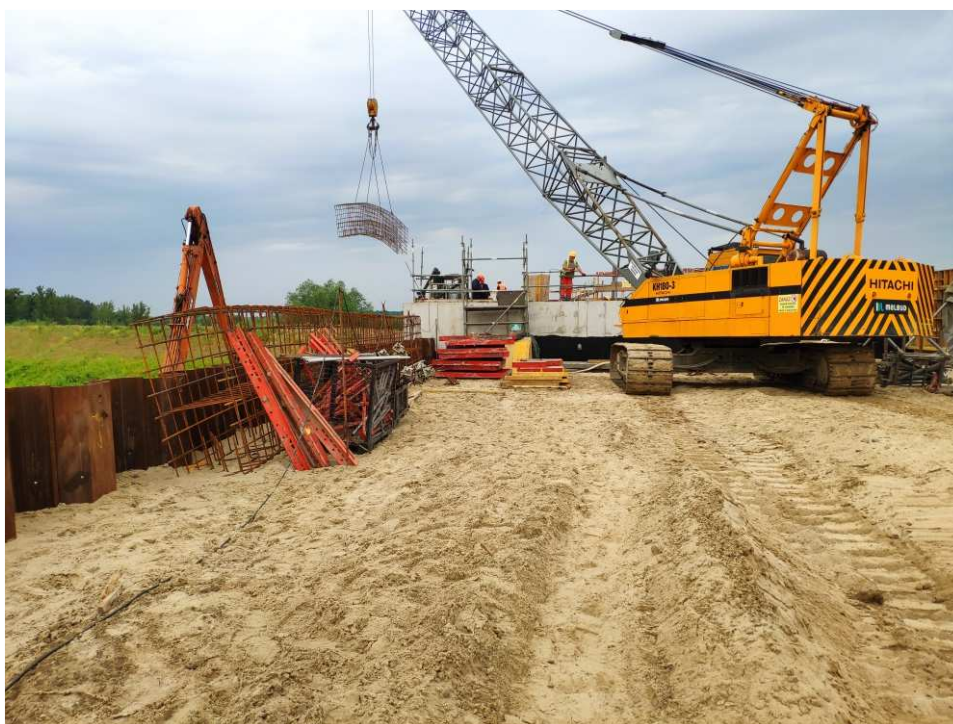
Fig. 44. Construction of a flood gate on the port channel in Sandomierz, status in the first decade of July 2022 (view towards the north-west).

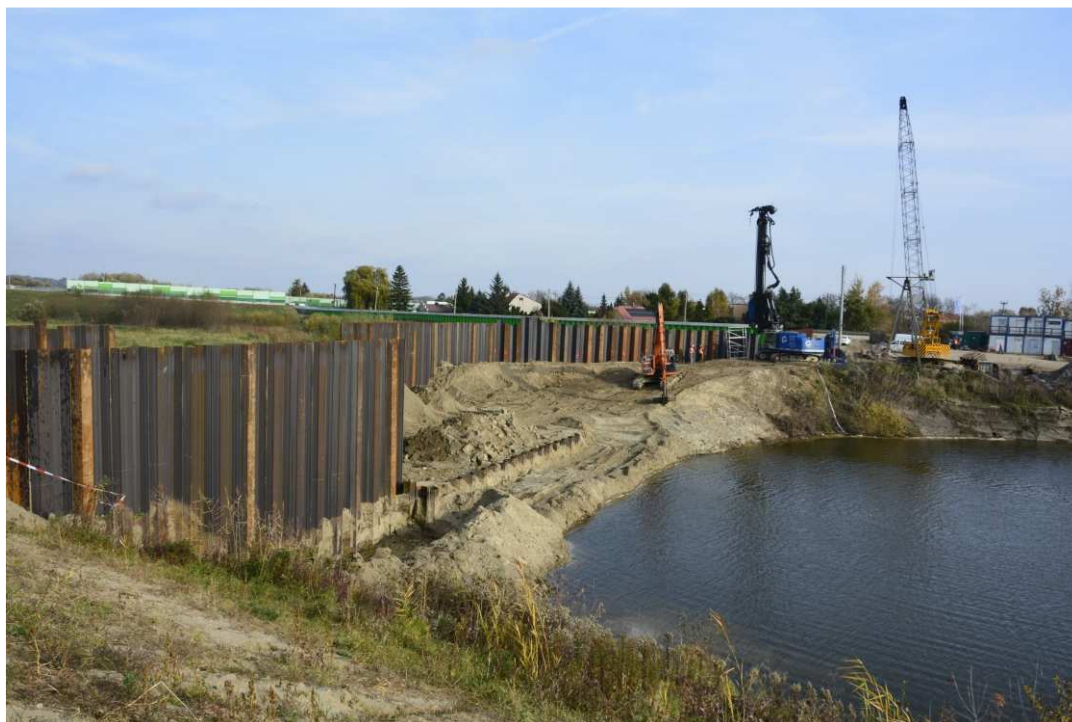
Fig. 45. Works in a bed of the port channel carried out under the cover of sheet piling – flood gate on the port channel in Sandomierz, status in the third decade of October 2021 (view towards the south-east).

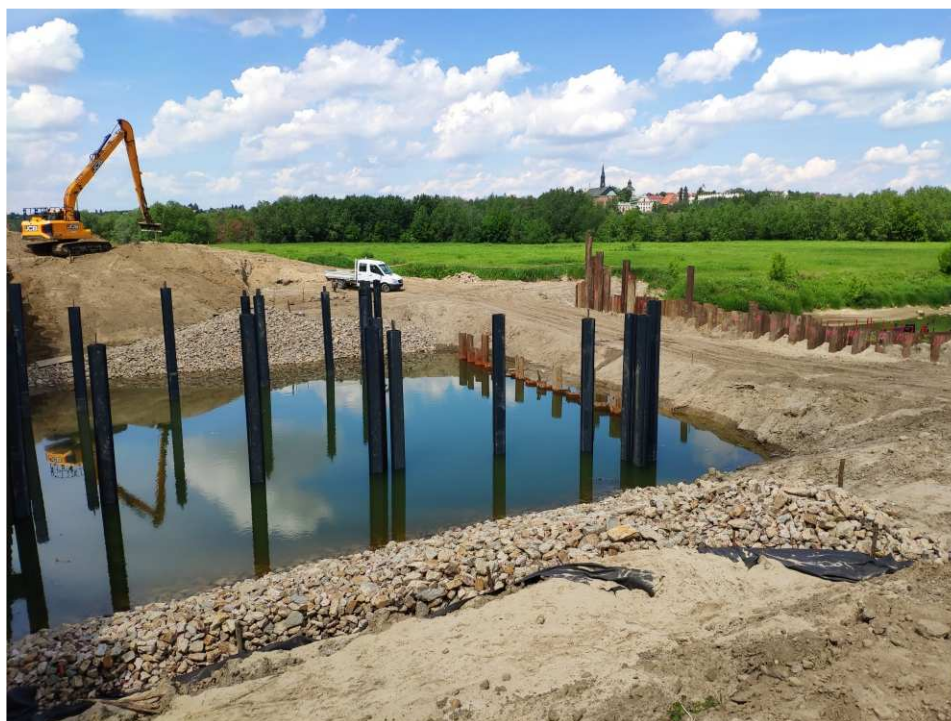
Fig. 46. Works in a bed of the port channel carried out under the cover of sheet piling – flood gate on the port channel in Sandomierz, status in the third decade of May 2022 (view towards the north-west).

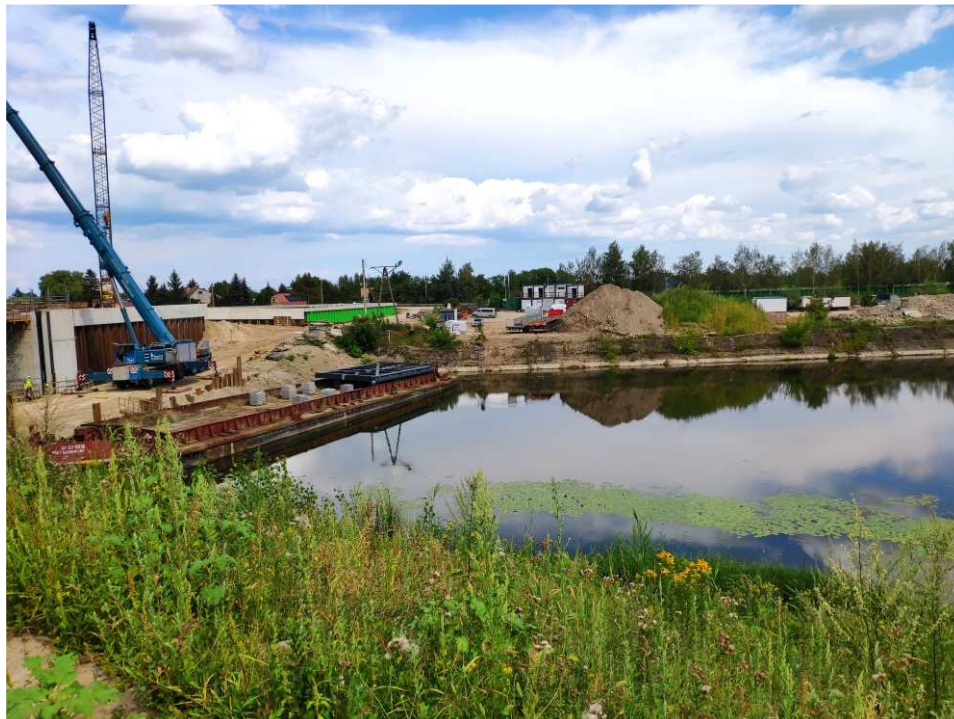
Fig. 47. No impact on water environment beyond the boundaries of the works site – flood gate on the port channel in Sandomierz, status in the first decade of August 2022 (view towards the south-east).

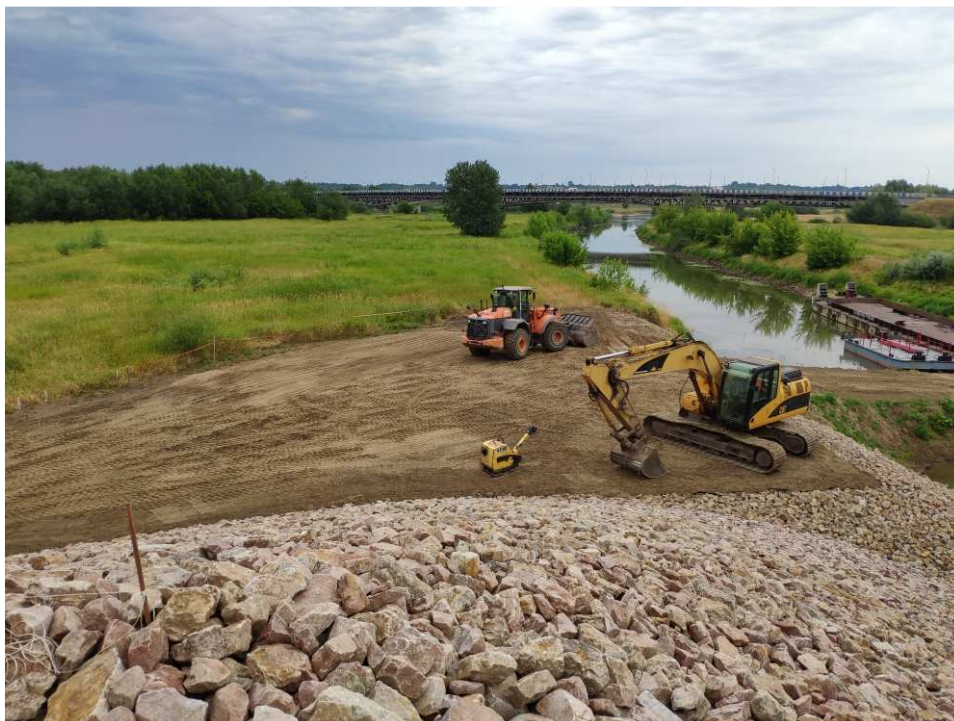
Fig. 48. No impact on Natura 2000 site beyond the boundaries of the works site – flood gate on the port channel in Sandomierz, status in the first decade of July 2022 (view towards the north-east).

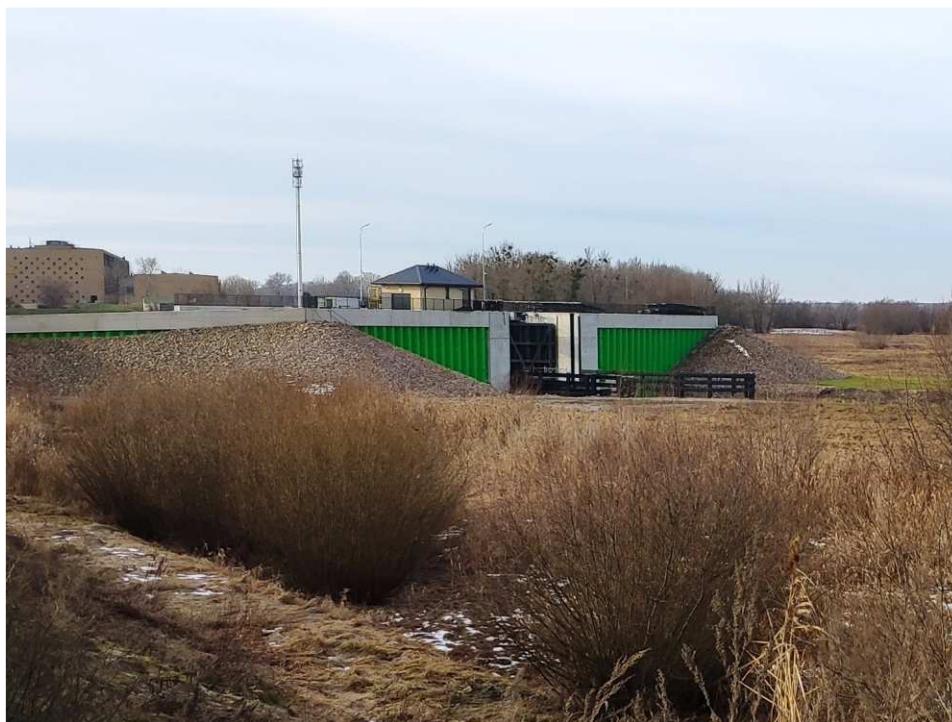
Fig. 49. Site condition in the last quarter of the works implementation period on Task 3 – flood gate on the port channel in Sandomierz, status in the third decade of December 2022 (view towards the west).

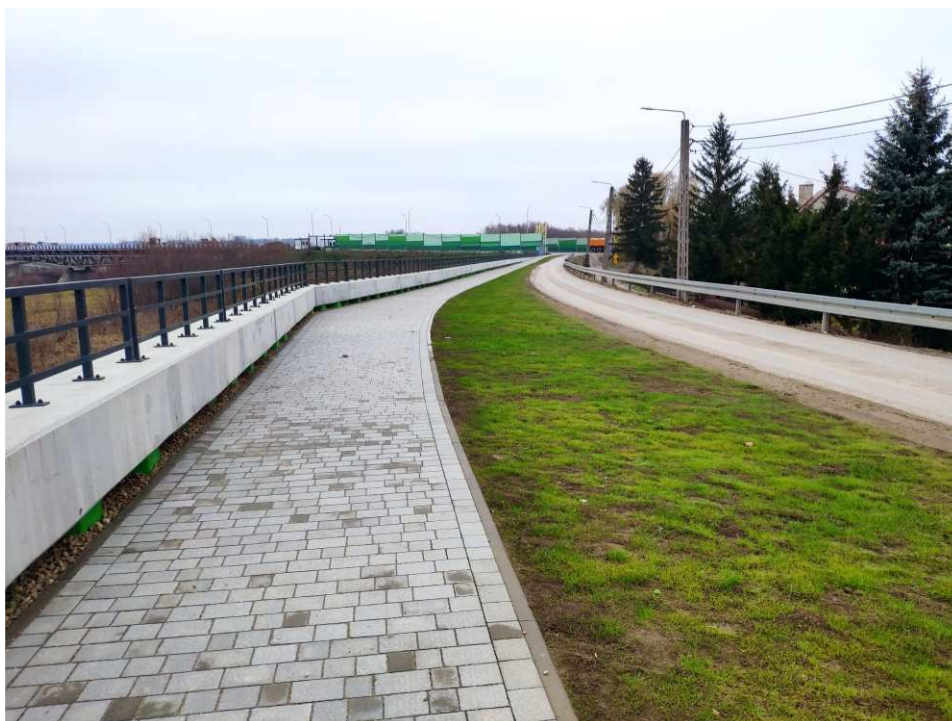
Fig. 50. Site condition in the last quarter of the works implementation period on Task 3 – band embankment within the artery of Mostowa Street, status in the third decade of November 2022 (view towards the north-east).

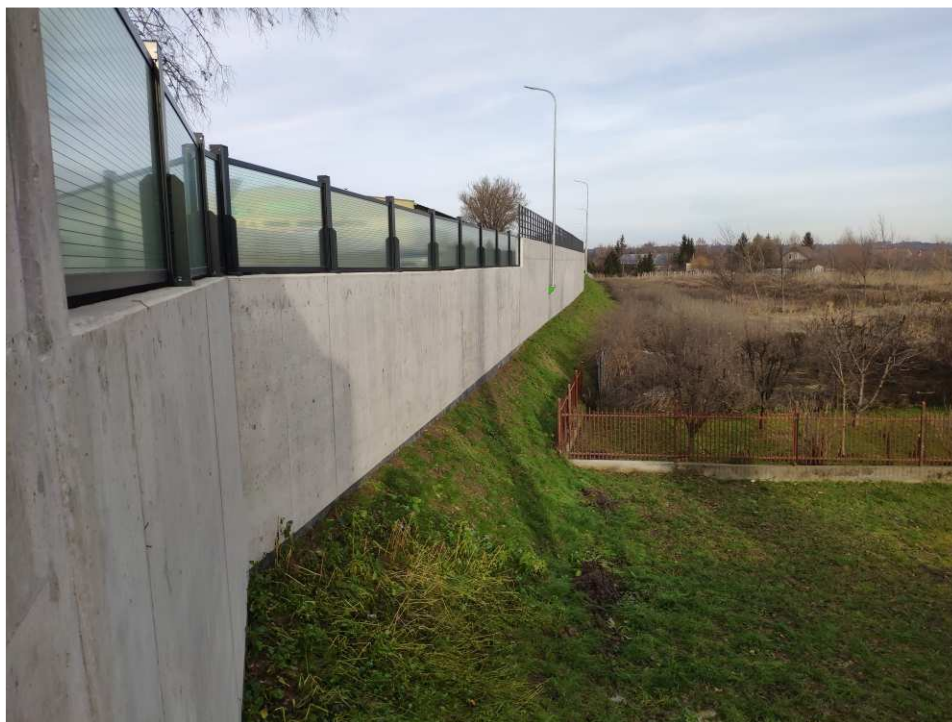
Fig. 51. Site condition in the last quarter of the works implementation period on Task 3 – band embankment within the artery of Mostowa Street, status in the third decade of December 2022 (view towards the north-east).

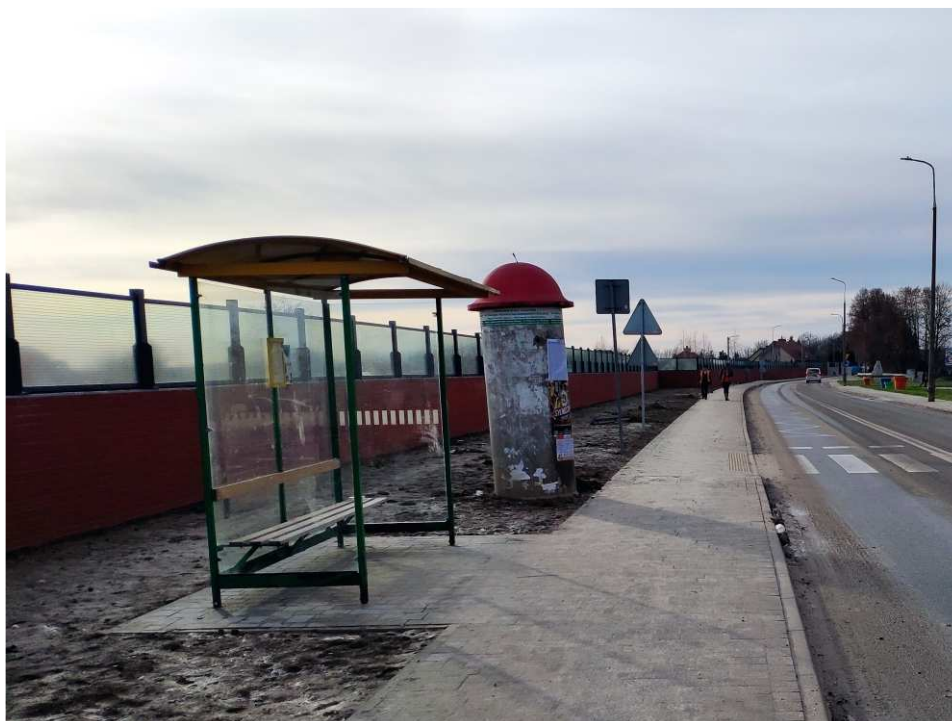
Fig. 52. Site condition in the last quarter of the works implementation period on Task 3 – band embankment within the artery of Portowa Street, status in the third decade of December 2022 (view towards the south-west).

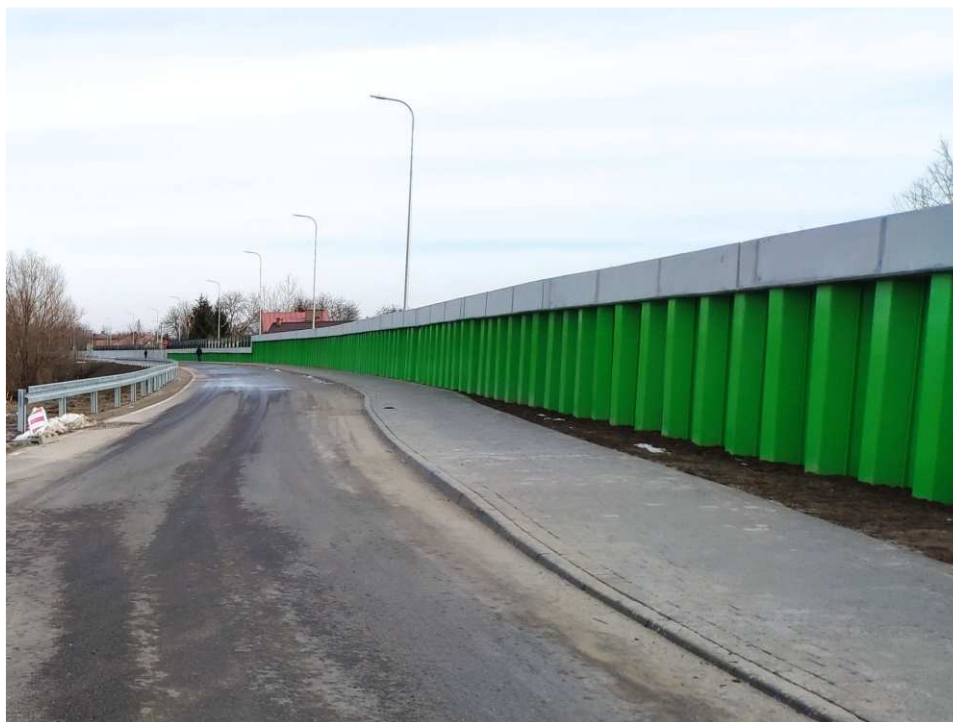
Fig. 53. Site condition in the last quarter of the works implementation period on Task 3 – band embankment within the artery of Zarzekowice Street, status in the third decade of December 2022 (view towards the north-east).

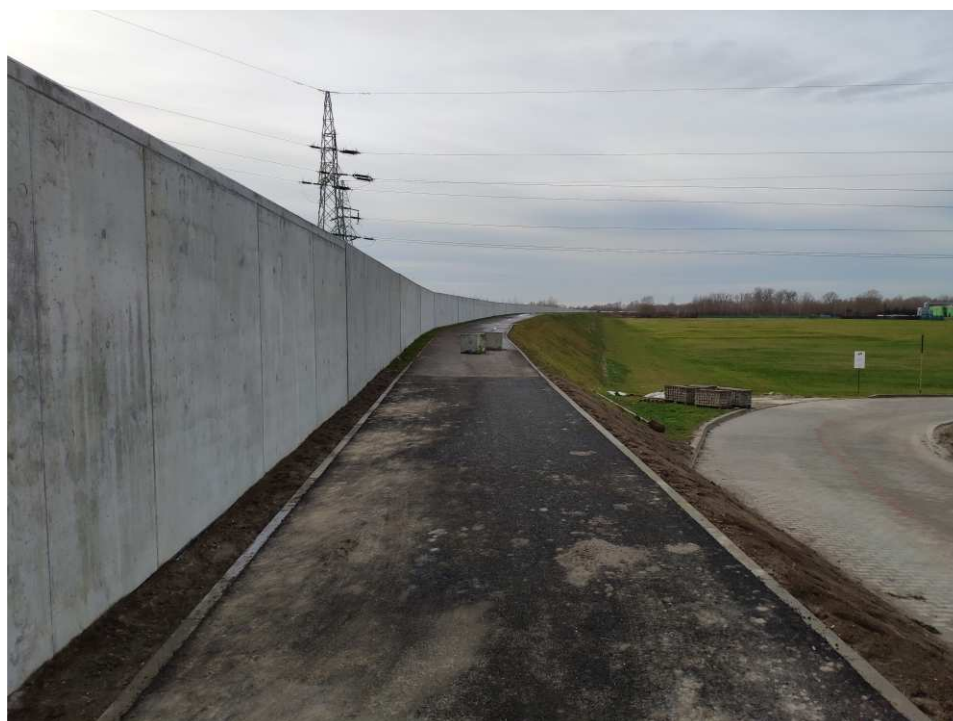
Fig. 54. Site condition in the last quarter of the works implementation period on Task 3 – band embankment between Zarzekowice Street and the right embankment of Vistula, status in the third decade of December 2022 (view towards the south-west).

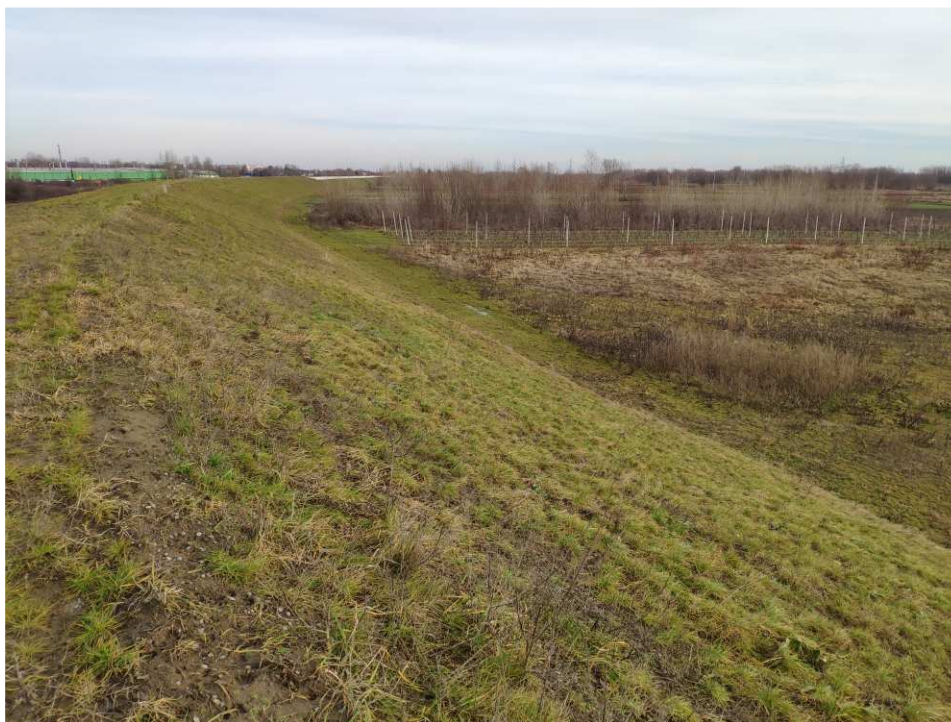
Fig. 55. Site condition in the last quarter of the works implementation period on Task 3 – band embankment between Zarzekowice Street and the right embankment of Vistula, status in the third decade of December 2022 (view towards the north-east).

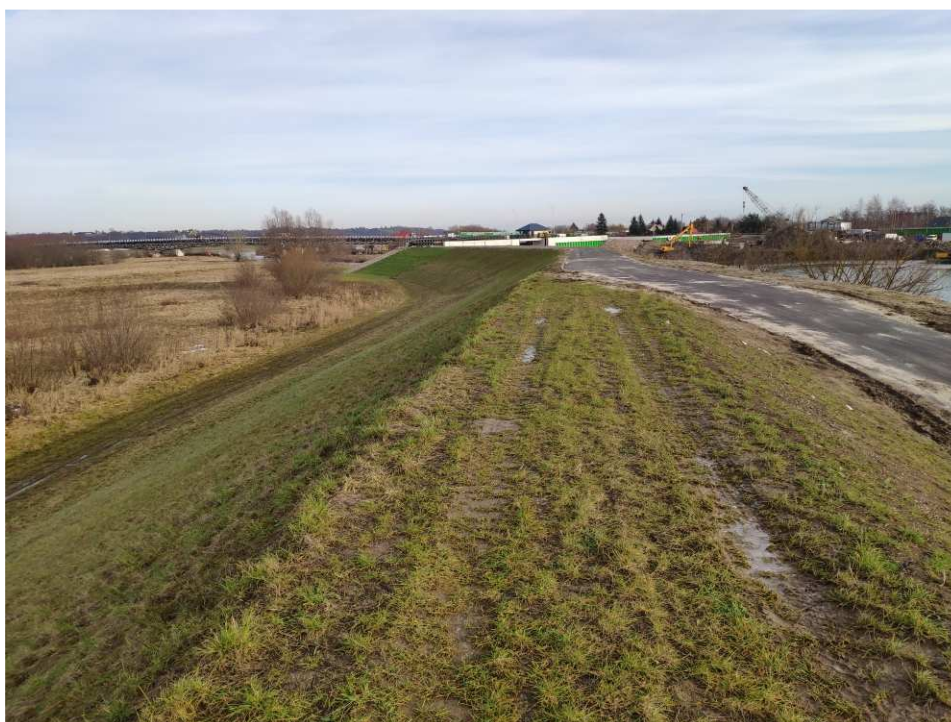
Fig. 56. Site condition in the last quarter of the works implementation period on Task 3 – right-bank Vistula embankment along the bank of the port channel, status in the third decade of December 2022 (view towards the north-east).
