Appendix no. 6 to the Final Report on Implementation of the Land Acquisition and Resettlement Action Plan (LARAP) for Contract 3A.3 entitled *Section 4 – The right embankment of the Vistula River from the estuary of Skawinka to the Kościuszko barrage.*

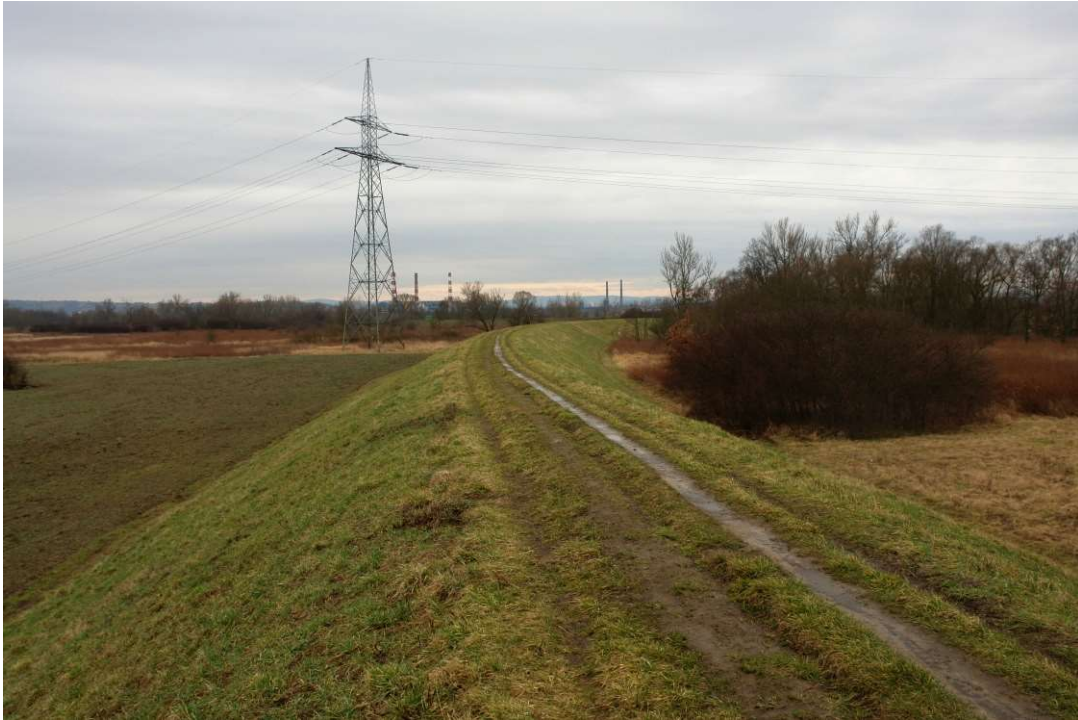
Photo. 1. Condition of the Construction Site before the start of works - the right embankment of the Vistula River planned for reconstruction for Task 1, the condition in the third decade of February 2020 (upstream view).

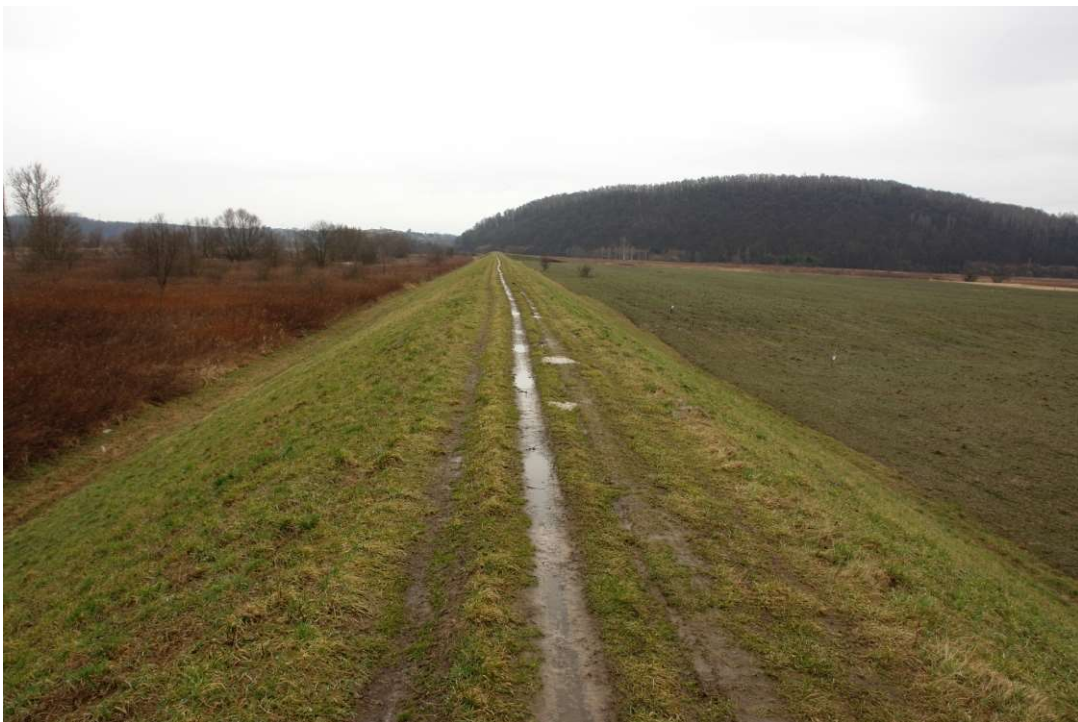
Photo. 2. Condition of the Construction Site before the start of works - the right embankment of the Vistula River planned for reconstruction for Task 1, the condition in the third decade of February 2020 (downstream view).

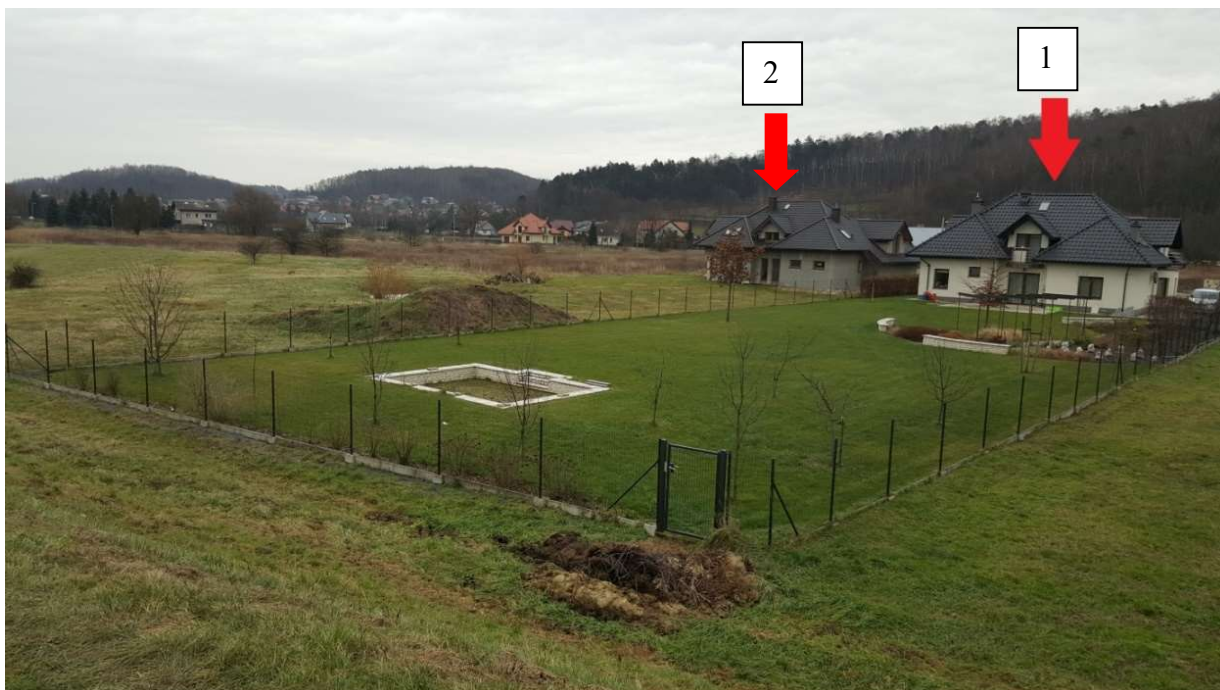
Photo. 3. Condition of the Construction Site before the start of works – household located at 58. Walgierz Wdale St. (1) and developed land property no. 197/12 (2).

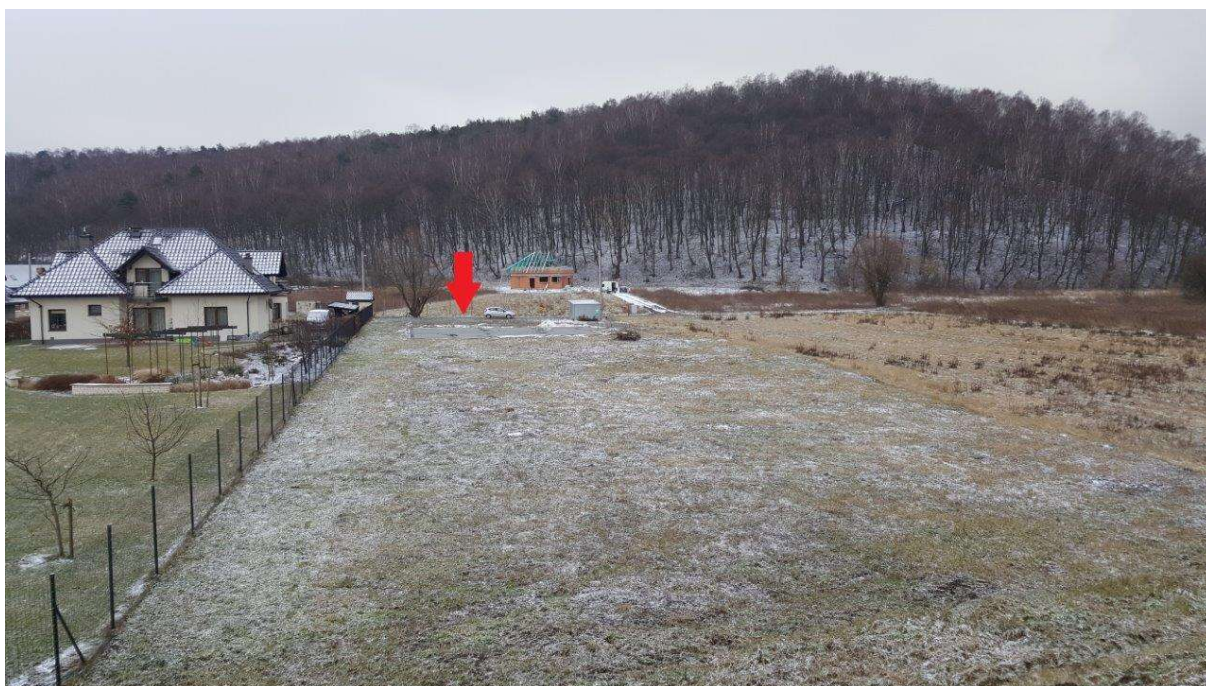
Photo. 4. Condition of the Construction Site before the start of works – foundations located on land property no. 197/6 (197/1 before split-up).

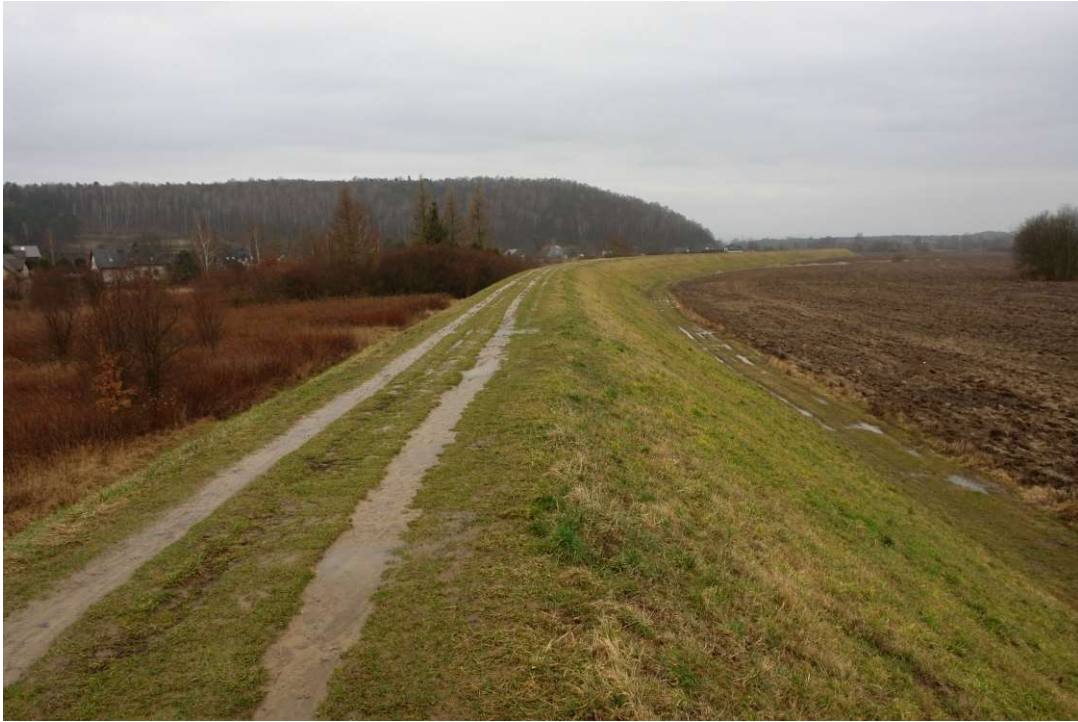
Photo. 5. Condition of the Construction Site before the start of works - the right embankment of the Vistula River planned for reconstruction for Task 2, the condition in the third decade of February 2020 (upstream view).

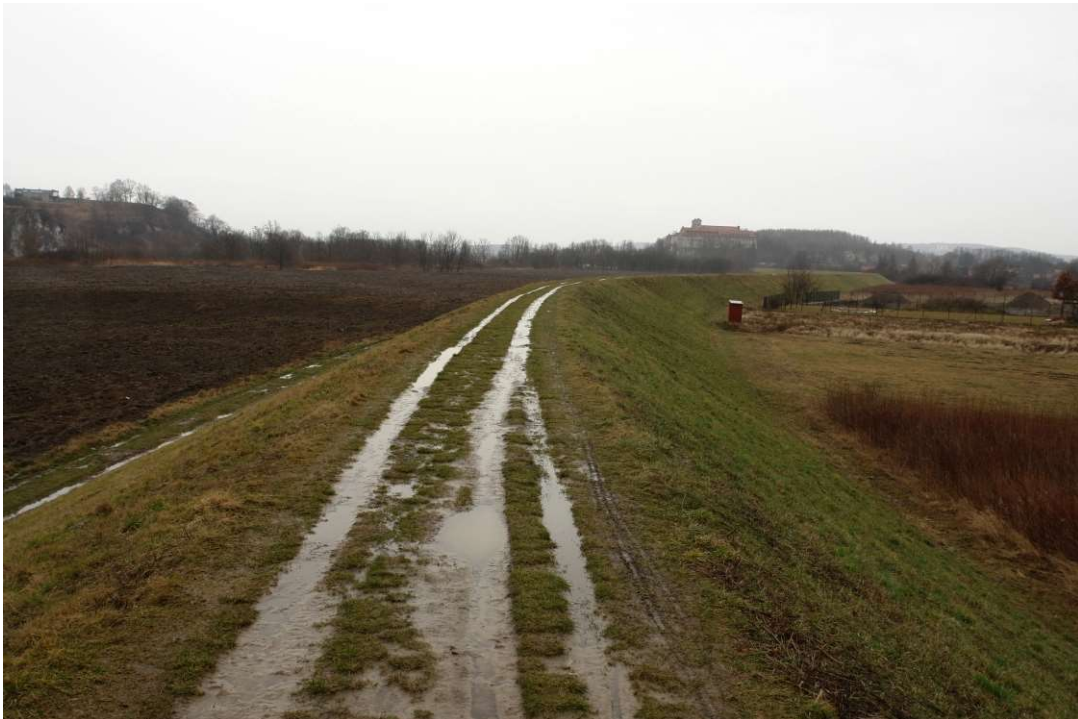
Photo. 6. Condition of the Construction Site before the start of works - the right embankment of the Vistula River planned for reconstruction for Task 2, the condition in the third decade of February 2020 (downstream view).

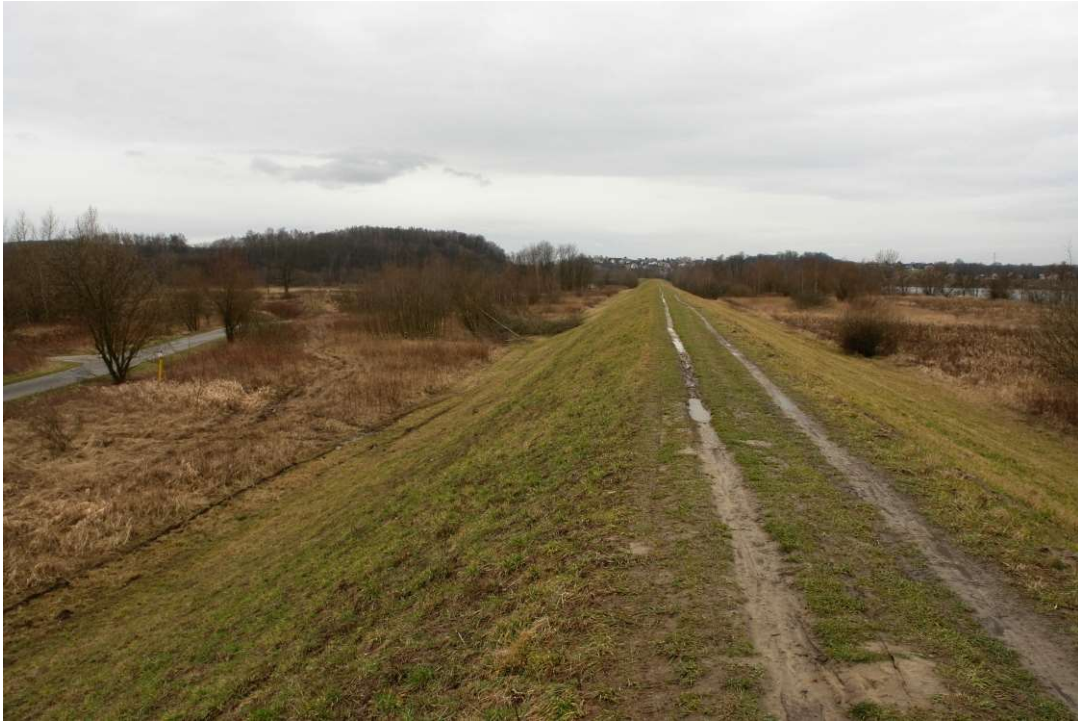
Photo. 7. Condition of the Construction Site before the start of works - the right embankment of the Vistula River planned for reconstruction for Task 3, the condition in the third decade of February 2020 (upstream view).

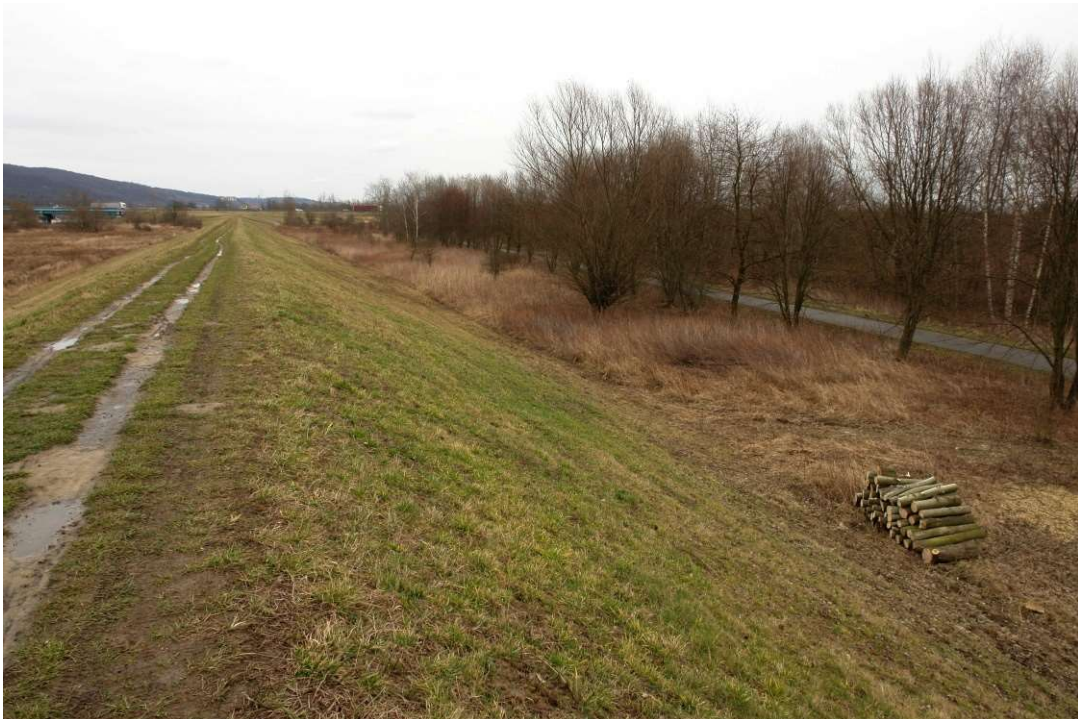
Photo. 8. Condition of the Construction Site before the start of works - the right embankment of the Vistula River planned for reconstruction for Task 3, the condition in the third decade of February 2020 (downstream view).

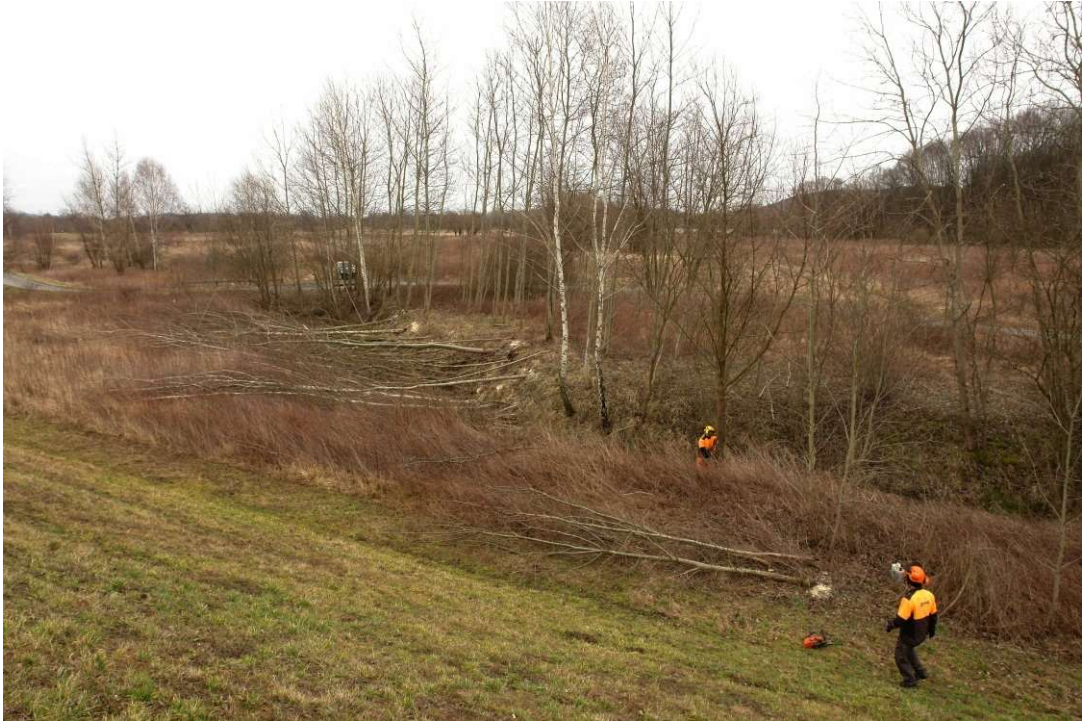
Photo. 9. Removal of trees for Task 3, condition in the third decade of February 2020 (view towards the area beyond the embankment).

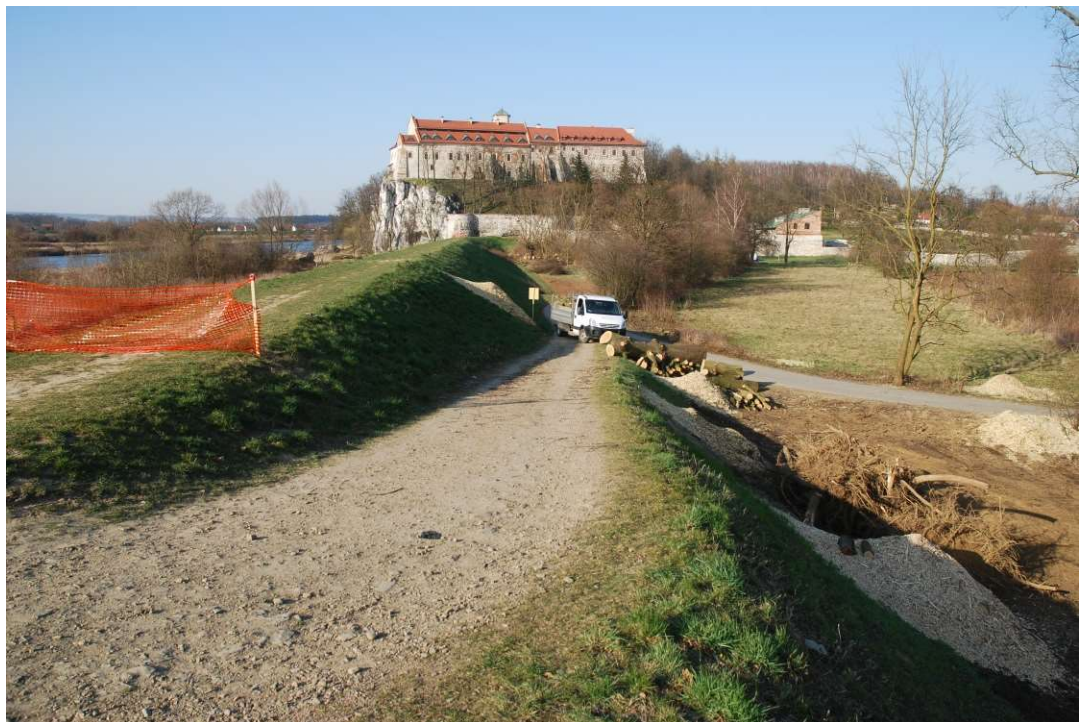
Photo. 10. Tidying-up of the area after removal of trees for Task 2, condition in the third decade of March 2020 (downstream view).

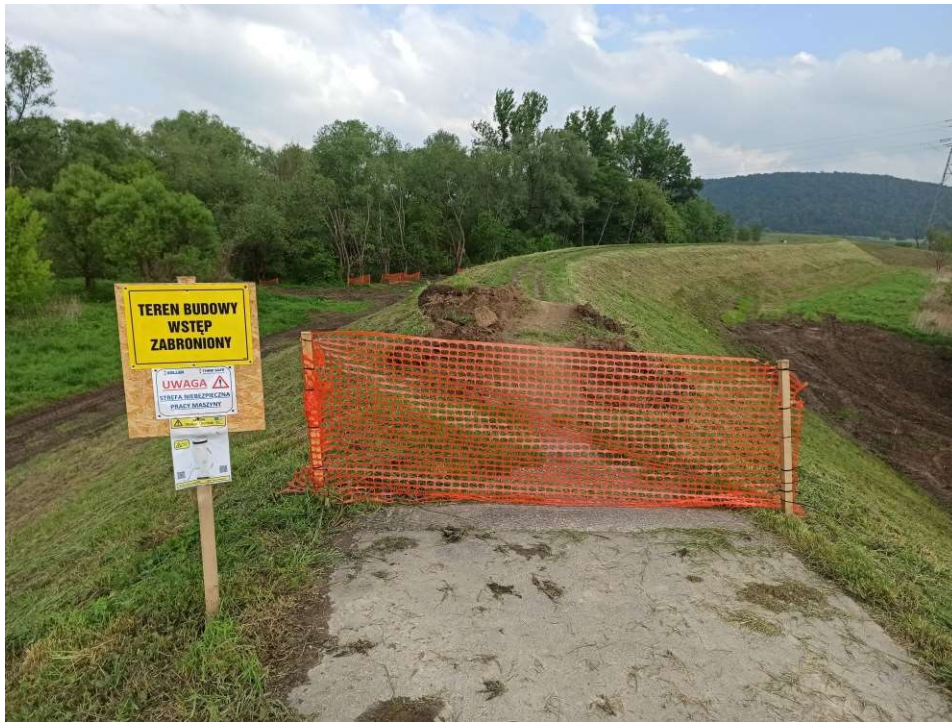
Photo. 11. Marking of the construction site for Task 1, condition in the third decade of May 2020 (downstream view).

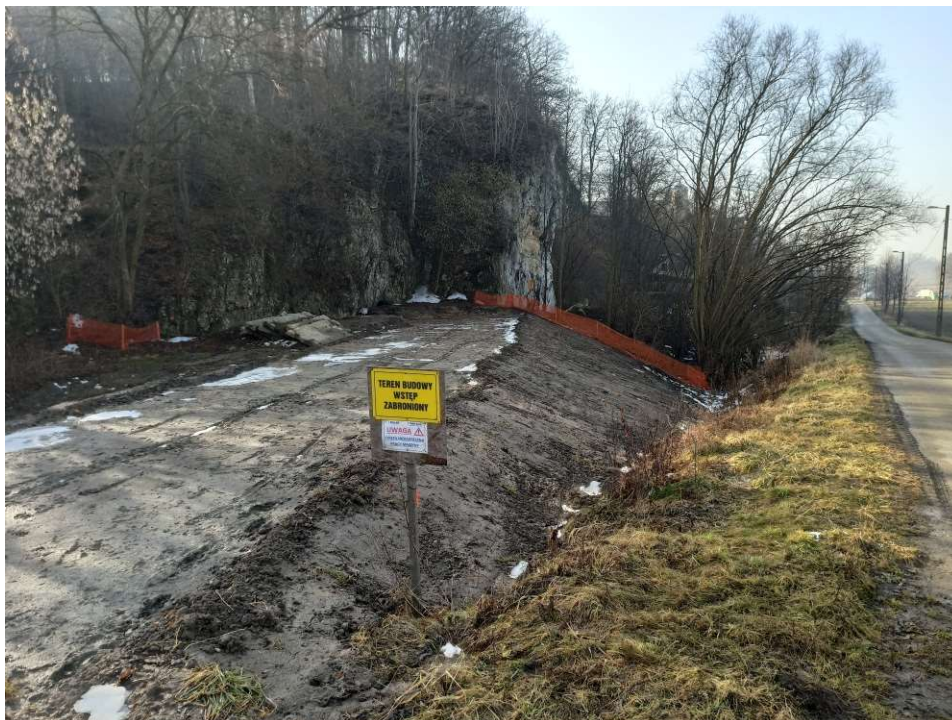
Photo. 12. Marking of the construction site for Task 3, condition in the third decade of February 2021 (upstream view).

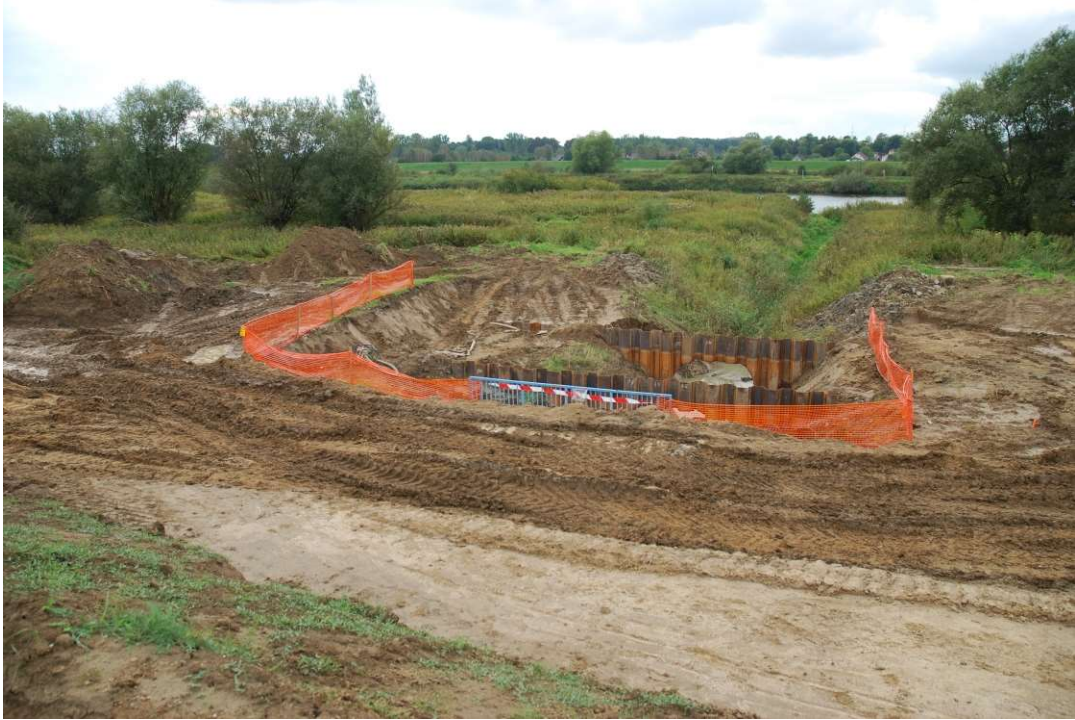
Photo. 13. Protection of hazardous places for Task 1, condition in the third decade of September 2020 (view towards the embanked area).

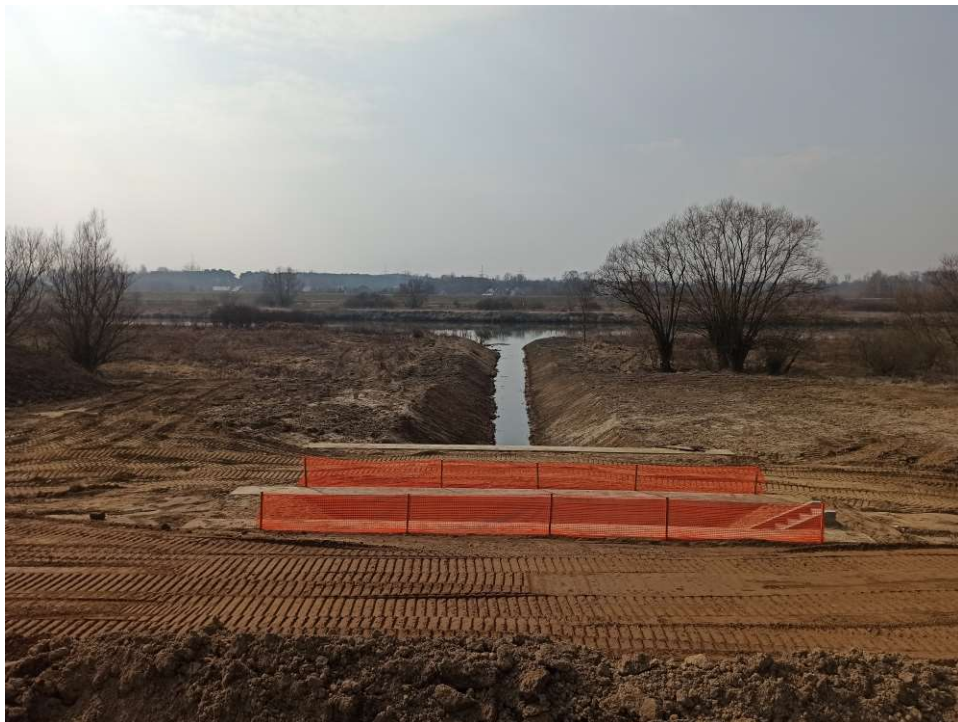
Photo. 14. Protection of hazardous places for Task 1, condition in the third decade of March 2021 (view towards the embanked area).

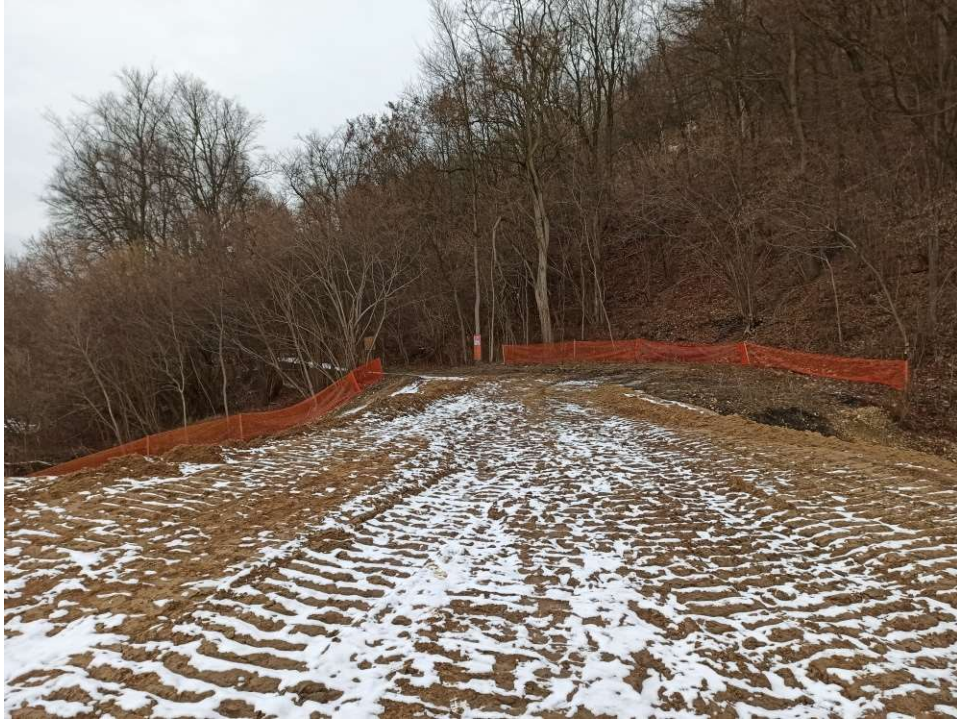
Photo. 15. Protection of trees and bushes not planned for removal for Task 1, condition in the third decade of January 2021 (downstream view).

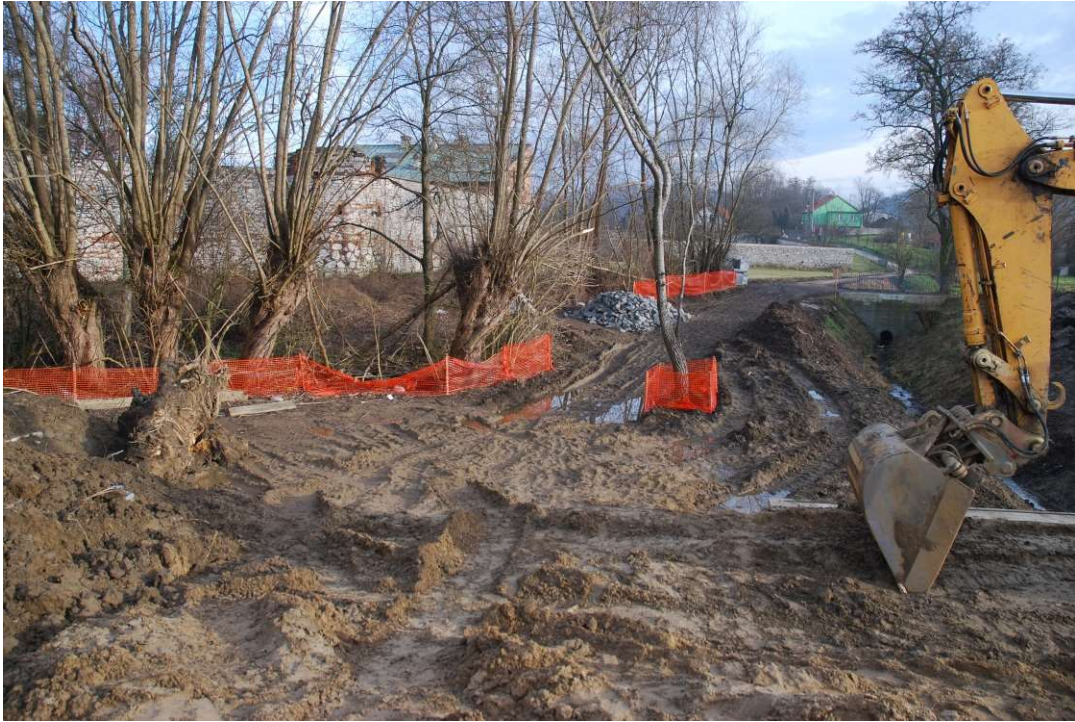
Photo. 16. Protection of trees and bushes not planned for removal for Task 2, condition in the third decade of December 2020 (view towards the area beyond the embankment).

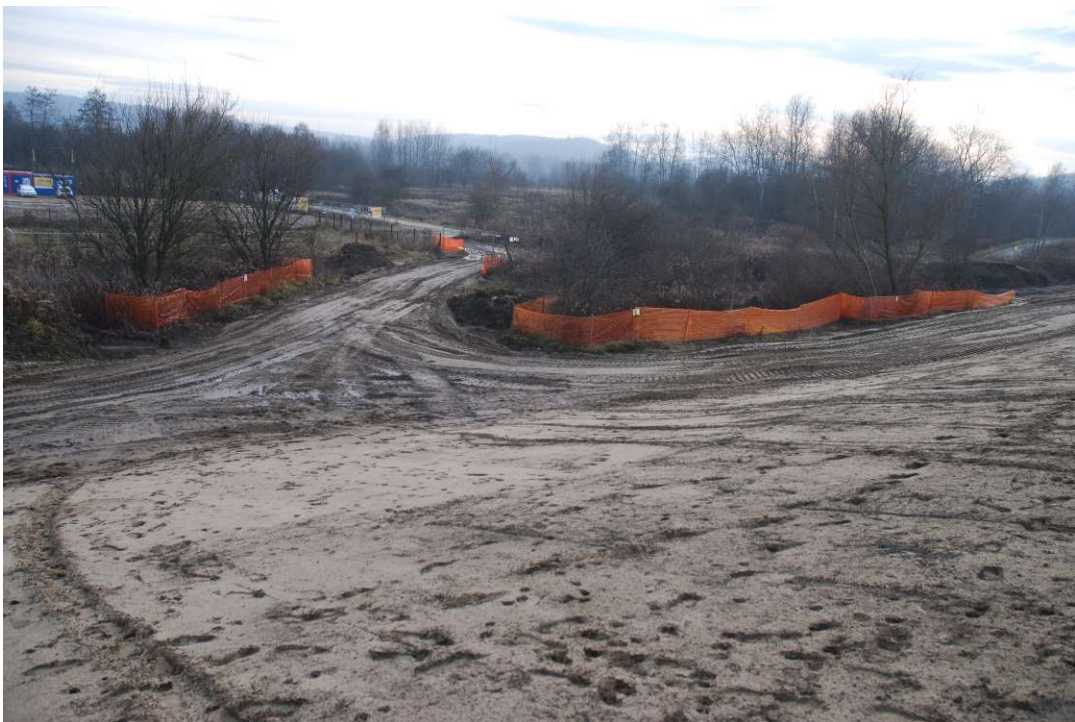
Photo. 17. Protection of trees and bushes not planned for removal for Task 3, condition in the third decade of December 2020 (view towards the area beyond the embankment).

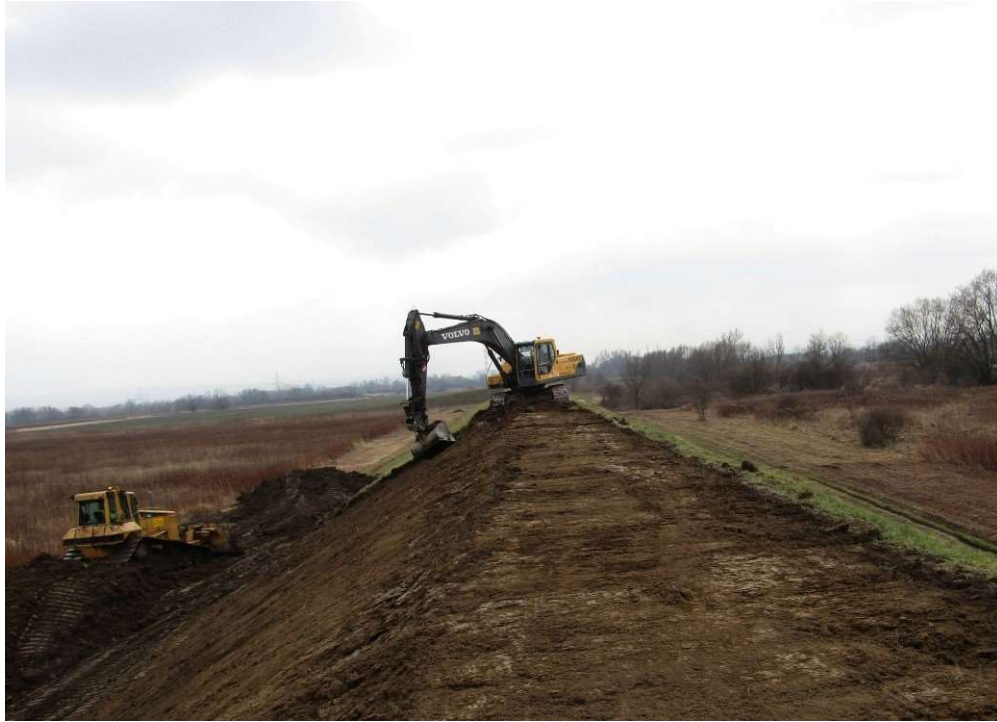
Photo. 18. Removal of the topsoil layer for Task 1, condition in the third decade of February 2020 (upstream view).

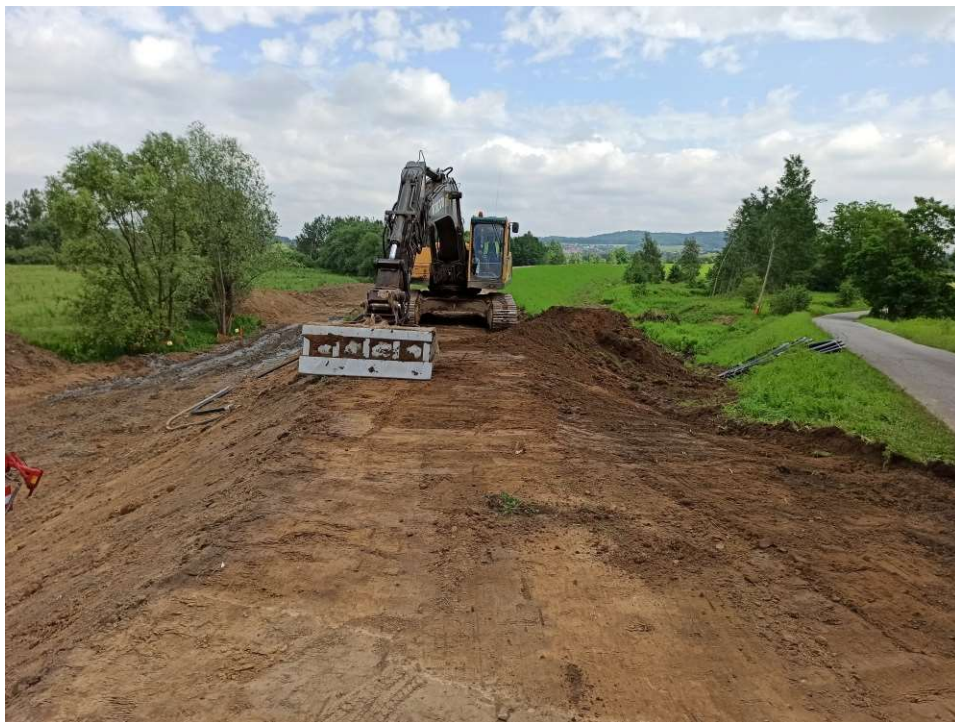
Photo. 19. Removal of the topsoil layer for Task 3, condition in the third decade of June 2020 (downstream view).

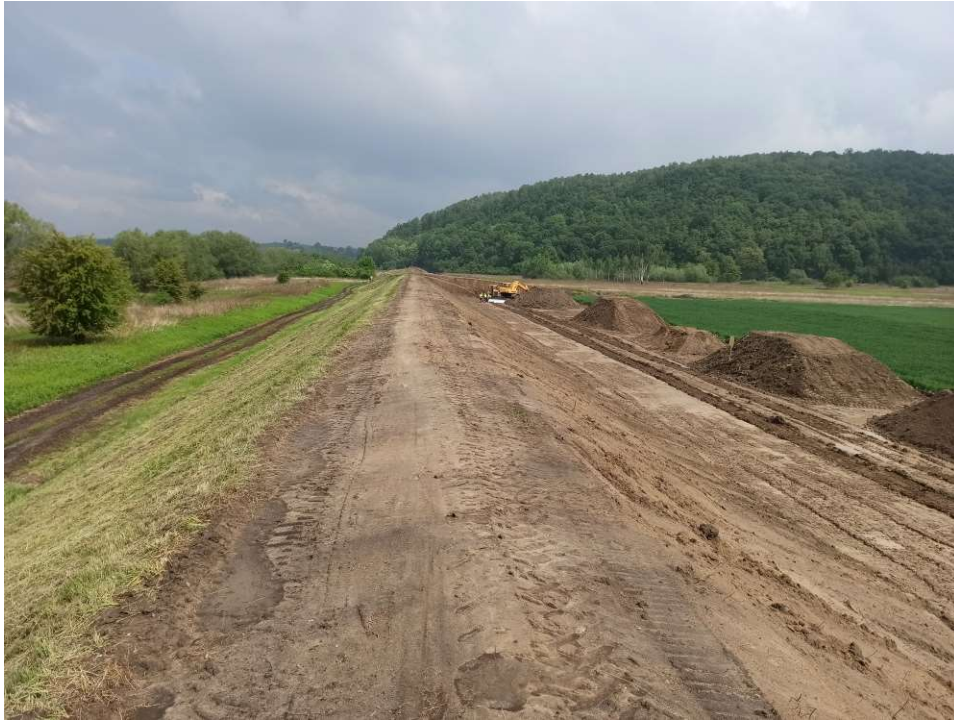
Photo. 20. Protection of the topsoil piles for Task 1, condition in the third decade of May 2020 (downstream view).

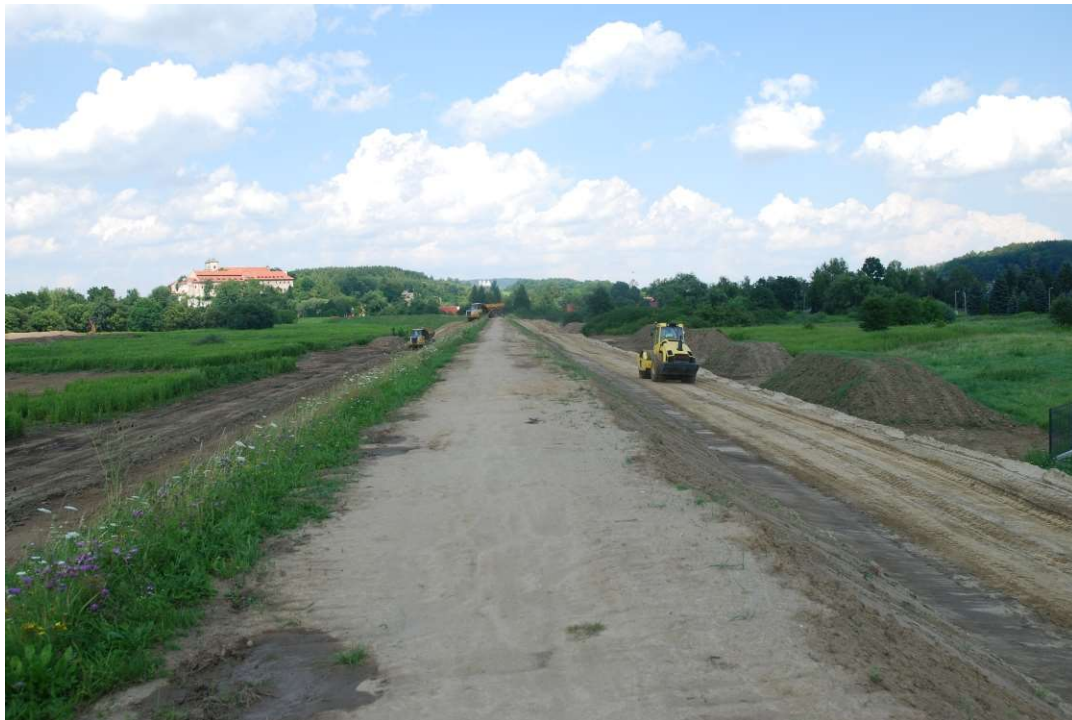
Photo. 21. Protection of the topsoil piles for Task 2, condition in the third decade of July 2020 (downstream view).

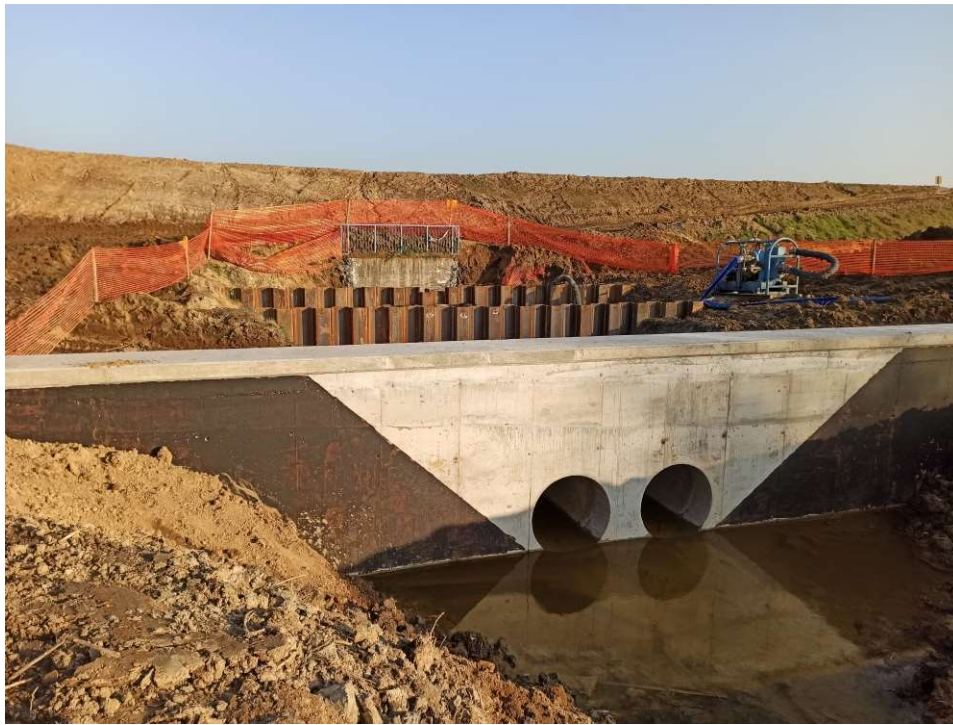
Photo. 22. Reconstruction of the embankment culvert at km 61+239 of the embankment of the Vistula River for Task 1, condition in the third decade of November 2020 (view from the embanked area).

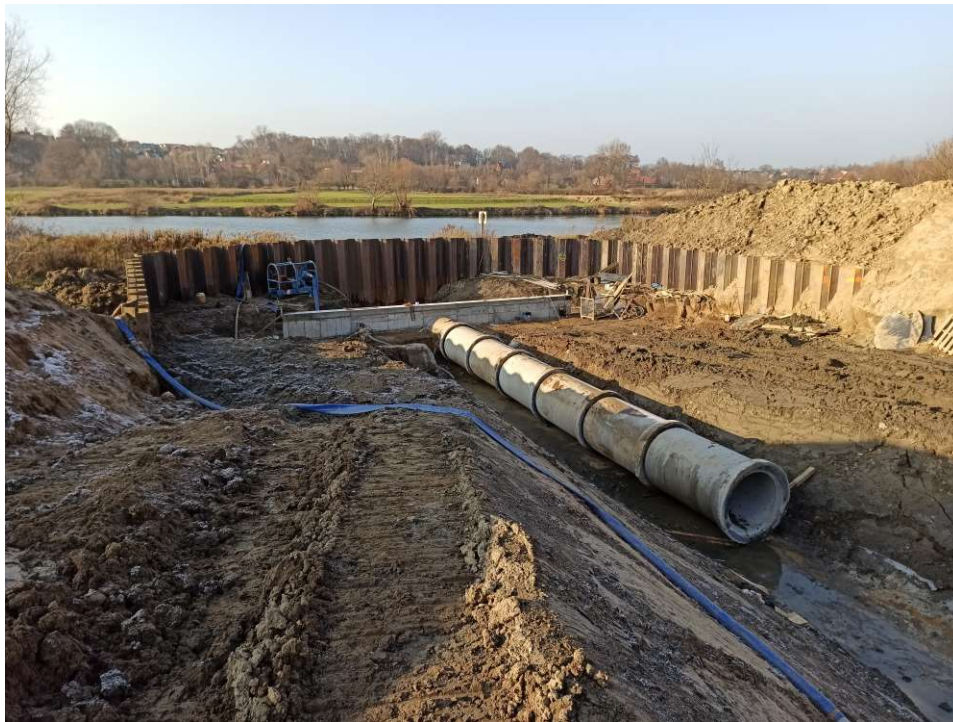
Photo. 23. Reconstruction of the embankment culvert at km 63+115 of the embankment of the Vistula River for Task 2, condition in the third decade of November 2020 (view towards the embanked area).

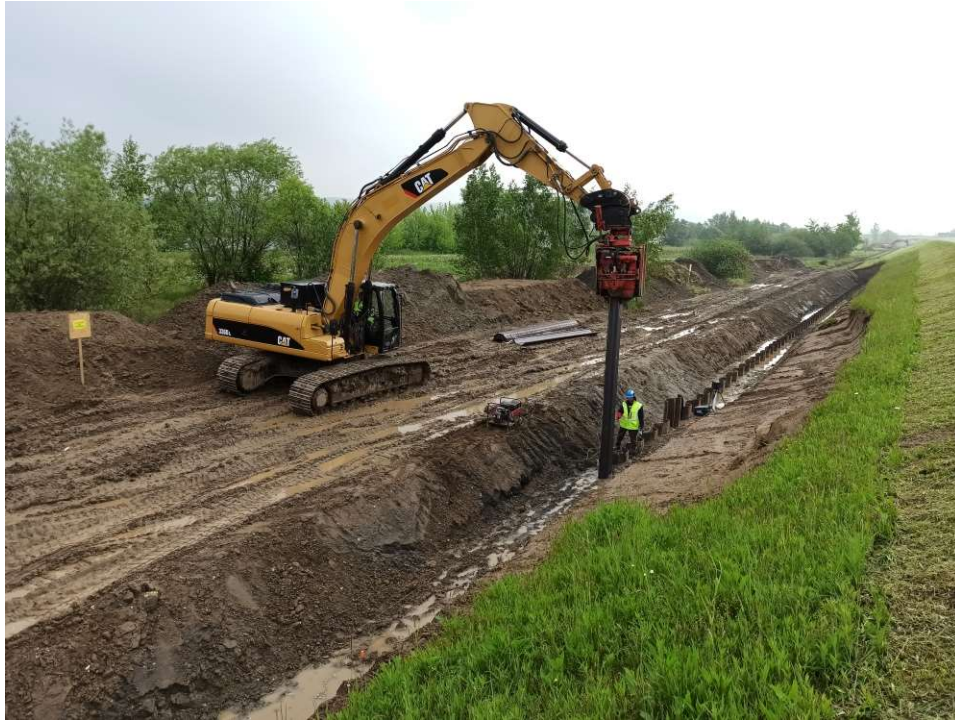
Photo. 24. Construction of the membrane made of sheet piles for Task 3, condition in the third decade of May 2020 (downstream view).

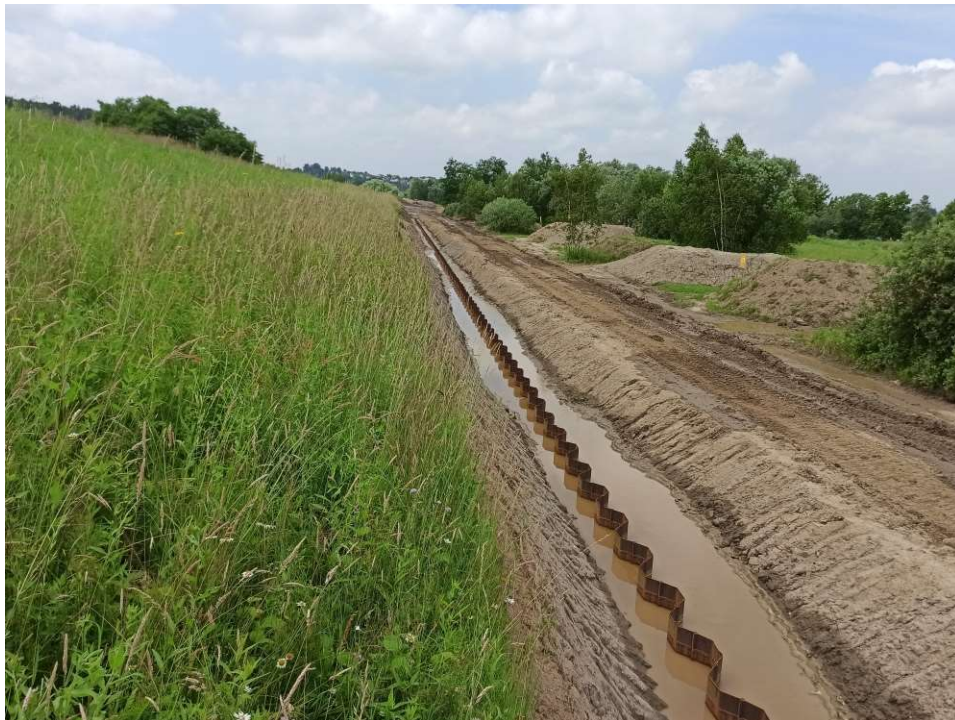
Photo. 25. Construction of the membrane made of sheet piles for Task 3, condition in the third decade of June 2020 (upstream view).

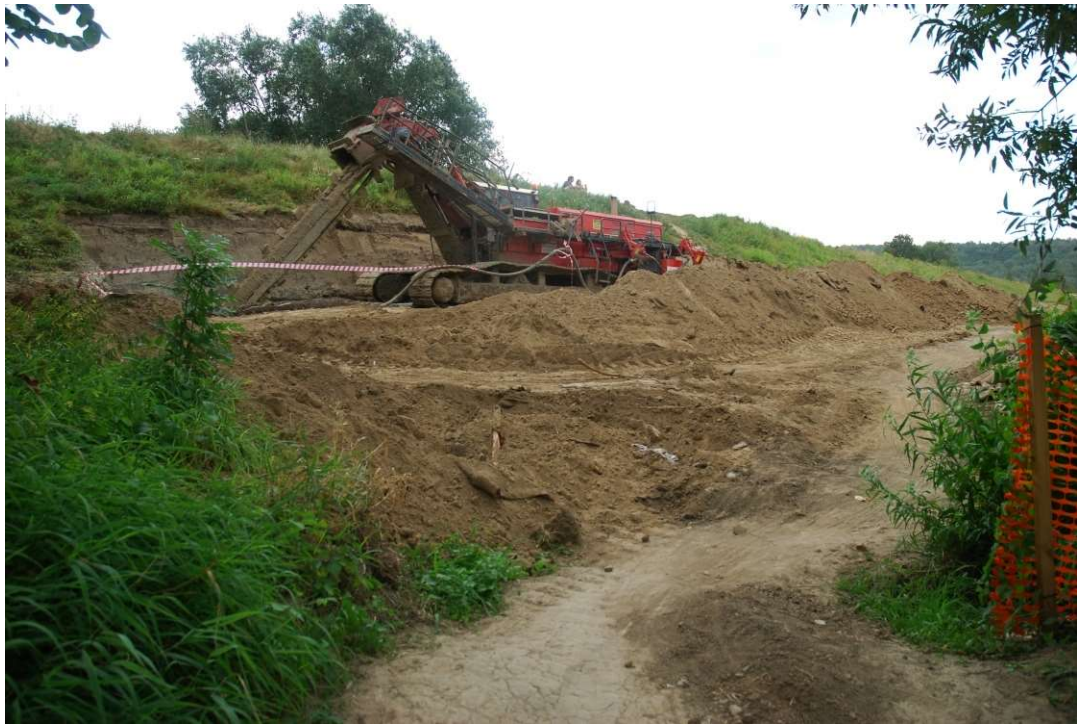
Photo. 26. Construction of the cement-bentonite membrane for Task 2, condition in the third decade of August 2020 (upstream view).

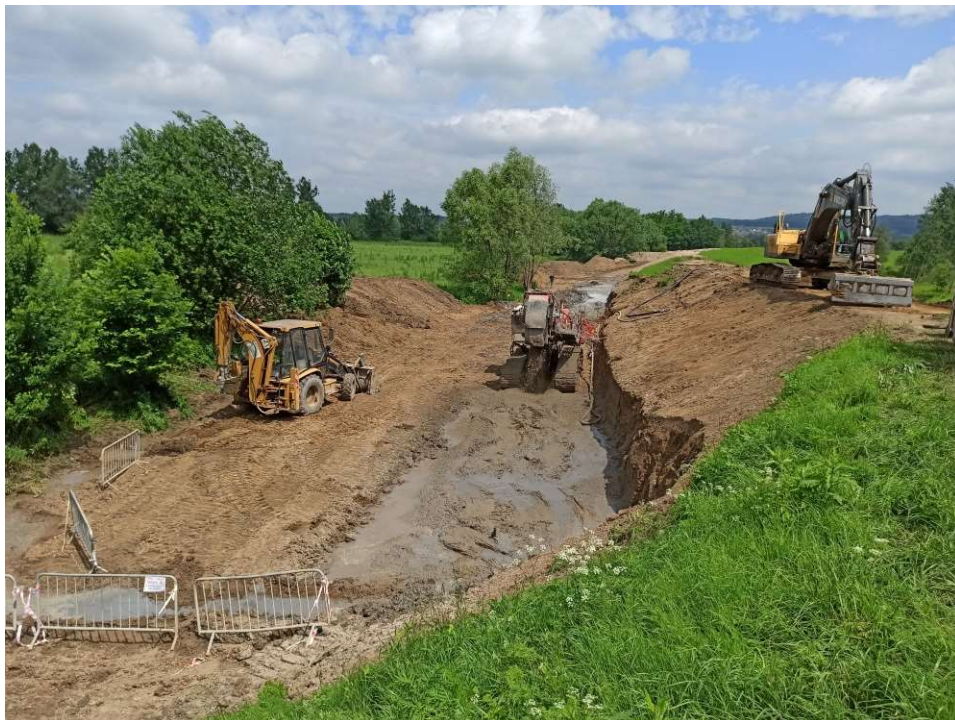
Photo. 27. Construction of the cement-bentonite for Task 3, condition in the third decade of June 2020 (downstream view).

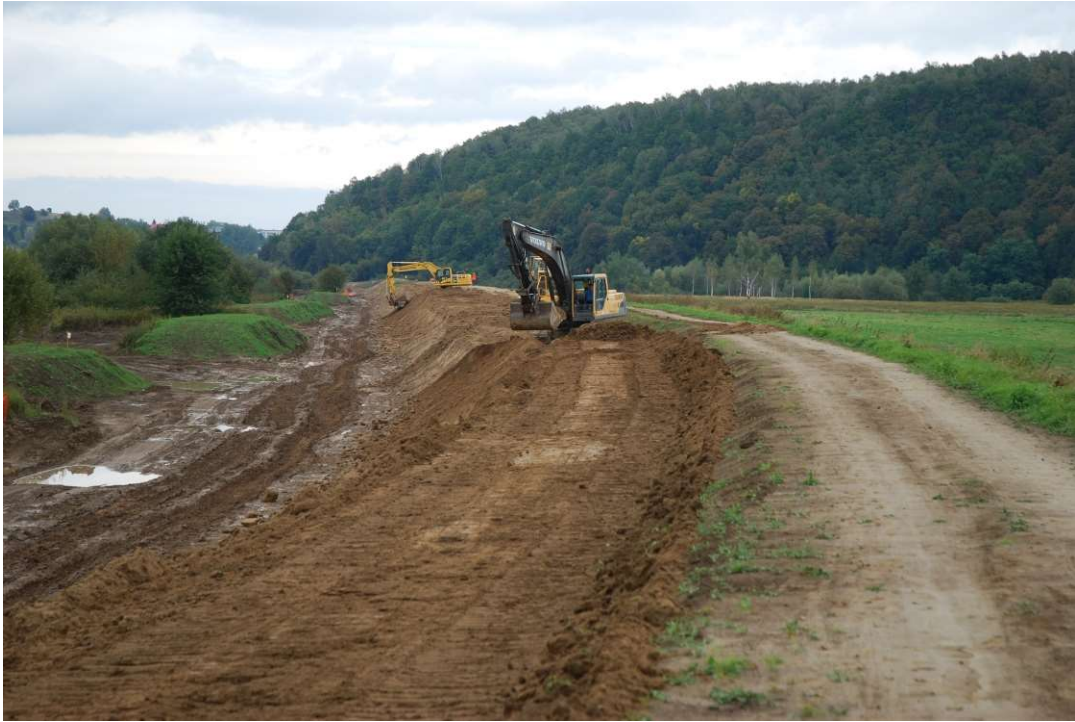
Photo. 28. Forming of slopes of flood protection embankment for Task 1, condition in the third decade of September 2020 (downstream view).

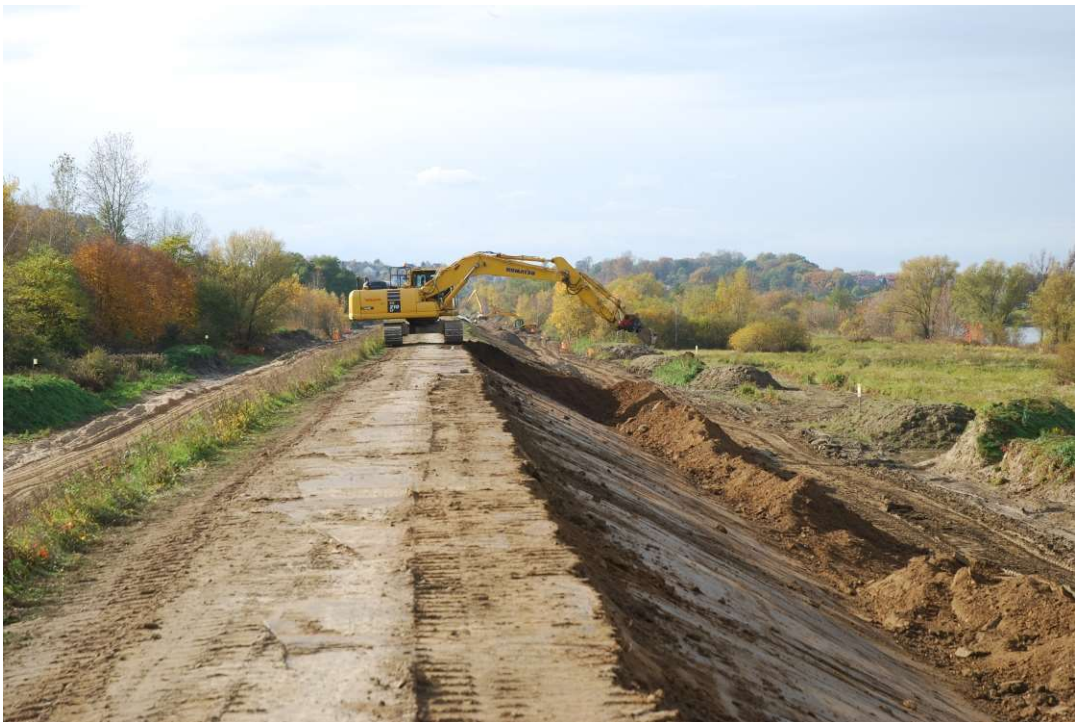
Photo. 29. Forming of slopes of flood protection embankment for Task 3, condition in the third decade of September 2020 (upstream view).
