Appendix no. 6 to the Final Report on Implementation of the Land Acquisition and Resettlement Action Plan (LARAP) for Contract 3A.3 entitled *Section 4 – The right embankment of the Vistula River from the estuary of Skawinka to the Kościuszko barrage.*

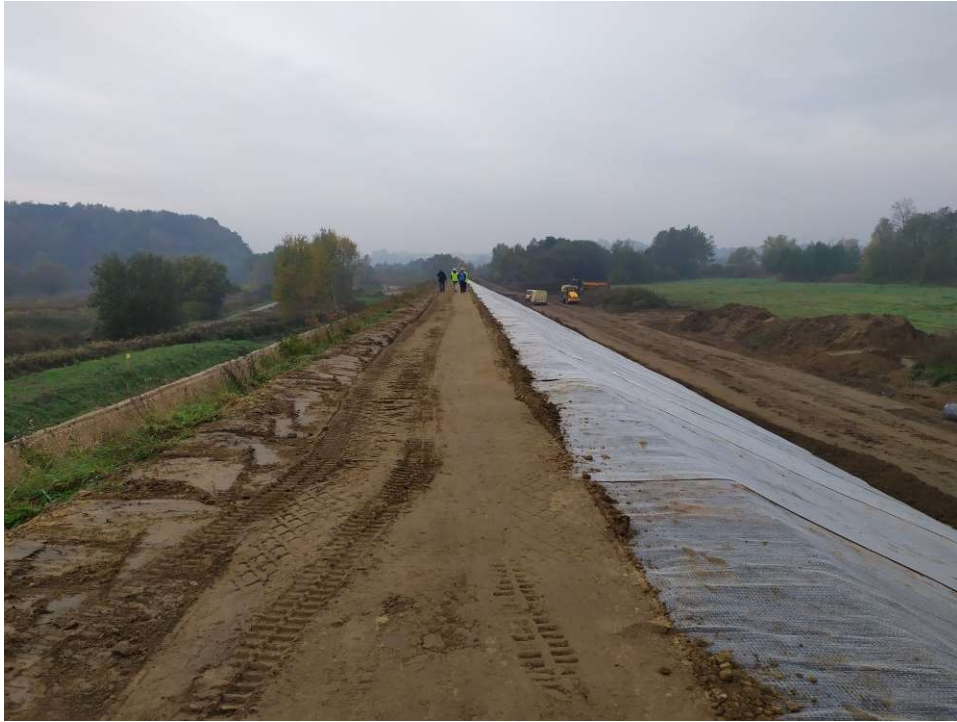
Photo. 30. Placement of bentonite mat on the flood protection embankment slope for Task 3, condition in the third decade of 2020 (upstream view).

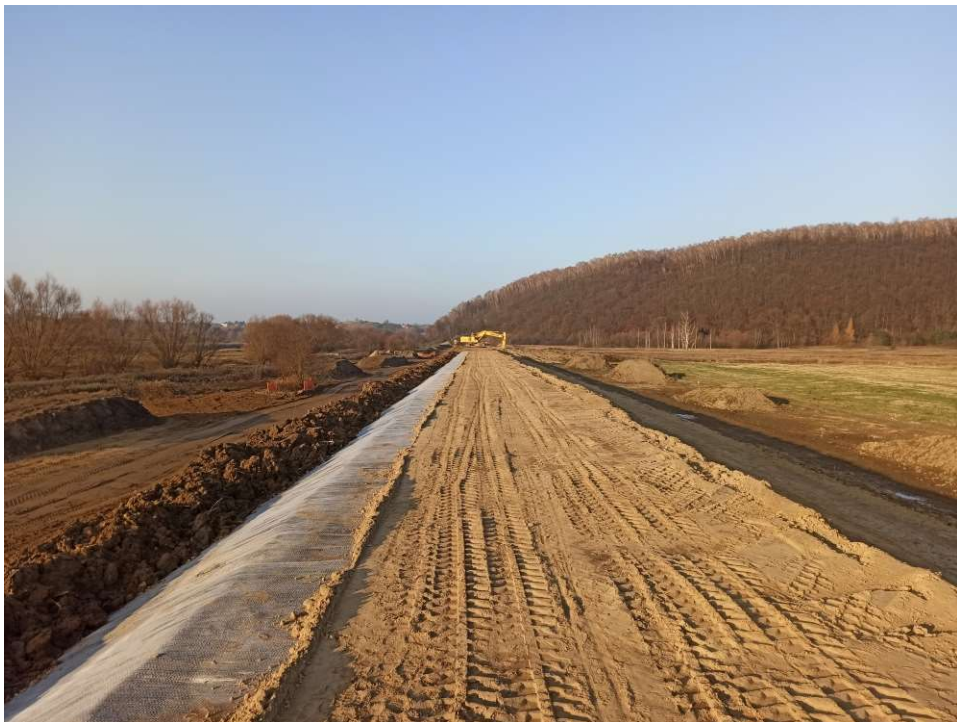
Photo. 31. Placement of bentonite mat on the flood protection embankment slope for Task 1, condition in the third decade of November 2020 (downstream view).

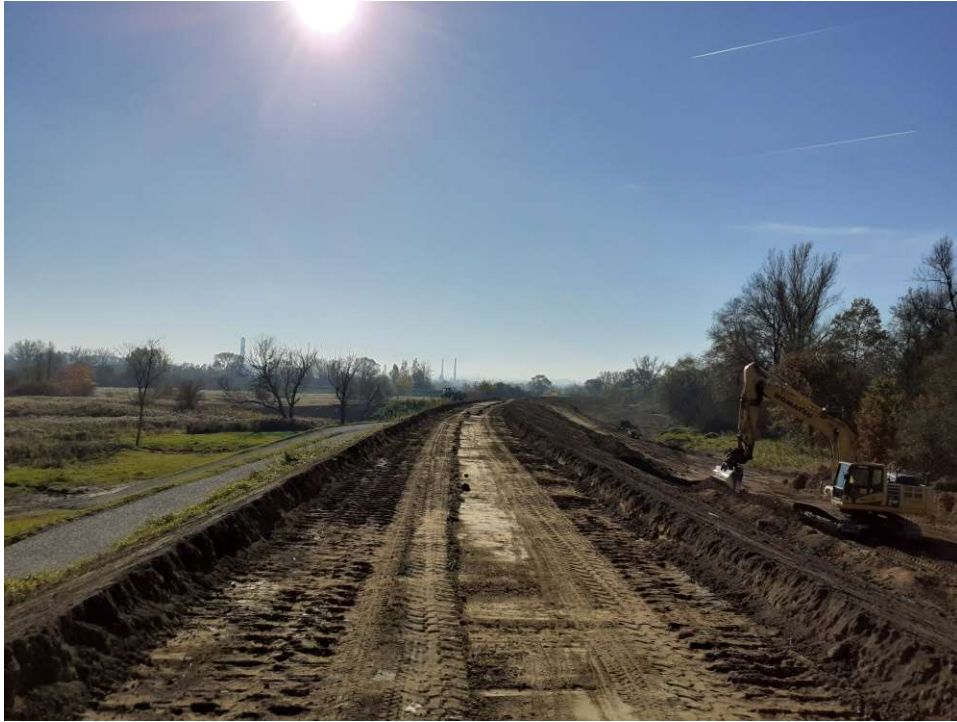
Photo. 32. Topsoiling of slopes of the flood protection embankment for Task 1, condition in the third decade of October 2021 (upstream view).

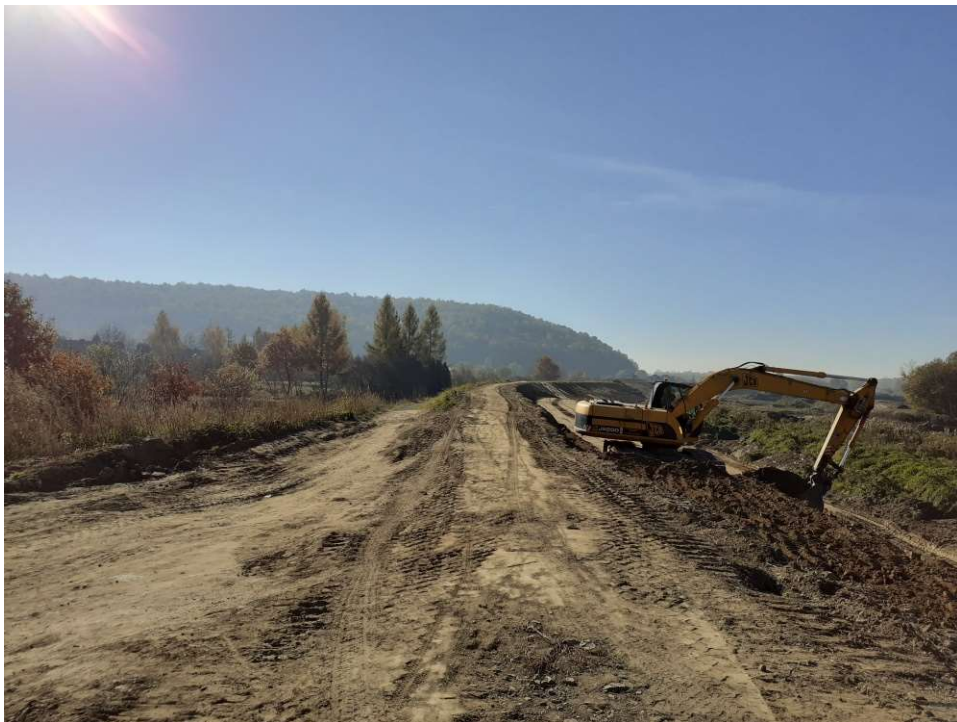
Photo. 33. Topsoiling of slopes of the flood protection embankment for Task 2, condition in the third decade of October 2021 (upstream view).

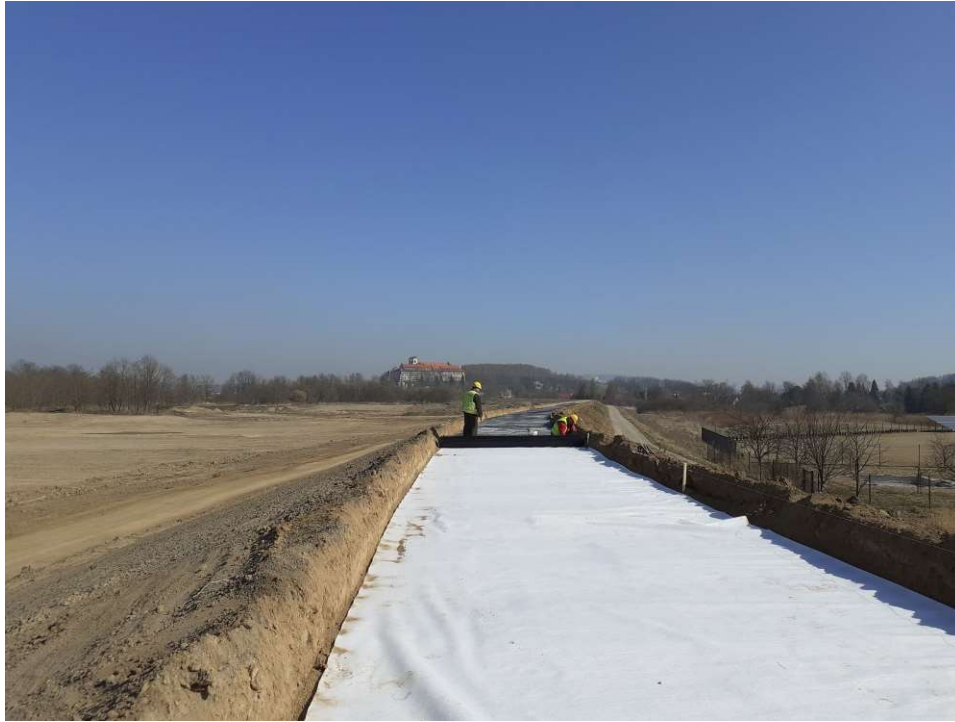
Photo. 34. Construction of the road on crest of the flood protection embankment for Task 2, condition in the third decade of March 2022 (downstream view).

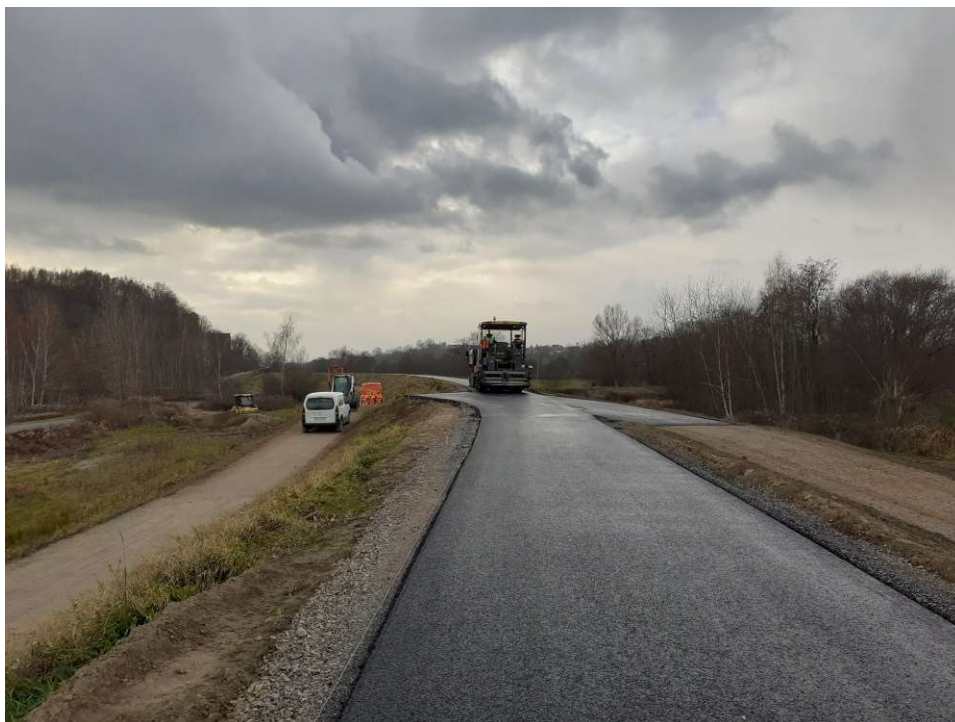
Photo. 35. Construction of the road on crest of the flood protection embankment for Task 3, condition in the third decade of November of 2021 (upstream view).

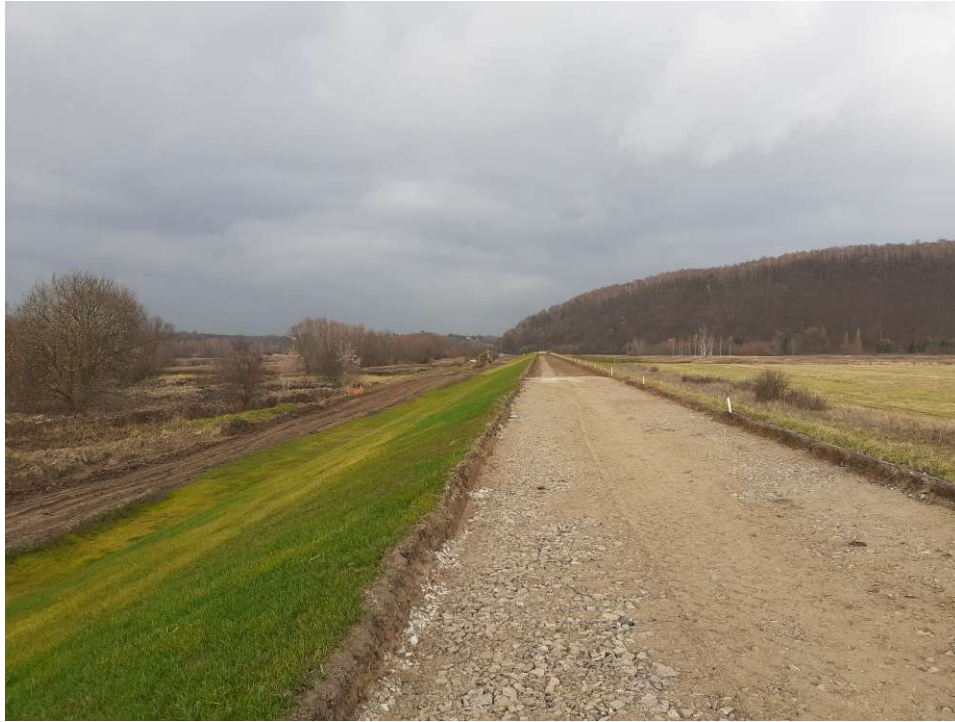
Photo. 36. Growth of grass sown on the flood protection embankment slope for Task 1, condition in the third decade of November 2021 (downstream view).

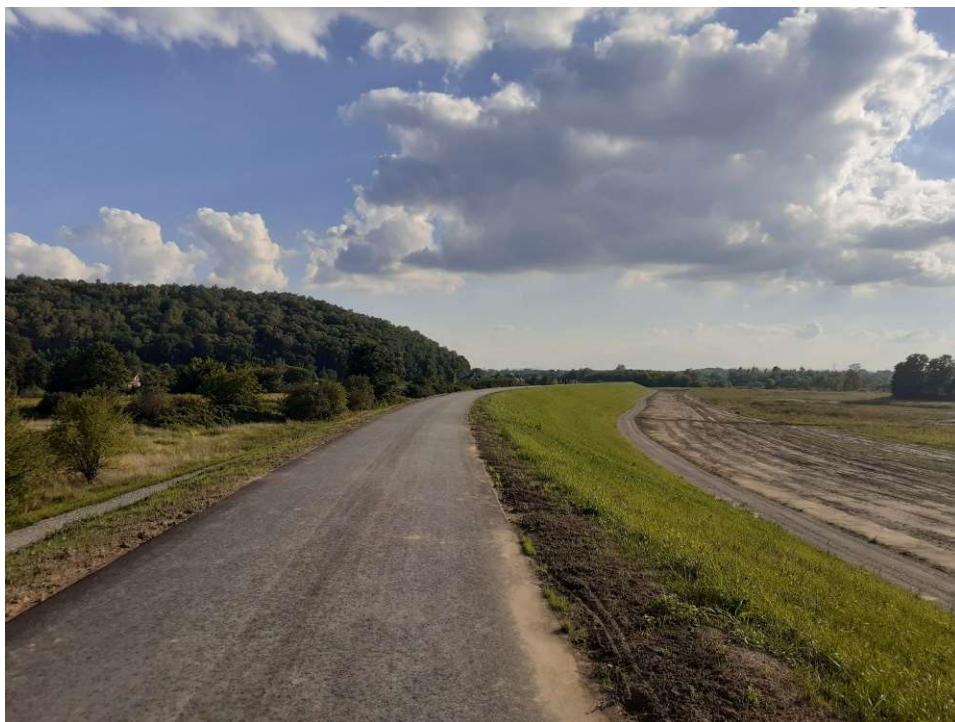
Photo. 37. Growth of grass sown on the flood protection embankment slope for Task 2, condition in the third decade of August 2022 (upstream view).

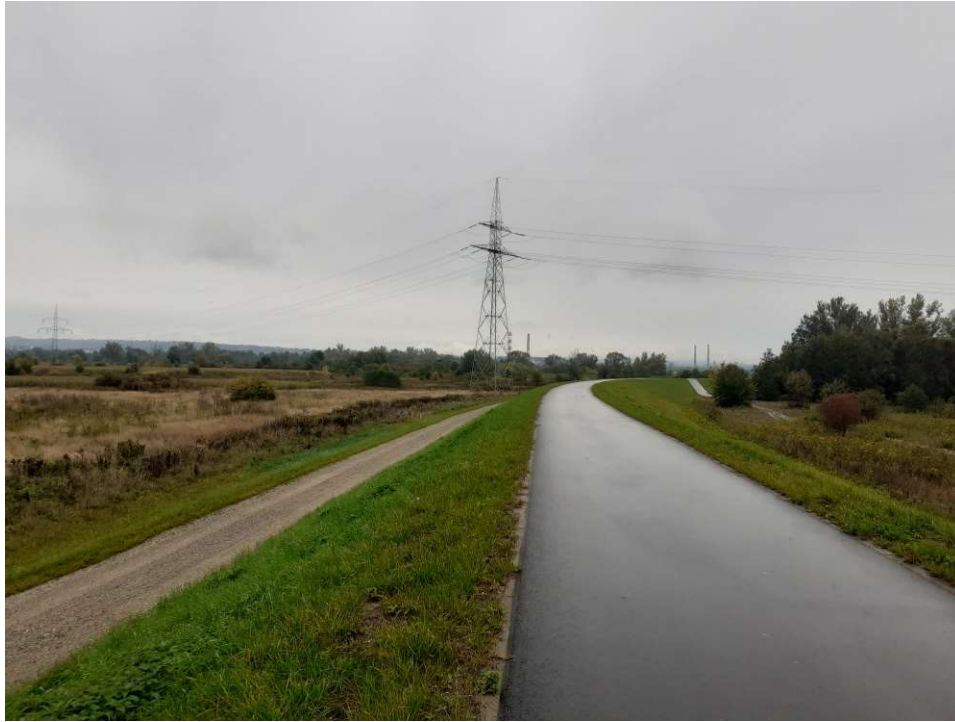
Photo. 38. Condition of the construction site in the last month of the period of execution of works – the right embankment of the Vistula River for Task 1, condition in the third decade of September 2022 (upstream view).

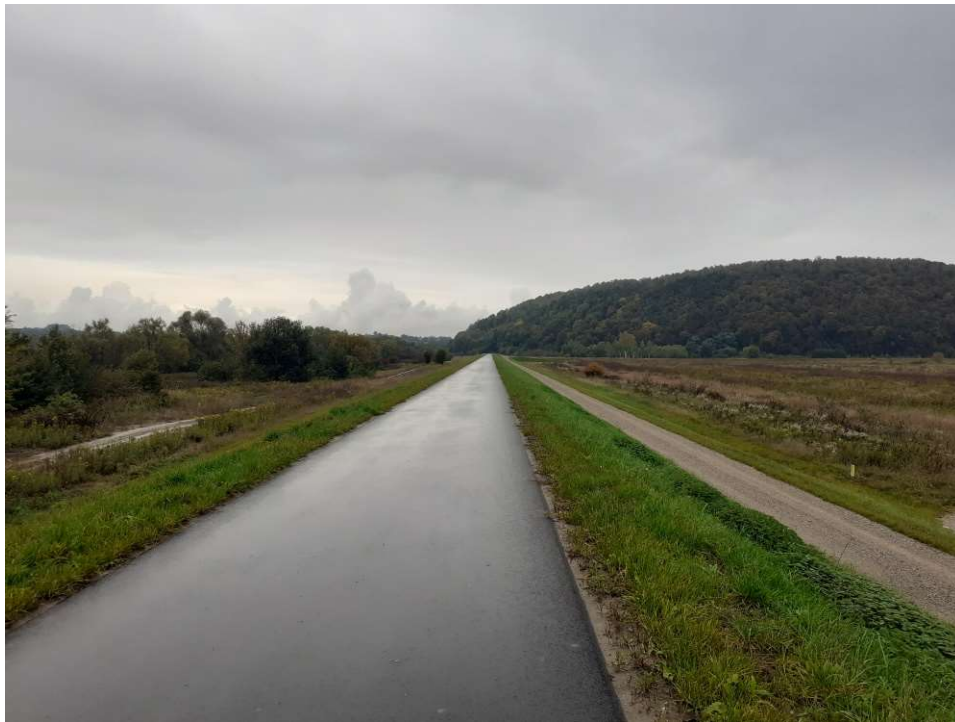
Photo. 39. Condition of the construction site in the last month of the period of execution of works – the right embankment of the Vistula River for Task 1, condition in the third decade of September 2022 (downstream view).

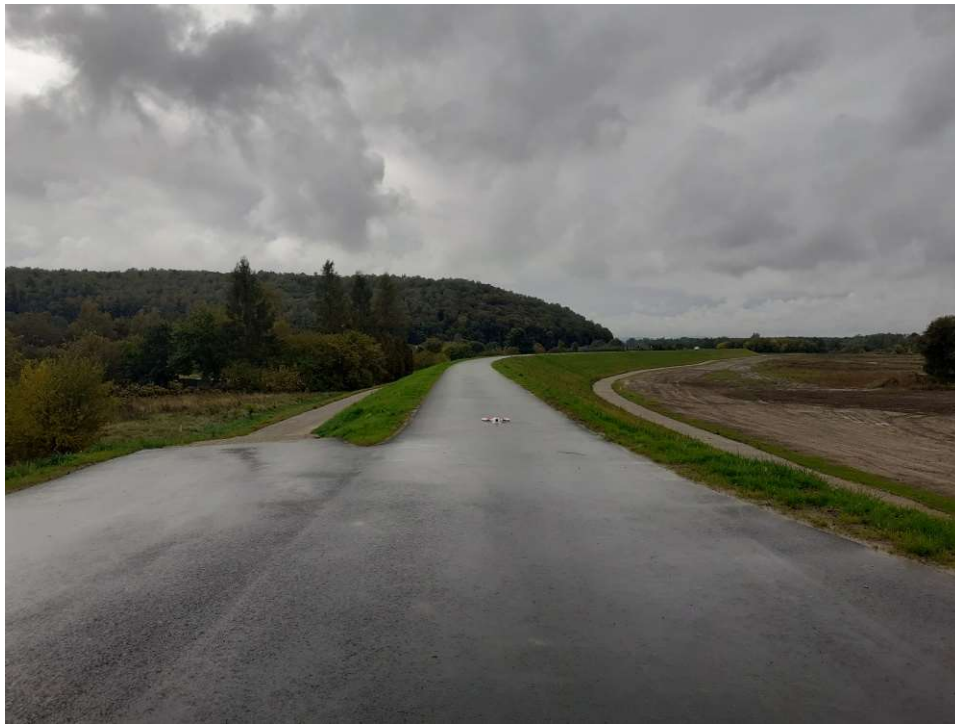
Photo. 40. Condition of the construction site in the last month of the period of execution of works – the right embankment of the Vistula River for Task 2, condition in the third decade of September 2022 (upstream view).

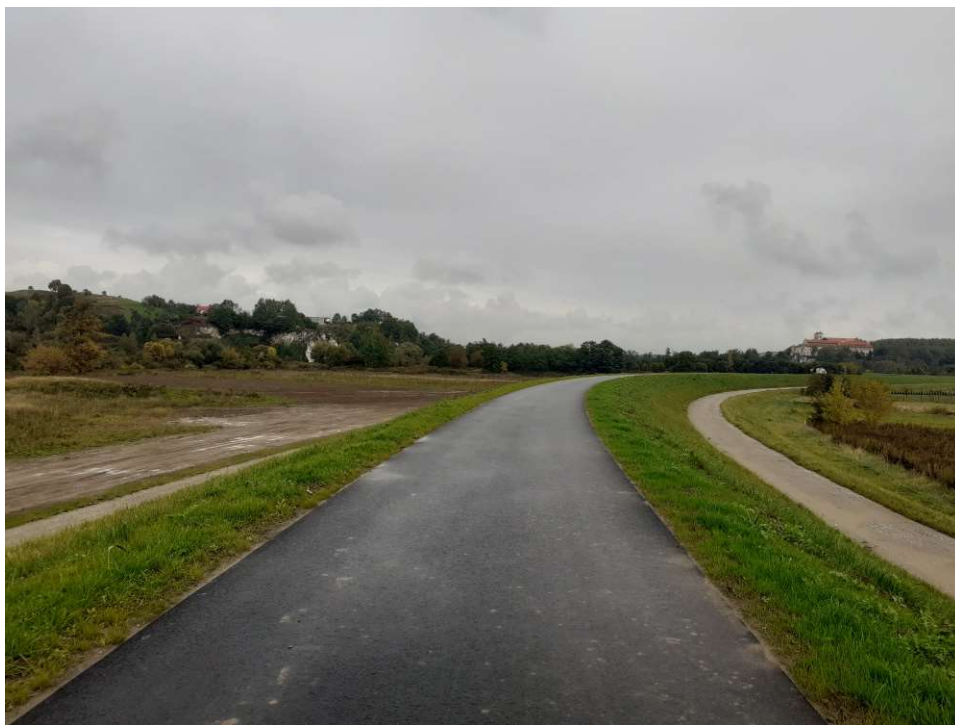
Photo. 41. Condition of the construction site in the last month of the period of execution of works – the right embankment of the Vistula River for Task 2, condition in the third decade of September 2022 (downstream view).

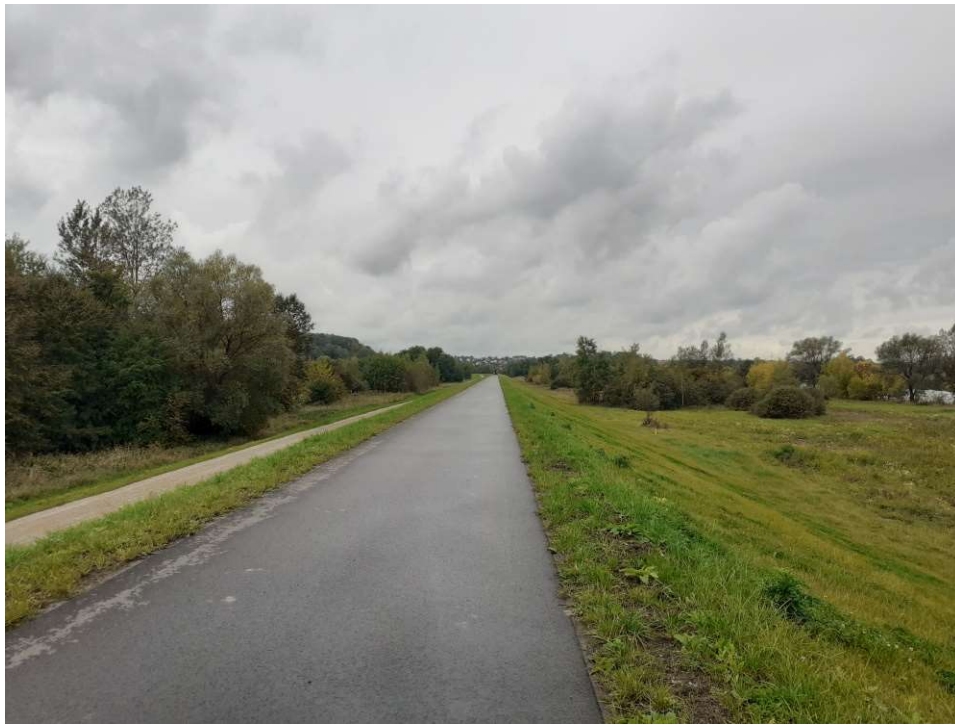
Photo. 42. Condition of the construction site in the last month of the period of execution of works – the right embankment of the Vistula River for Task 3, condition in the third decade of September 2022 (upstream view).

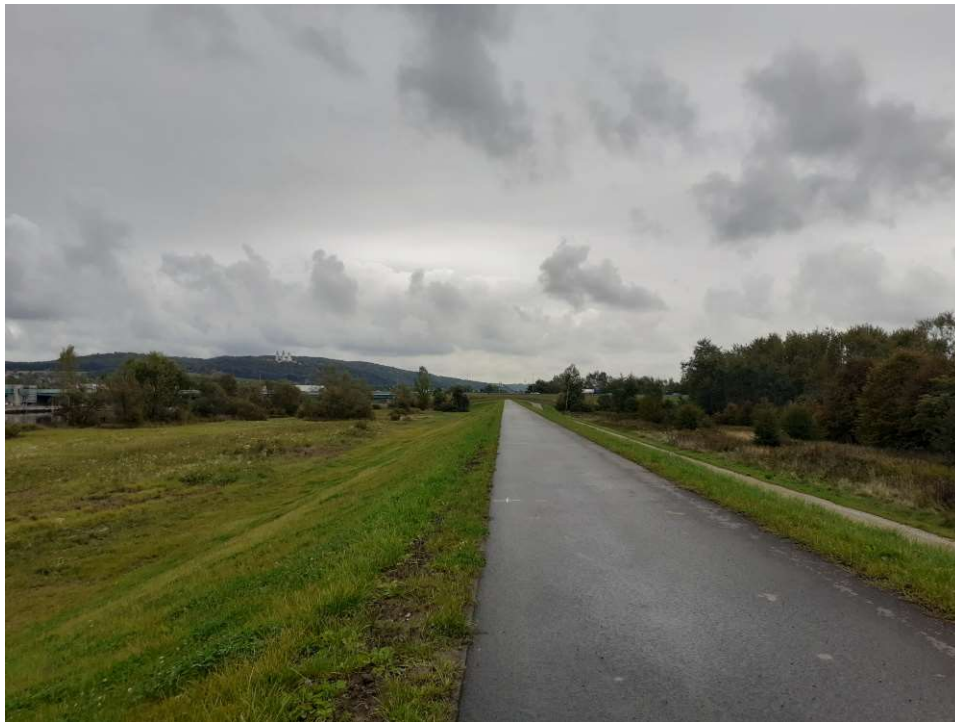
Photo. 43. Condition of the construction site in the last month of the period of execution of works – the right embankment of the Vistula River for Task 3, condition in the third decade of September 2022 (downstream view).

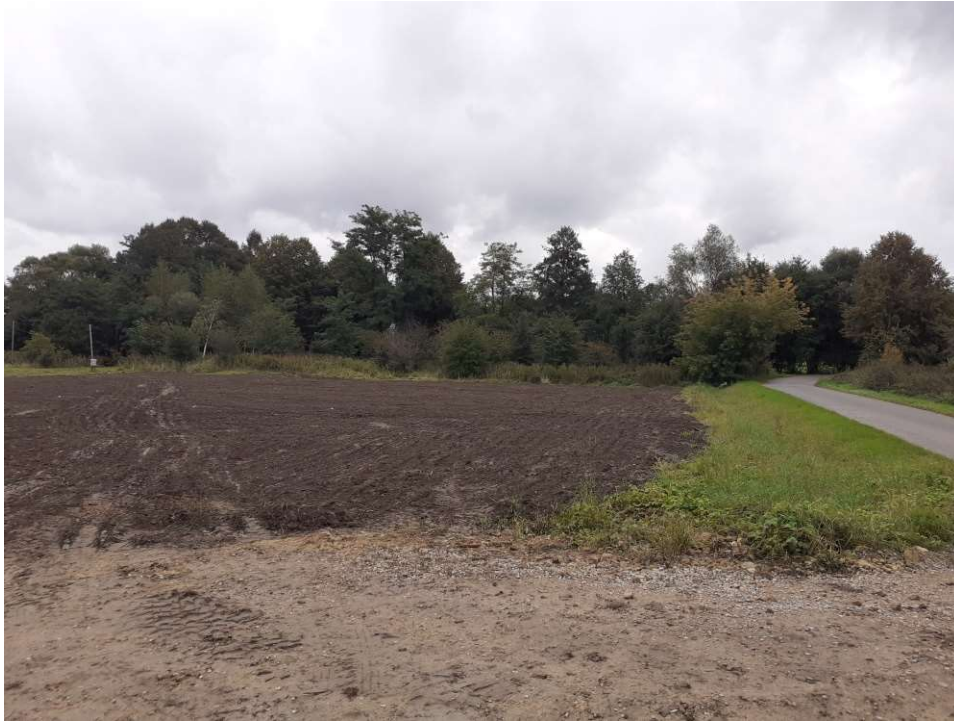
Photo. 44. Reclaimed area of the former operating backyard (after the end of temporary occupation) on the right-bank area beyond the embankment of the Vistula River along Task 3, condition in the third decade of September 2022 (southern view).

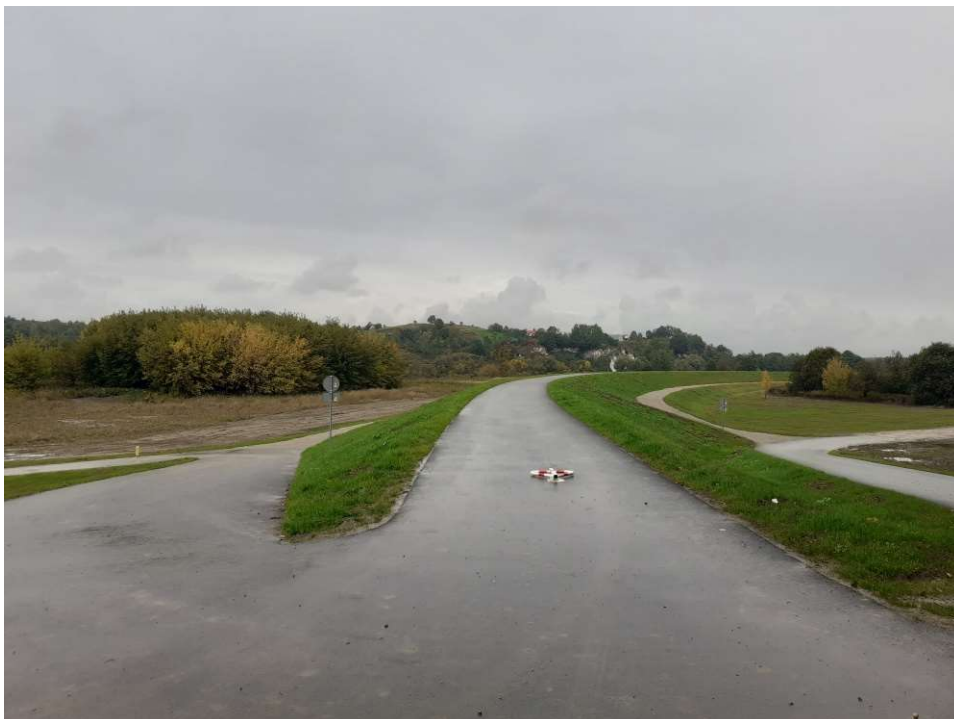
Photo. 45. Reclaimed area of the former operating backyard (after the end of temporary occupation) on the right-bank area beyond the embankment of the Vistula River along Task 2, condition in the third decade of September 2022 (downstream view).
