Appendix no. 6 to the Final Report on Implementation of the Land Acquisition and Resettlement Action Plan (LARAP) for Contract 3A.6 titled *Construction of a pumping station for mobile pumps to drain the Lesisko complex.*

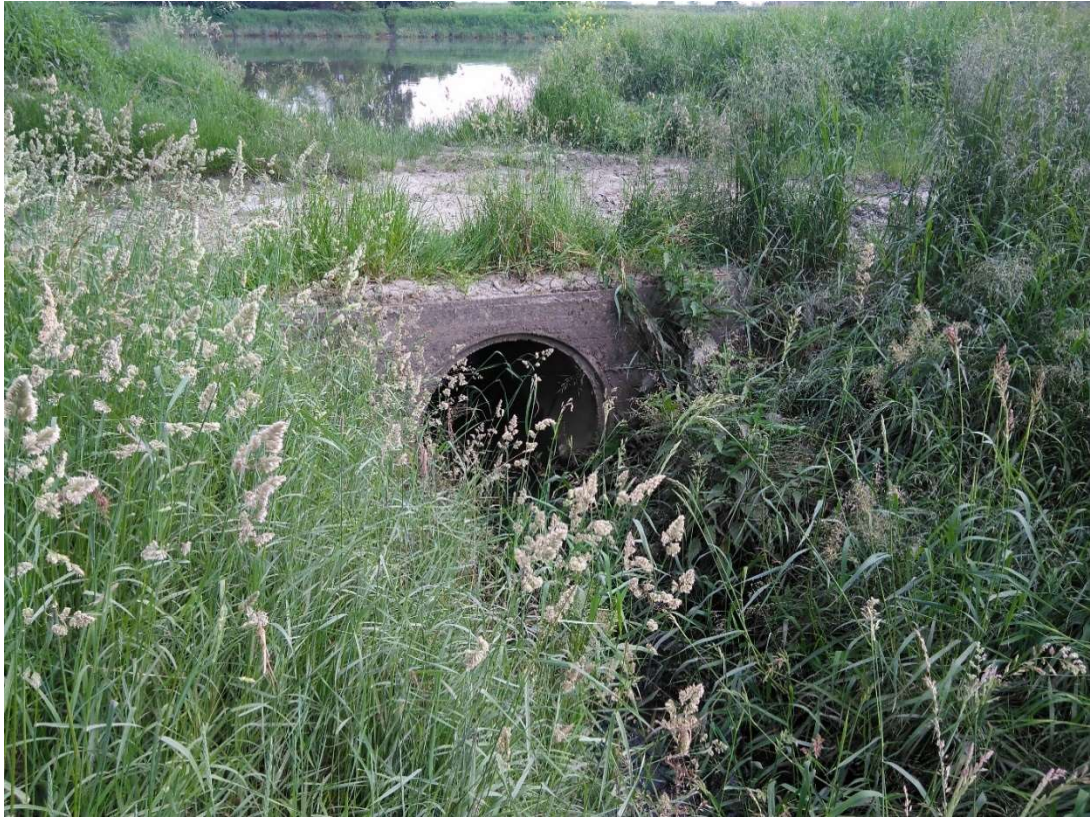
Photo. 1. Condition of the site before the start of construction – embankment culvert by which the Lesisko channel drains water to the Vistula.

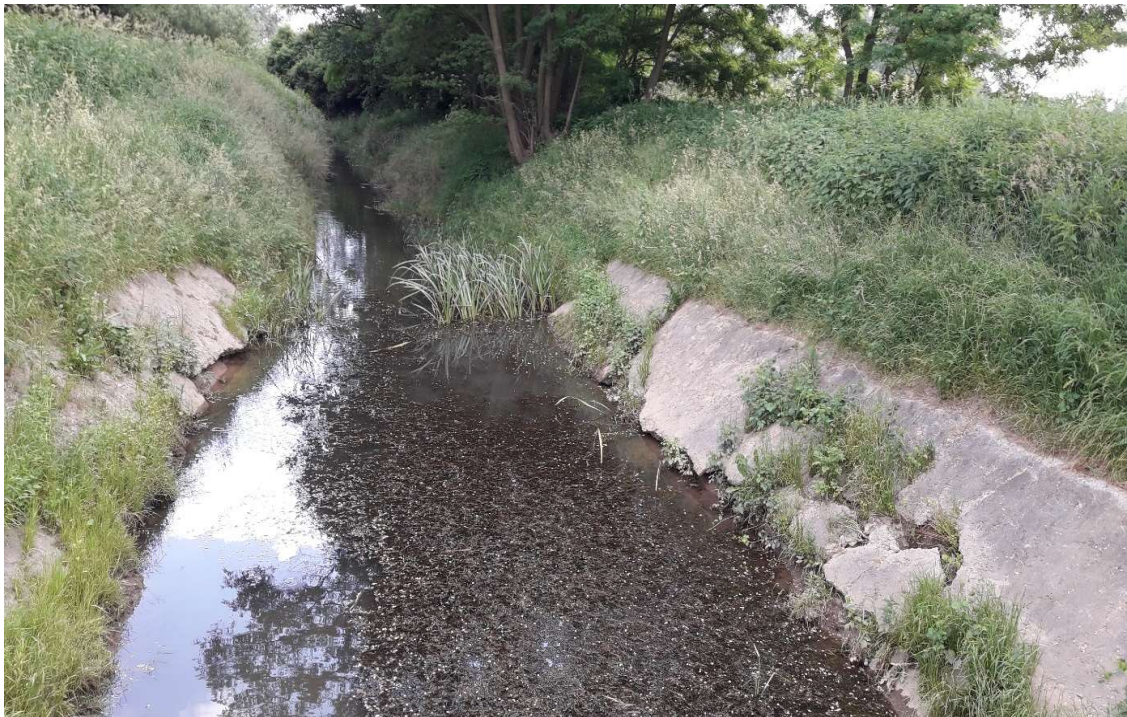
Photo. 2. Condition of the site before the start of construction – bed of the Lesisko channel.

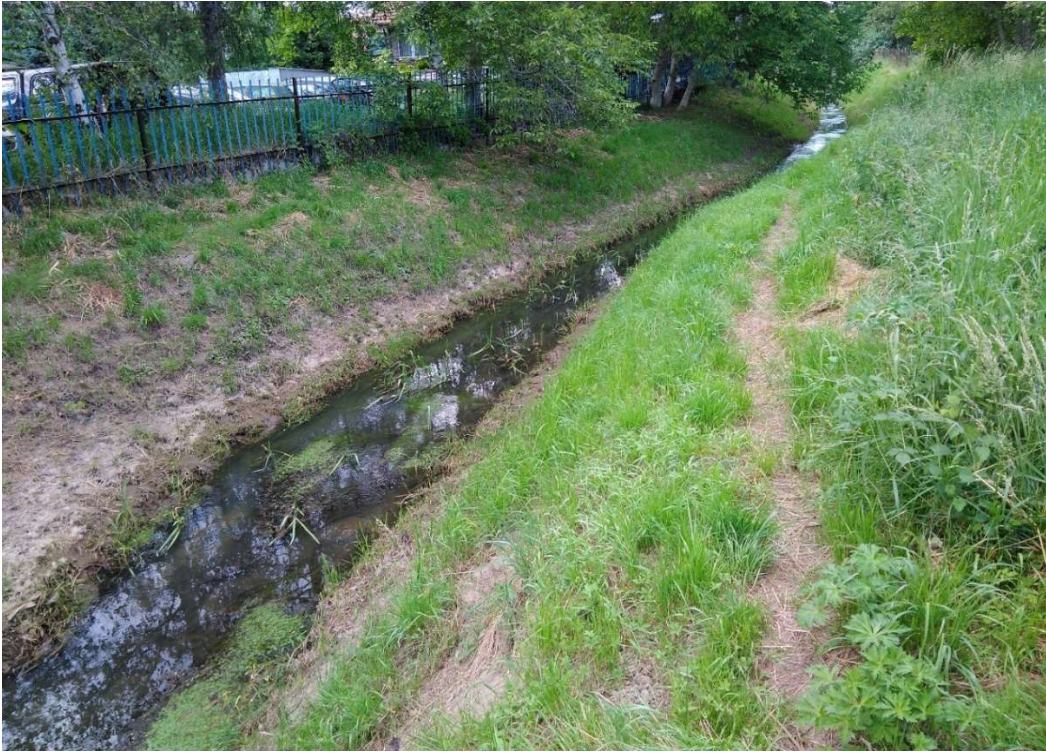
Photo. 3. Condition of the site before the start of construction – bed of the Lesisko channel.

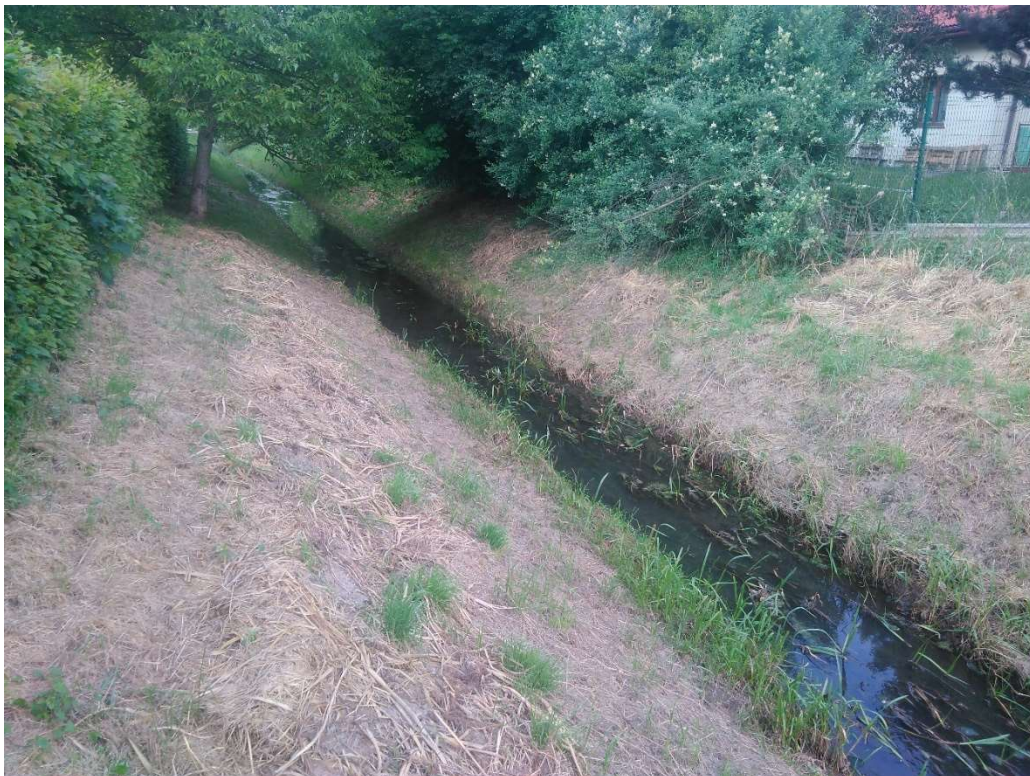
Photo. 4. Condition of the site before the start of construction – bed of the Lesisko channel.

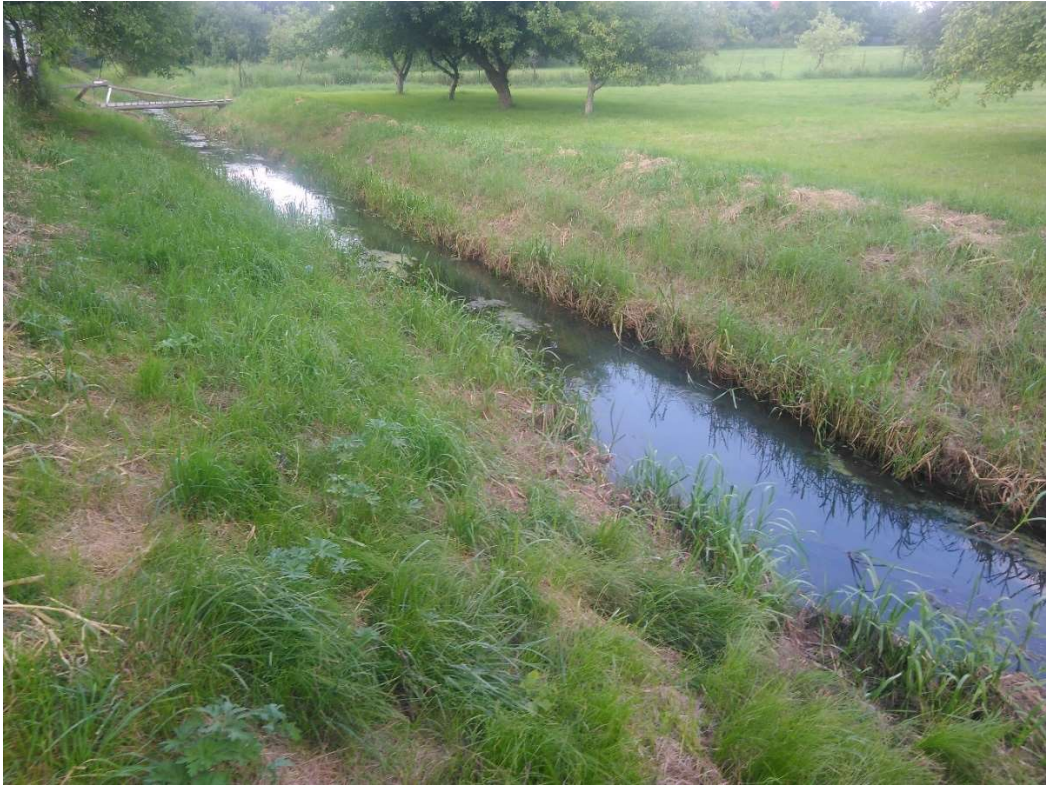
Photo. 5. Condition of the site before the start of construction – bed of the Lesisko channel.

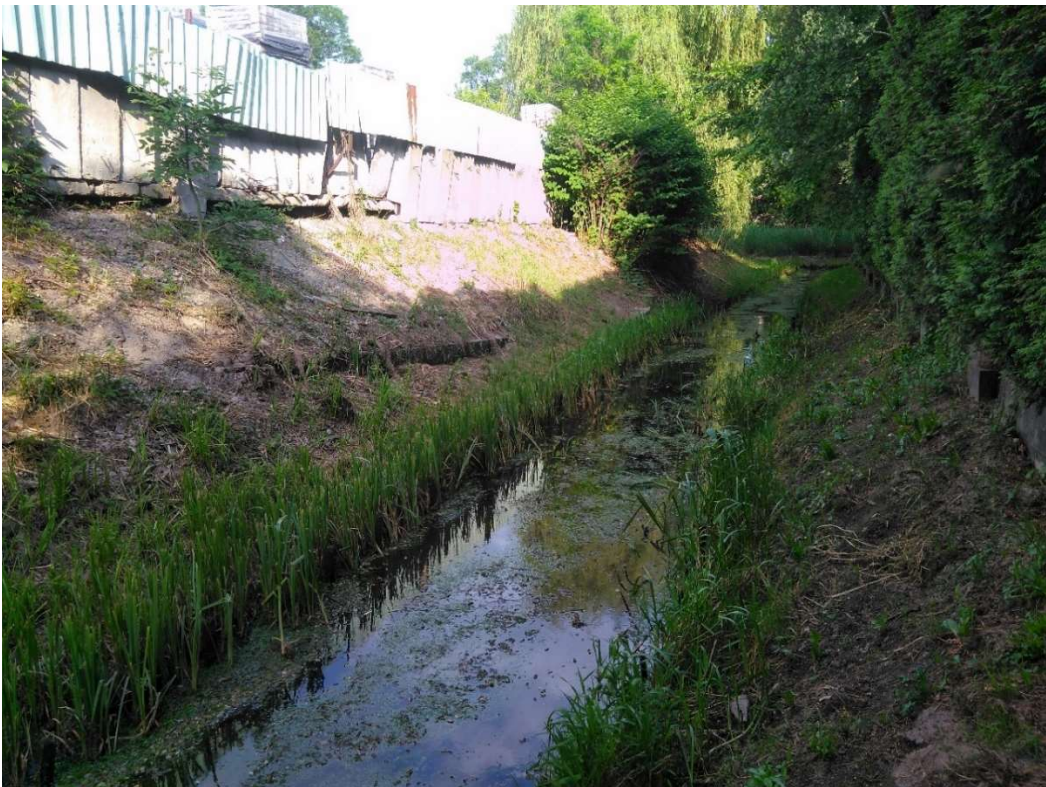
Photo. 6. Condition of the site before the start of construction – bed of the Lesisko channel.

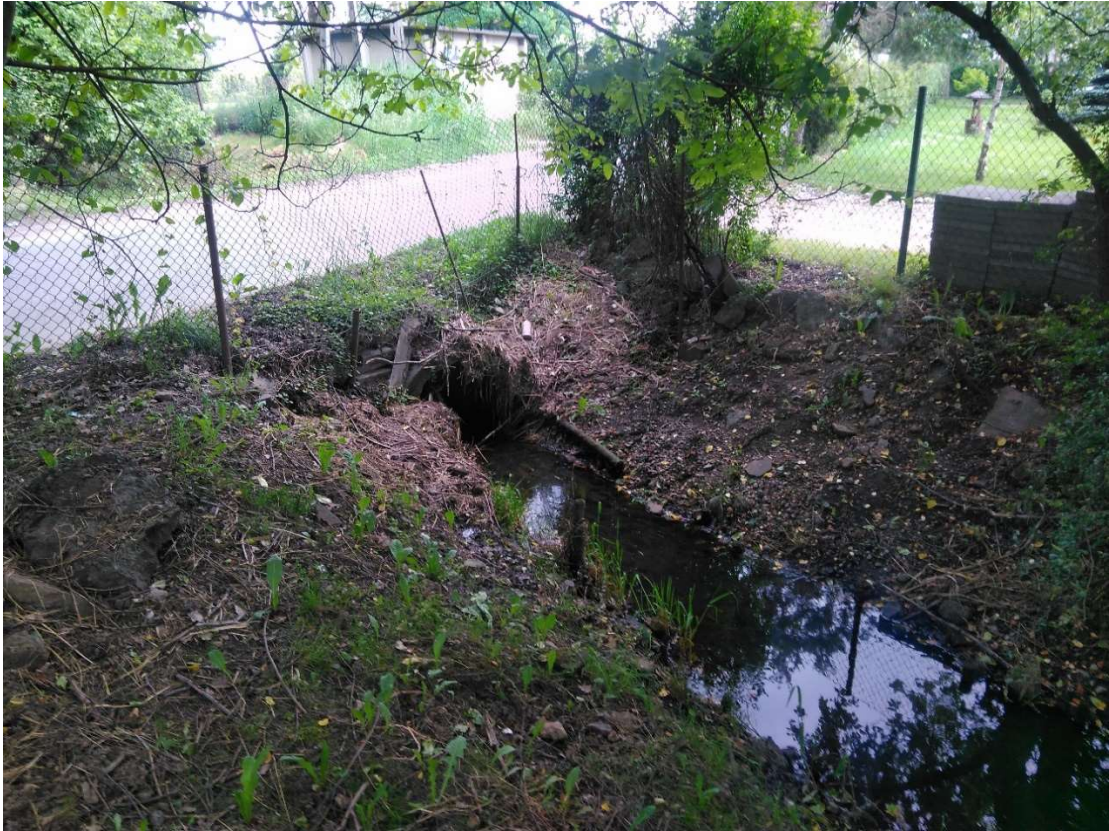
Photo. 7. Condition of the site before the start of construction – bed of the Lesisko channel.

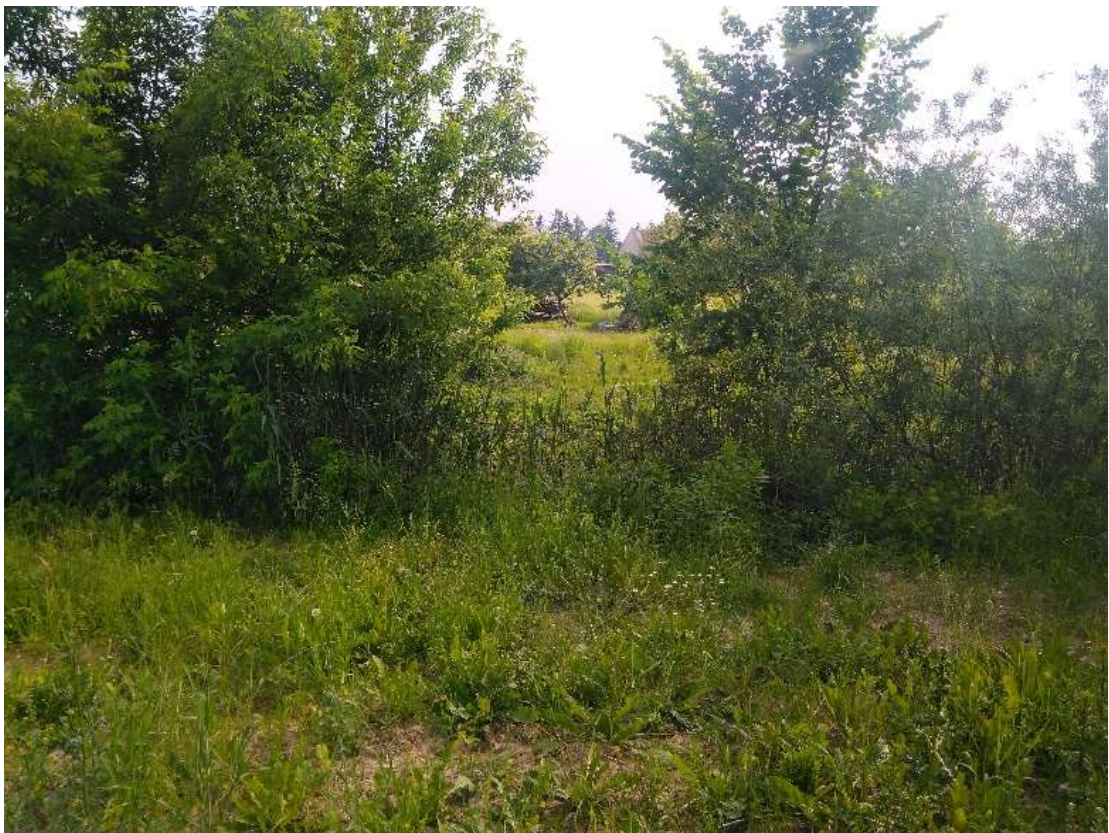
Photo. 8. Condition of the site before the start of construction – the area of the existing water reservoir at the section from km 0+935 to km 1+337 of the Lesisko channel.

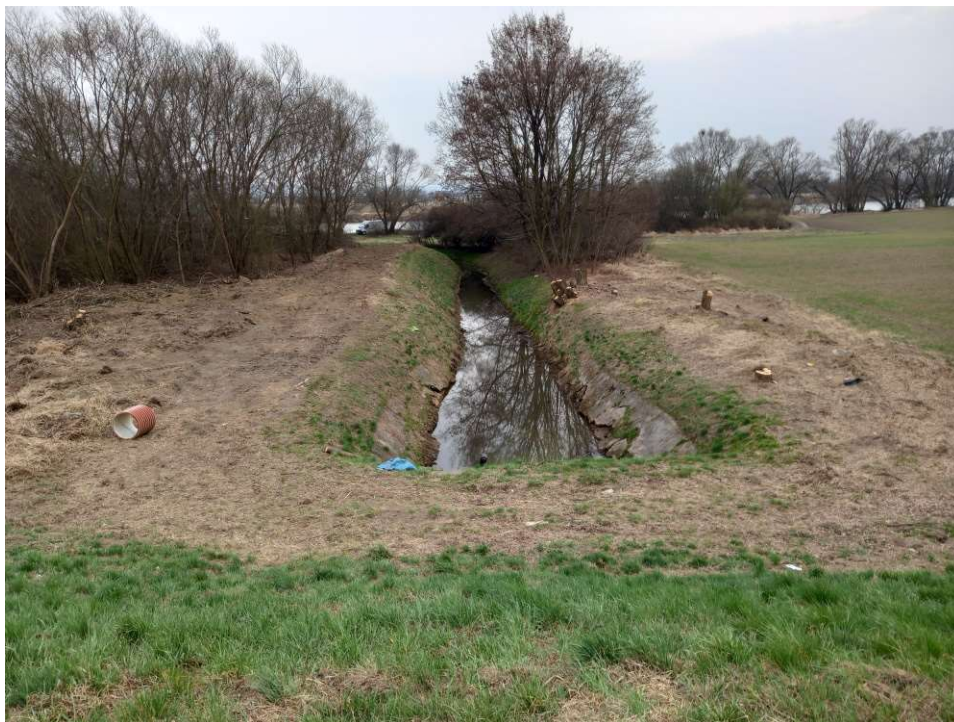
Photo. 9. Condition of the construction site in the first month of the execution of works – construction site of the embankment sluice at Ditch 2a from the side of the embanked area of the Vistula, status in the third decade of March 2022 (view towards the south).

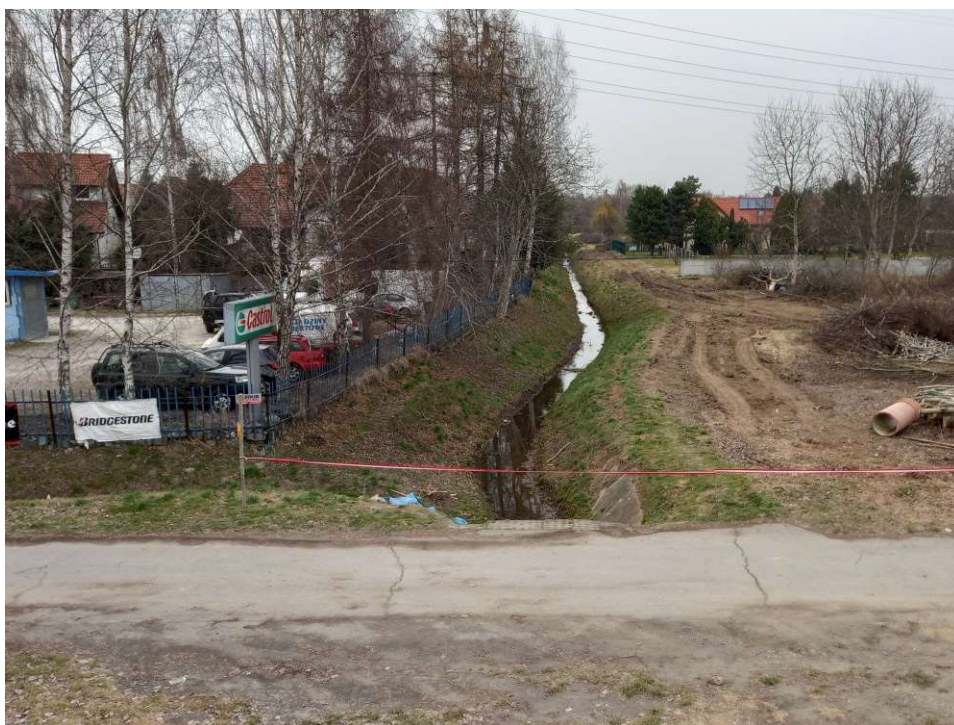
Photo. 10. Condition of the construction site in the first month of the execution of works – construction site of the embankment sluice at Ditch 2a from the side of the area beyond the embankment of the Vistula, status in the third decade of March 2022 (view towards the north).

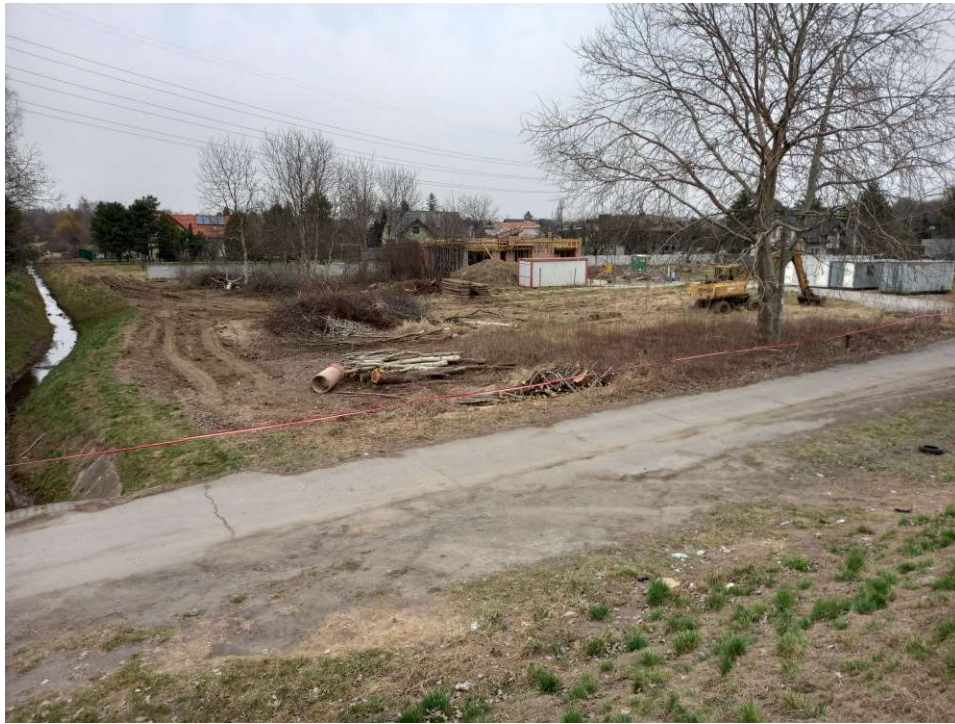
Photo. 11. Condition of the construction site in the first month of the execution of works – construction site of the pumping station for mobile pumps and the storage reservoir upstream of the embankment sluice, status in the third decade of March 2022 (view towards the north).

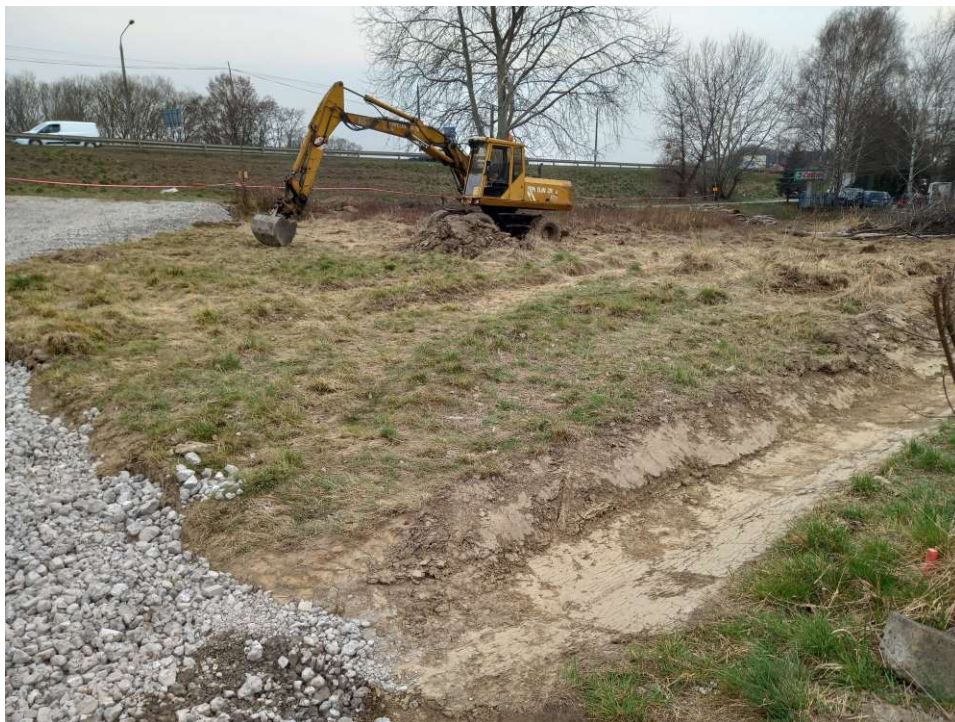
Photo. 12. Condition of the construction site in the first month of the execution of works – construction site of the storage reservoir upstream of the embankment sluice and of the pumping station for mobile pumps, status in the third decade of March 2022 (view towards the south).

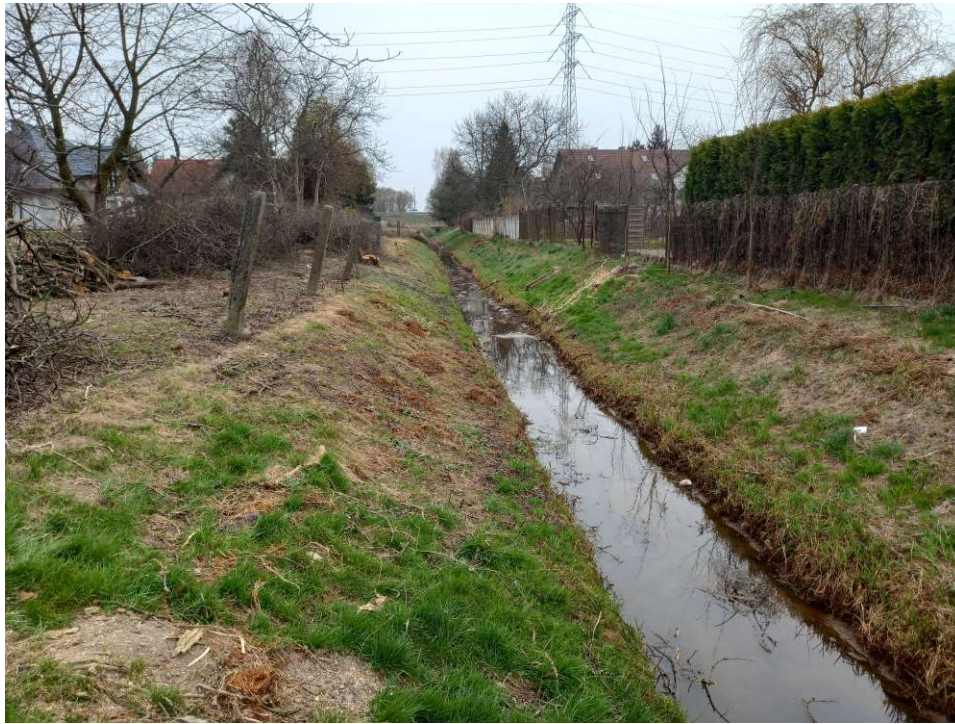
Photo. 13. Condition of the construction site in the first month of the execution of works – the reconstructed section of Ditch 2a – the lower part, status in the third decade of March 2022 (view towards the south).

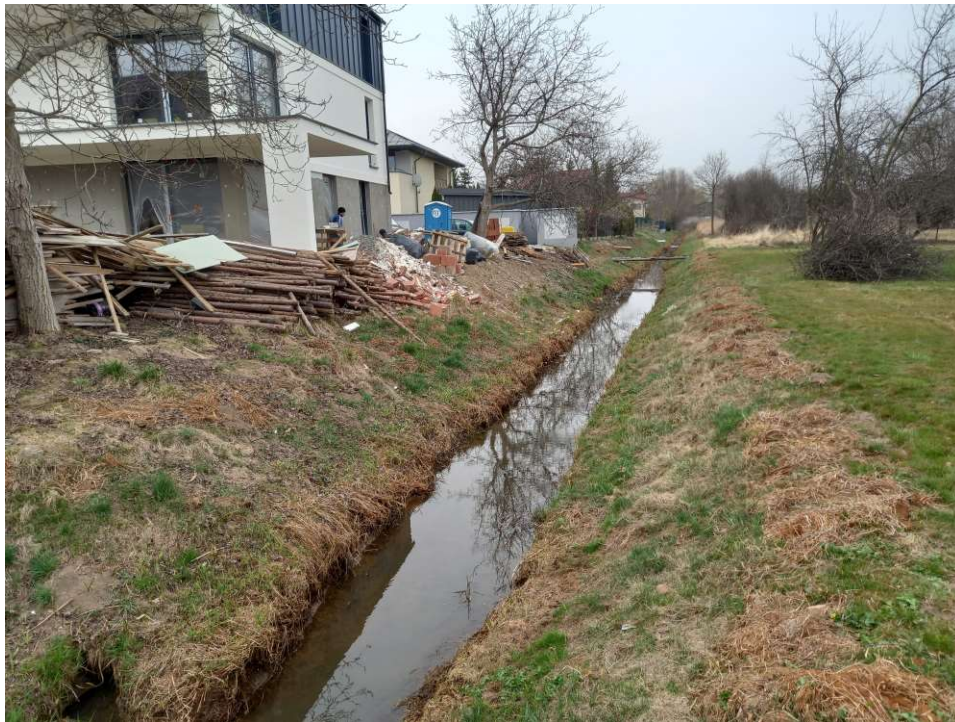
Photo. 14. Condition of the construction site in the first month of the execution of works – the reconstructed section of Ditch 2a – the upper part, status in the third decade of March 2022 (view towards the north).

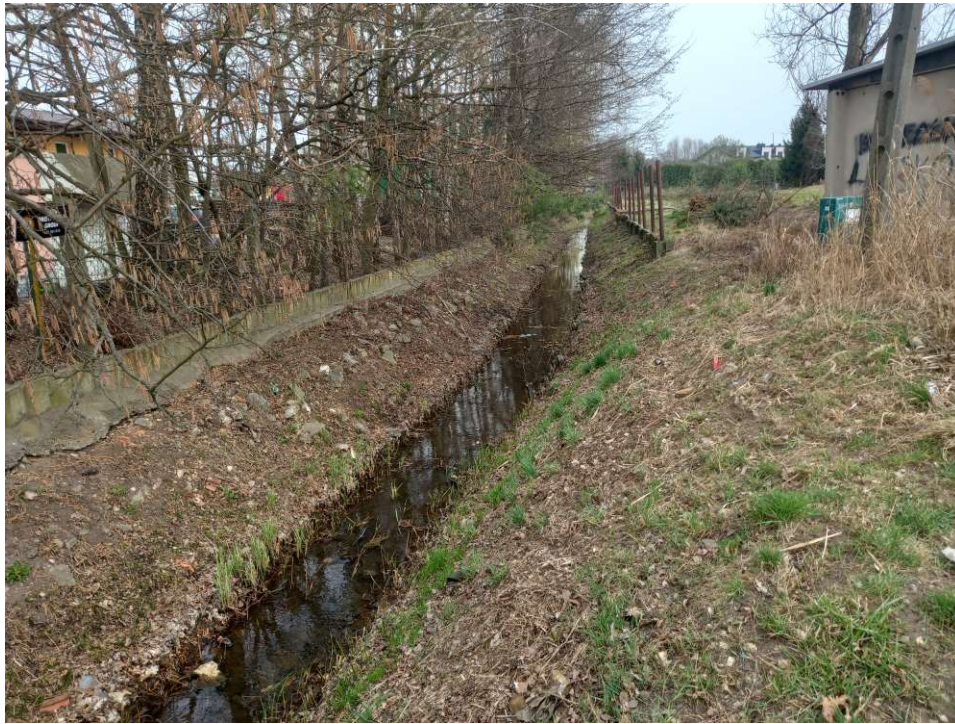
Photo. 15. Condition of the construction site in the first month of the execution of works – the reconstructed section of Ditch 2 – the lower part, status in the third decade of March 2022 (view towards the east).

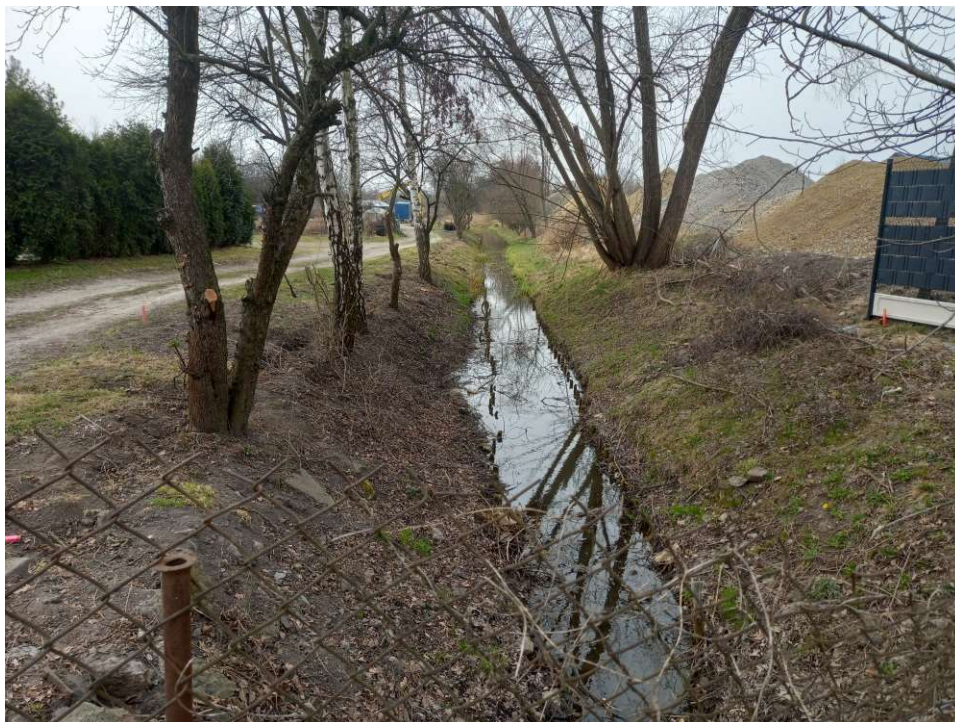
Photo. 16. Condition of the construction site in the first month of the execution of works – the reconstructed section of Ditch 2 – the upper part, status in the third decade of March 2022 (view towards the west).

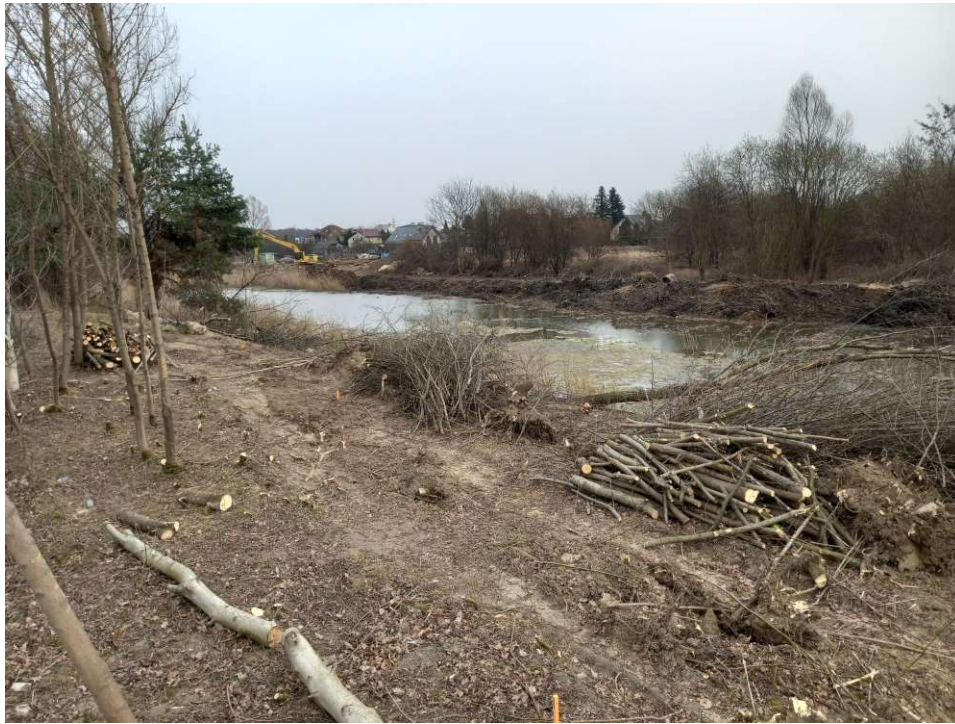
Photo. 17. Condition of the construction site in the first month of the execution of works – the reconstructed reservoir at Ditch 2, eastern part, status in the third decade of March 2022 (view towards the east).

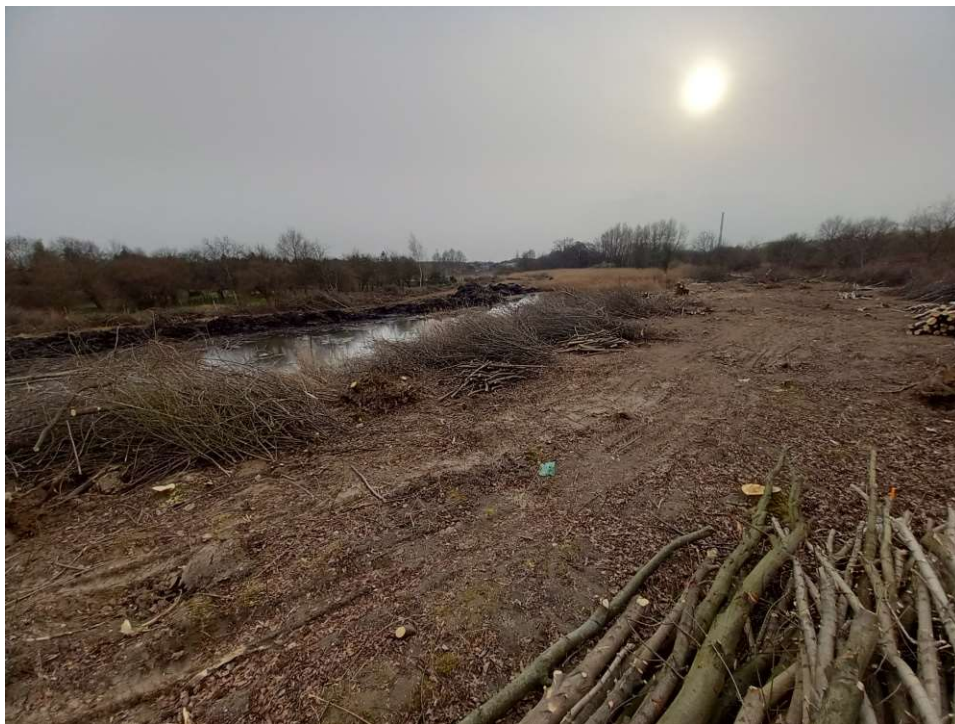
Photo. 18. Condition of the construction site in the first month of the execution of works – the reconstructed reservoir at Ditch 2, western part, status in the third decade of March 2022 (view towards the west).

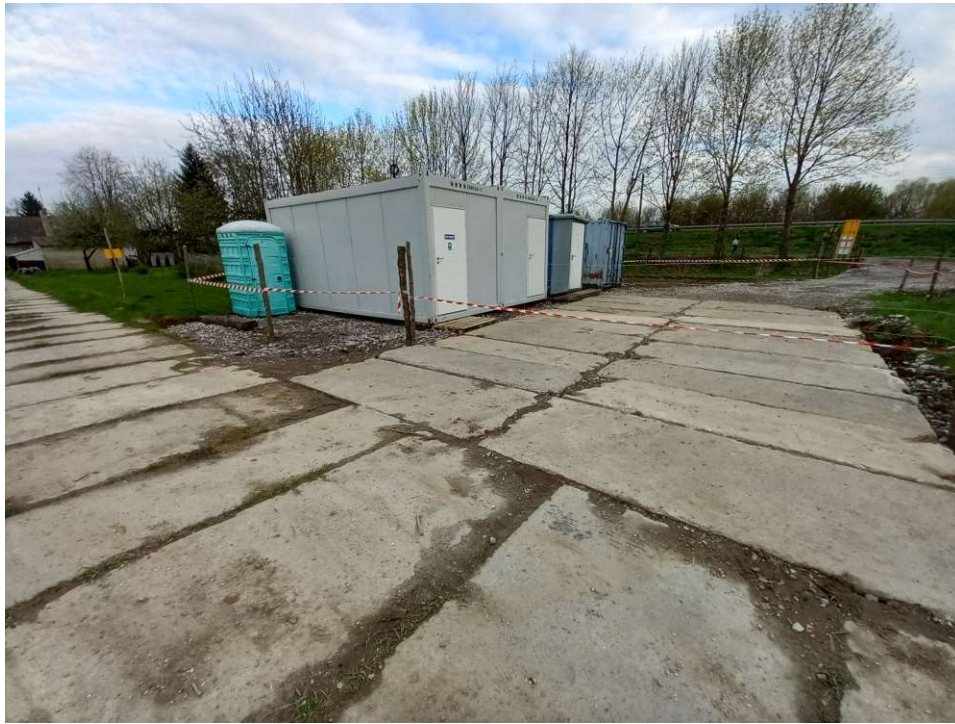
Photo. 19. Operating backyard on the left-bank area beyond the embankment of the Vistula River, status in the third decade of April 2022 (view towards the south).

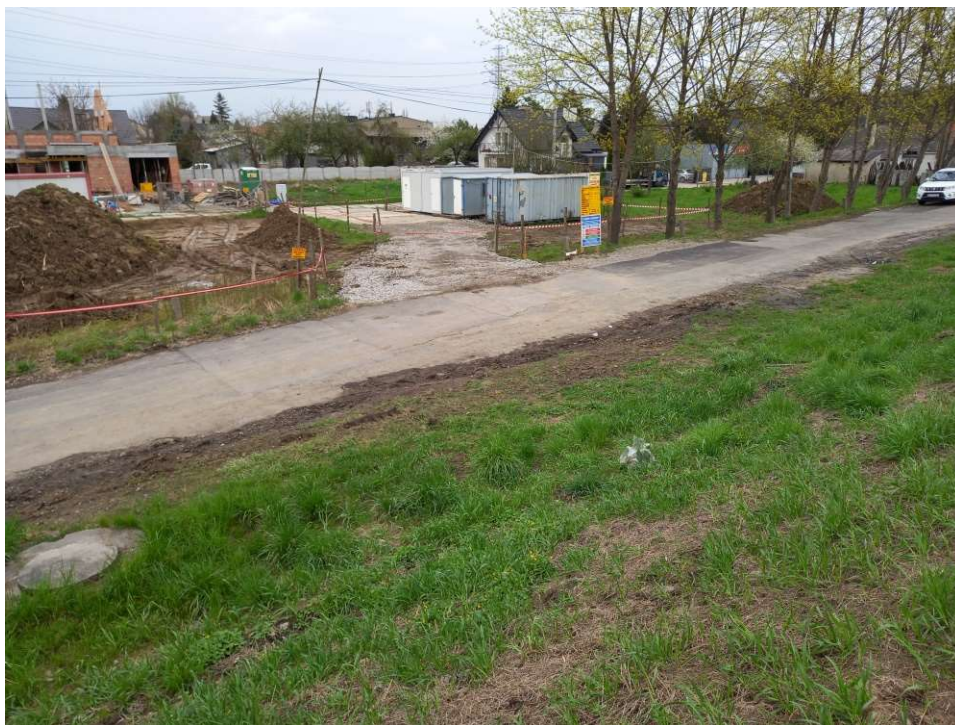
Photo. 20. Marking of the entrance to the construction site from Zagłoby Street, status in the third decade of April 2022 (view towards the north- east).

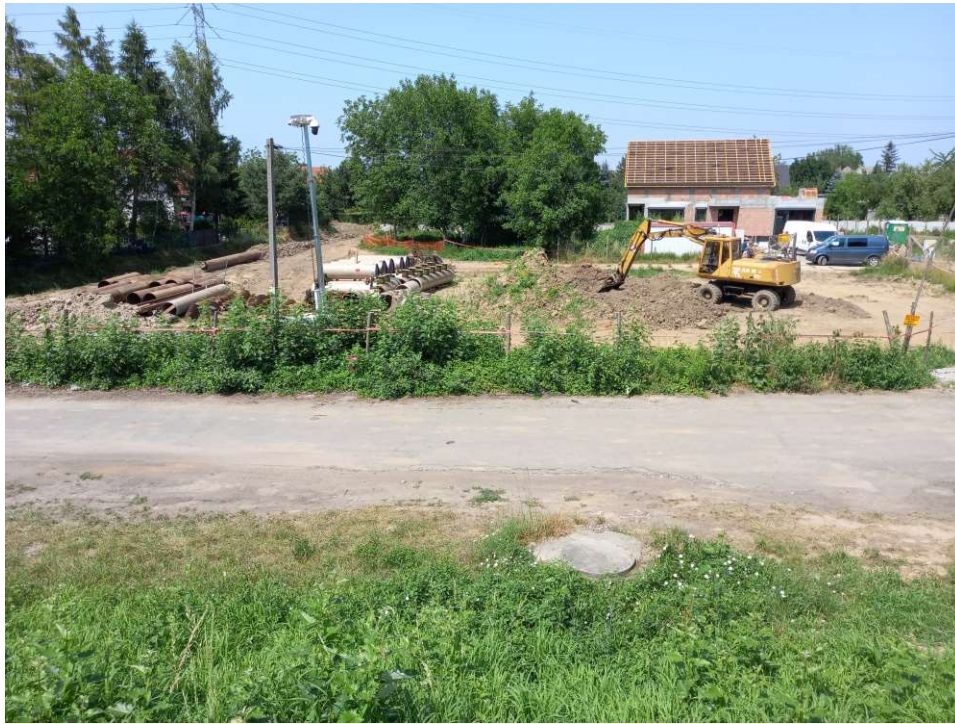
Photo. 21. Fencing off the construction site along Zagłoby Street, status in the third decade of June 2022 (view towards the north).

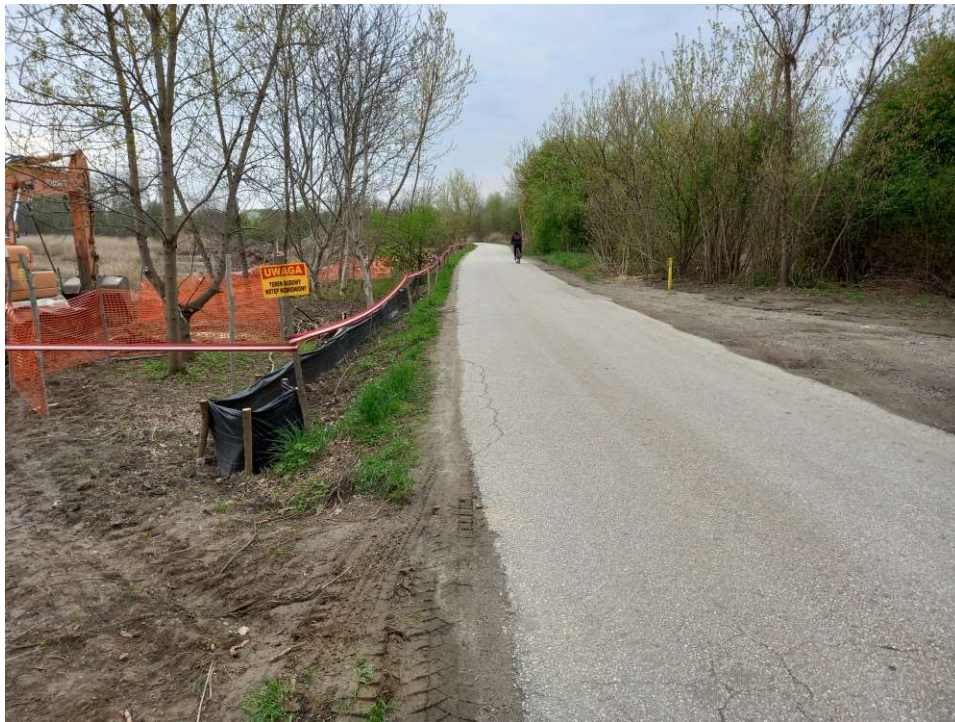
Photo. 22. Fencing off the construction site along Odmętowa Street, status in the third decade of April 2022 (view towards the west).

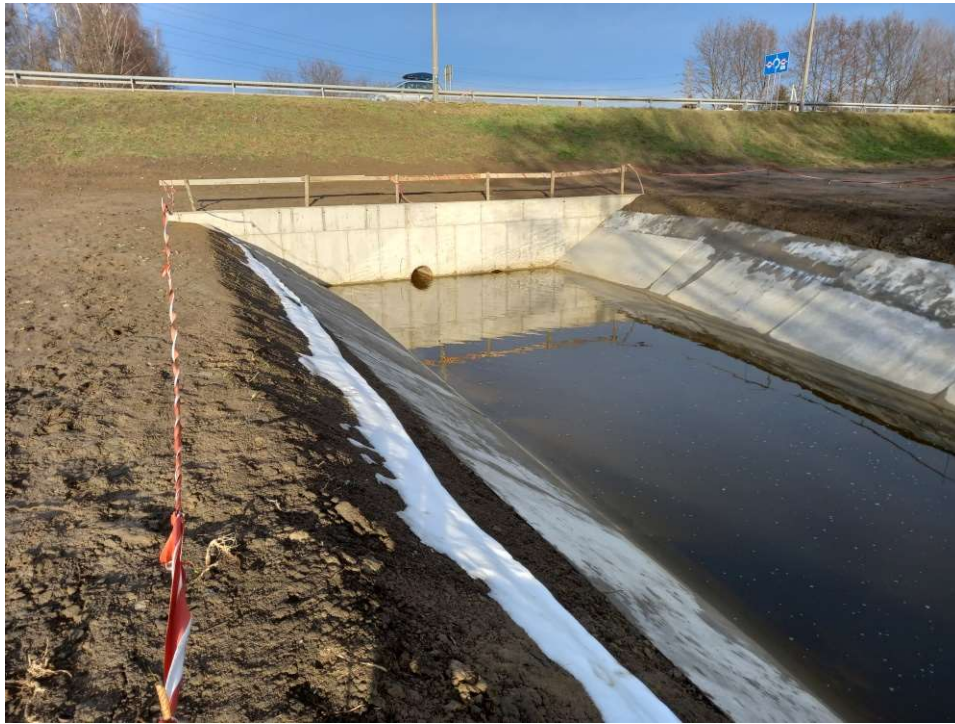
Photo. 23. Protection of hazardous places on the construction site of the embankment sluice at Ditch 2a at the embanked area of the Vistula, status in the third decade of December 2022 (view towards the north).

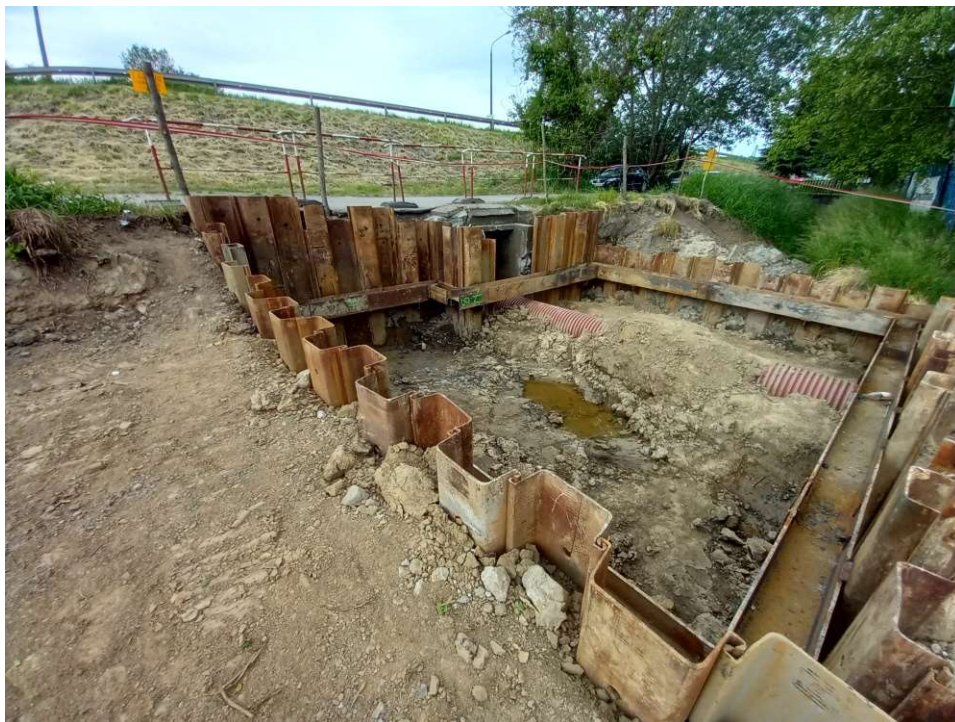
Photo. 24. Protection of hazardous places on the construction site of the embankment sluice at Ditch 2a at the area beyond the embankment of the Vistula River, status in the third decade of July 2022 (view towards the north).

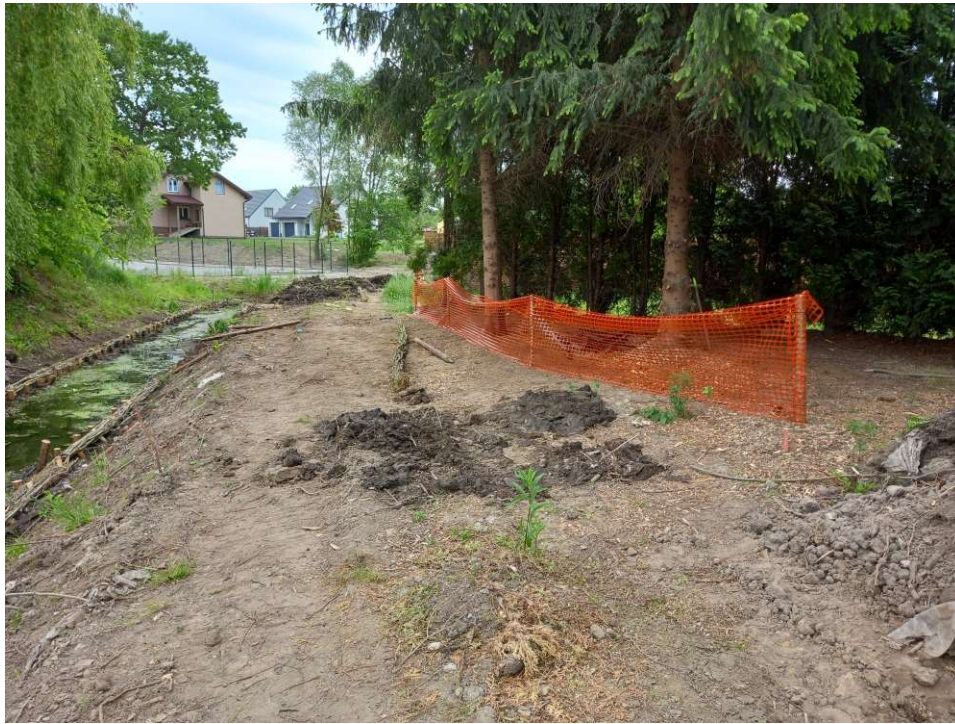
Photo. 25. Protection of trees and bushes not planned for removal in the vicinity of the construction site at Ditch 2, status in the third decade May 2022 (view towards the east).

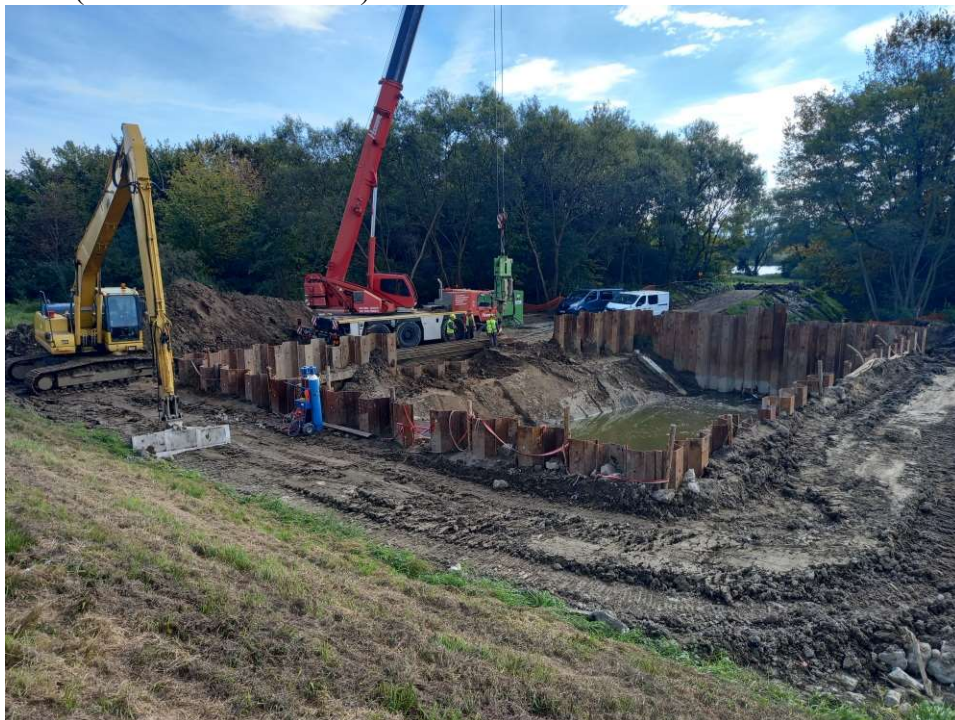
Photo. 26. Larsen works at the downstream station of the embankment sluice at Ditch 2a, status in the third decade of September 2022 (view towards the south).

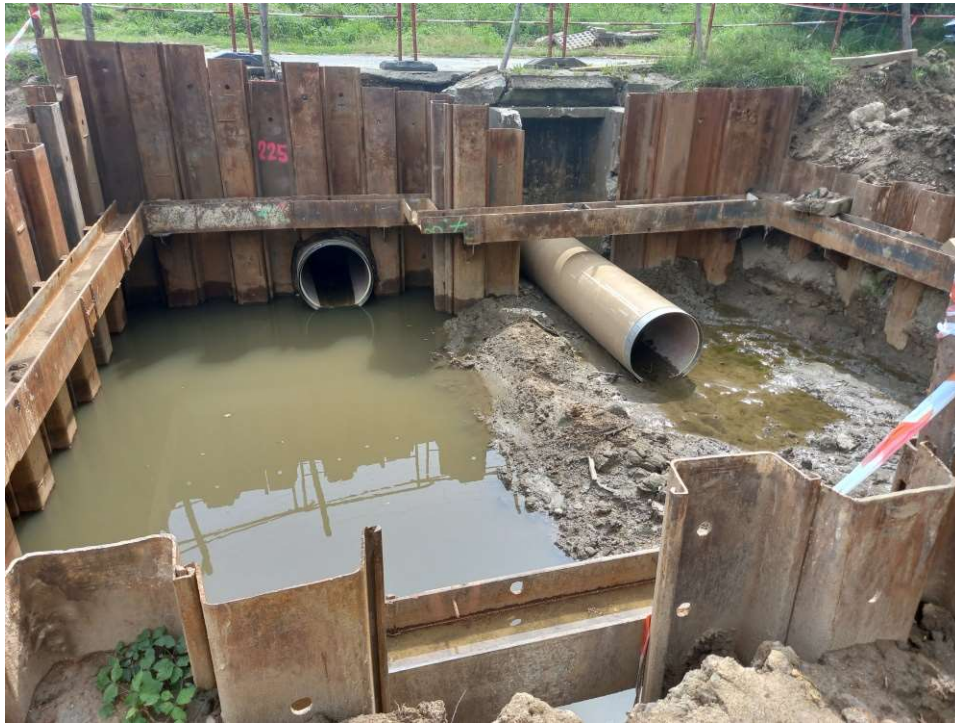
Photo. 27. Reconstructed gravity pipeline (on the right) and new pressure pipeline (on the left) at the embankment sluice construction site at Ditch 2a, status in the third decade of July 2022 (view towards the south).

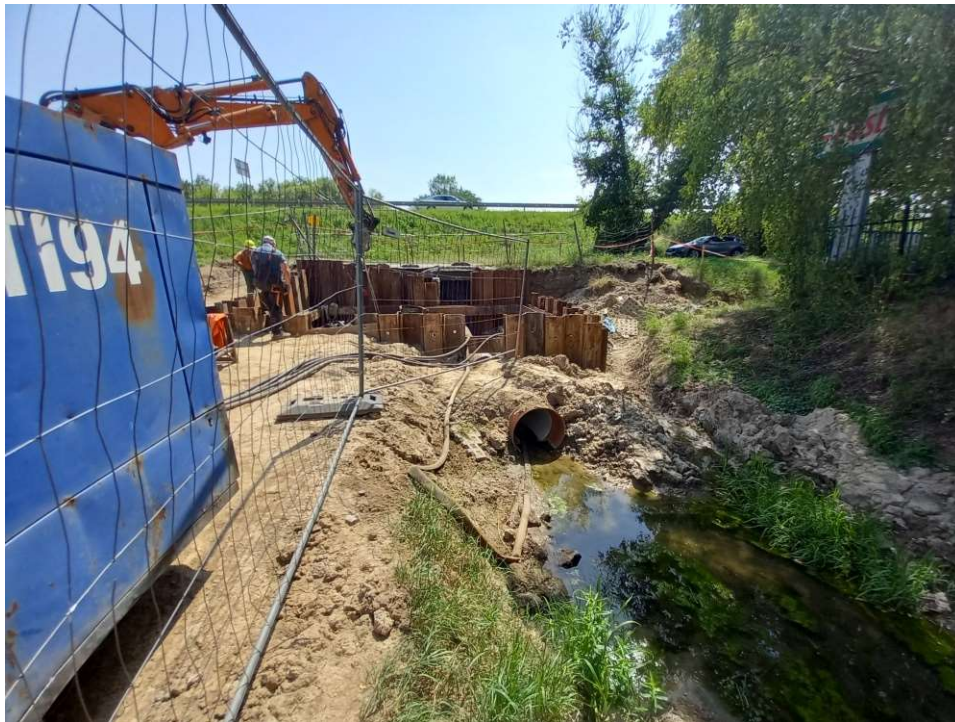
Photo. 28. Ensuring that the Ditch 2a remains unobstructed over the period of works at the embankment sluice, status in the third decade of June 2022 (view towards the south).

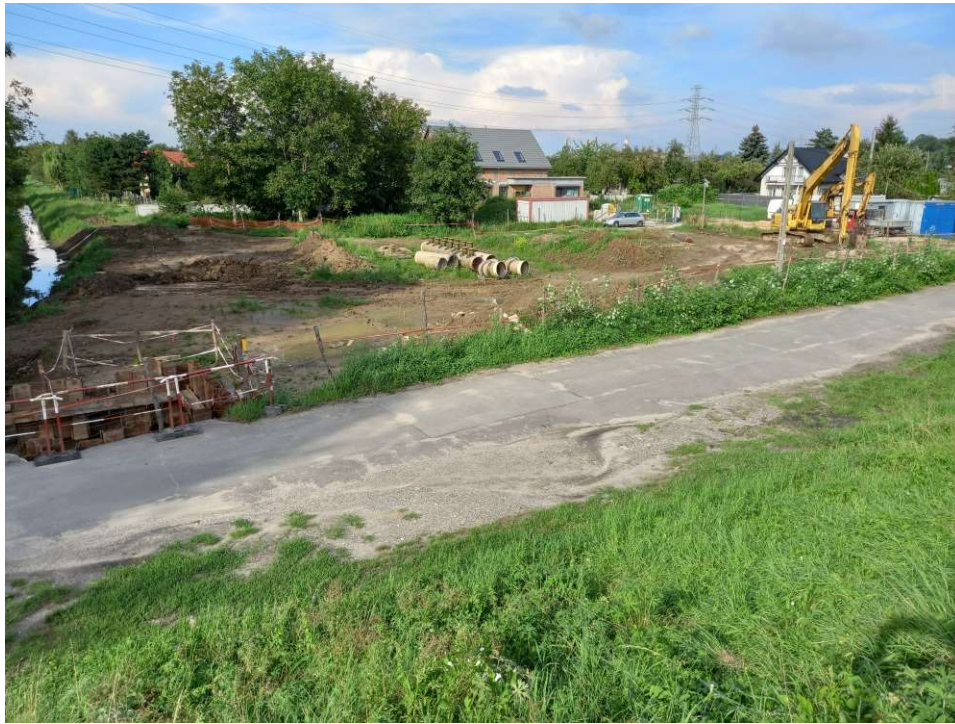
Photo. 29. Earthworks when building a storage reservoir at Ditch 2a, status in the third decade of August 2022 (view towards the north).
