Appendix no. 6 to the Final Report on Implementation of the Land Acquisition and Resettlement Action Plan (LARAP) for Contract 3A.6 titled *Construction of a pumping station for mobile pumps to drain the Lesisko complex.*

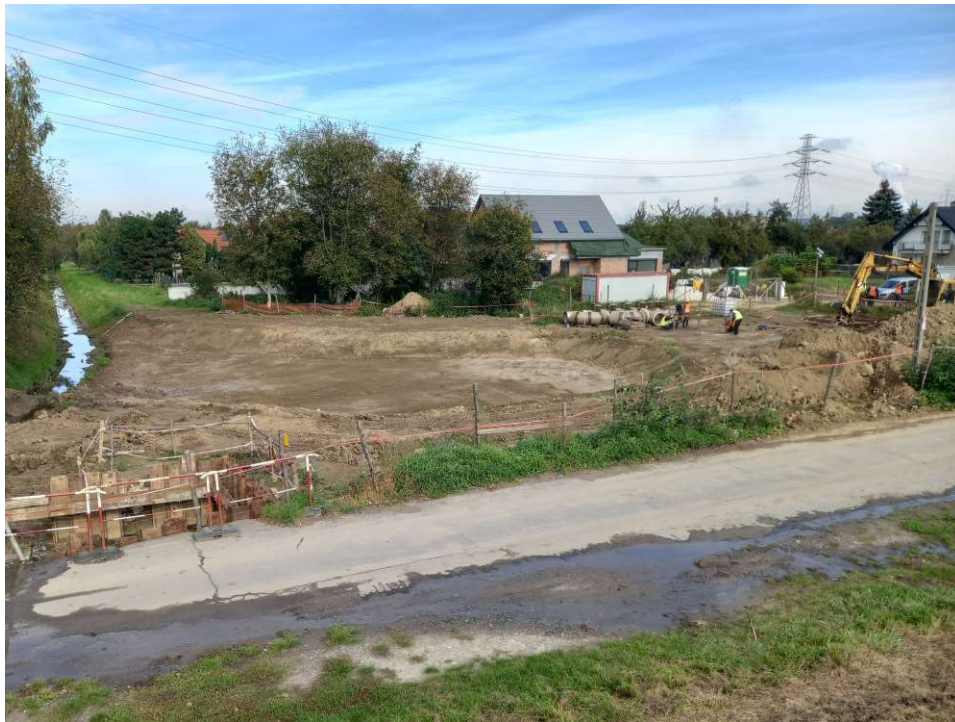
Photo. 30. Forming of slopes of the storage reservoir at Ditch 2a, status in the third decade of September 2022 (view towards the north).

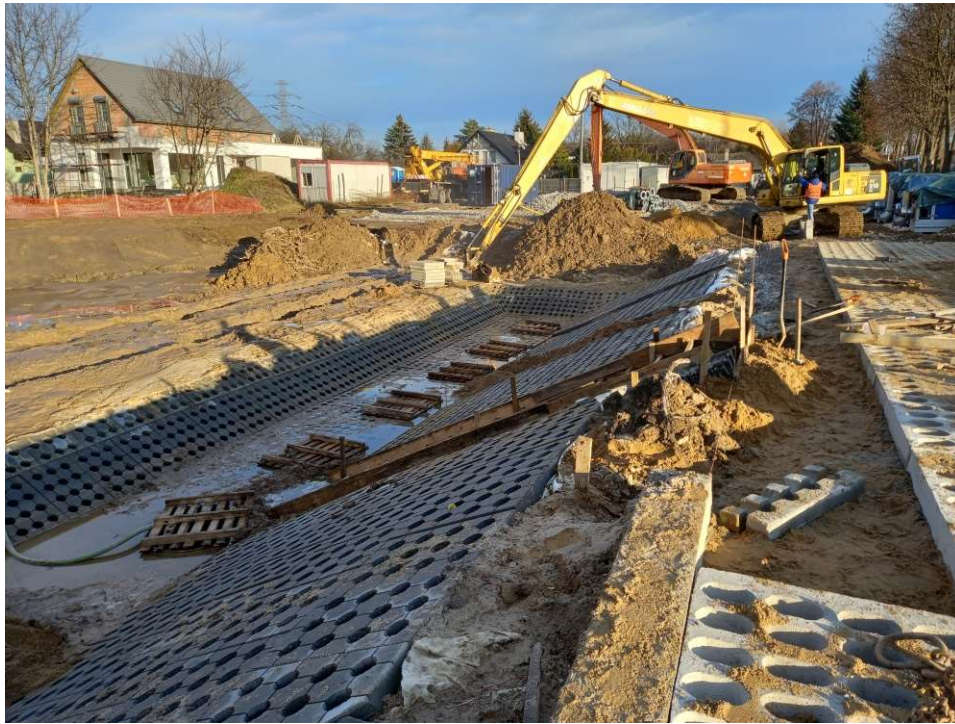
Photo. 31. Construction of a station for mobile pumps at Ditch 2a, status in the third decade of December 2022 (view towards the east).

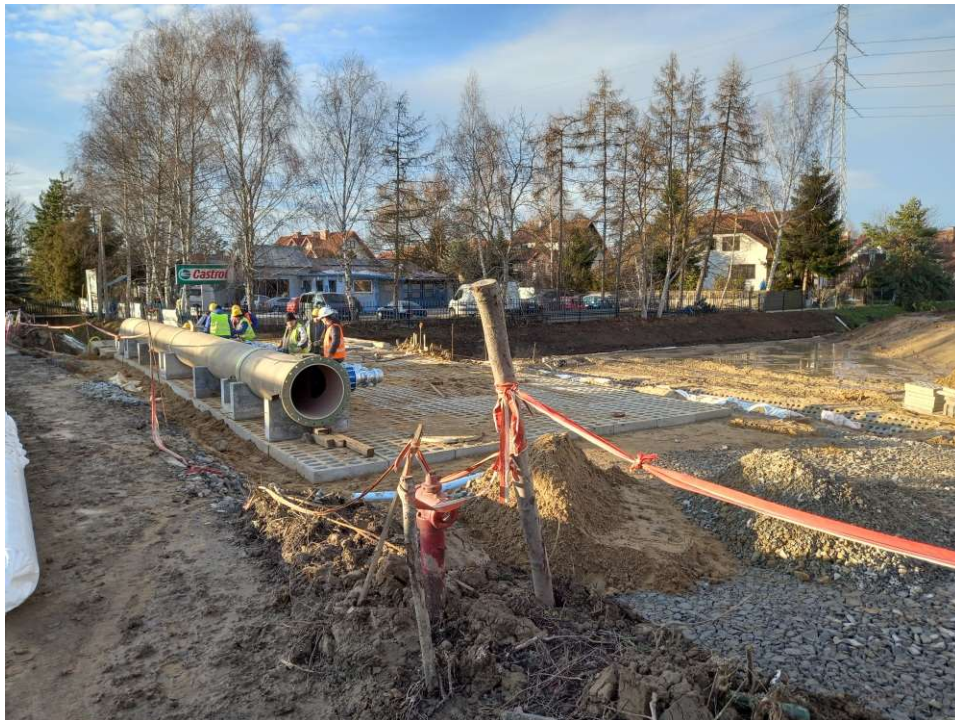
Photo. 32. Construction of a station for mobile pumps at Ditch 2a, status in the third decade of December 2022 (view towards the west).

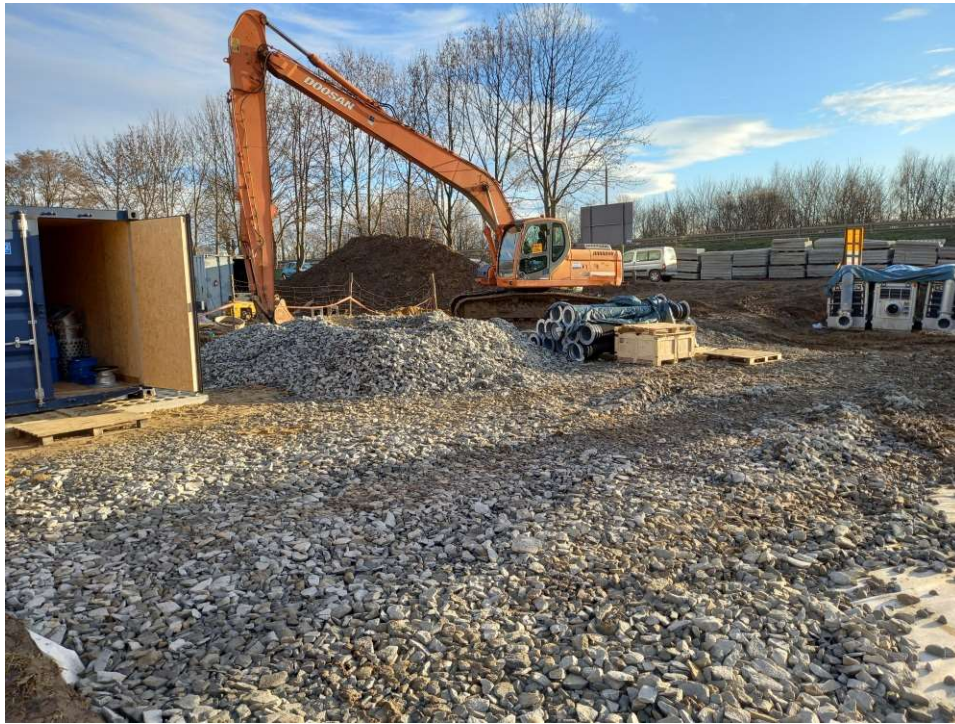
Photo. 33. Construction of manoeuvring yard at the station of mobile pumps at Ditch 2a, status in the third decade of December 2022 (view towards the south-east).

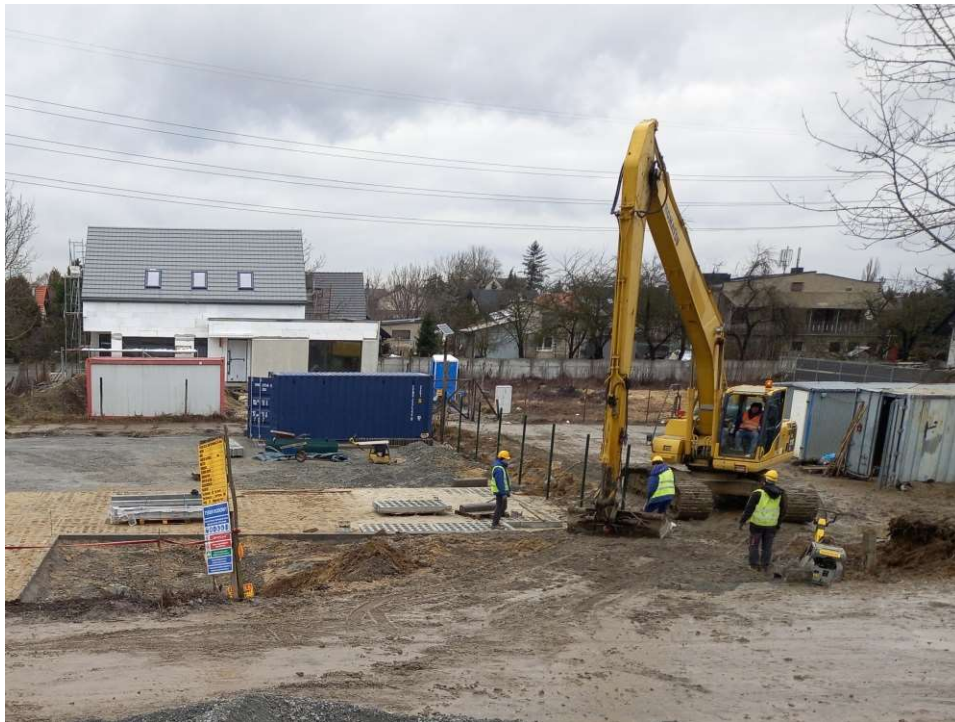
Photo. 34. Land reclamation in the surrounding of the manoeuvring yard and the station of mobile pumps at Ditch 2a, status in the third decade of January 2023 (view towards the north).

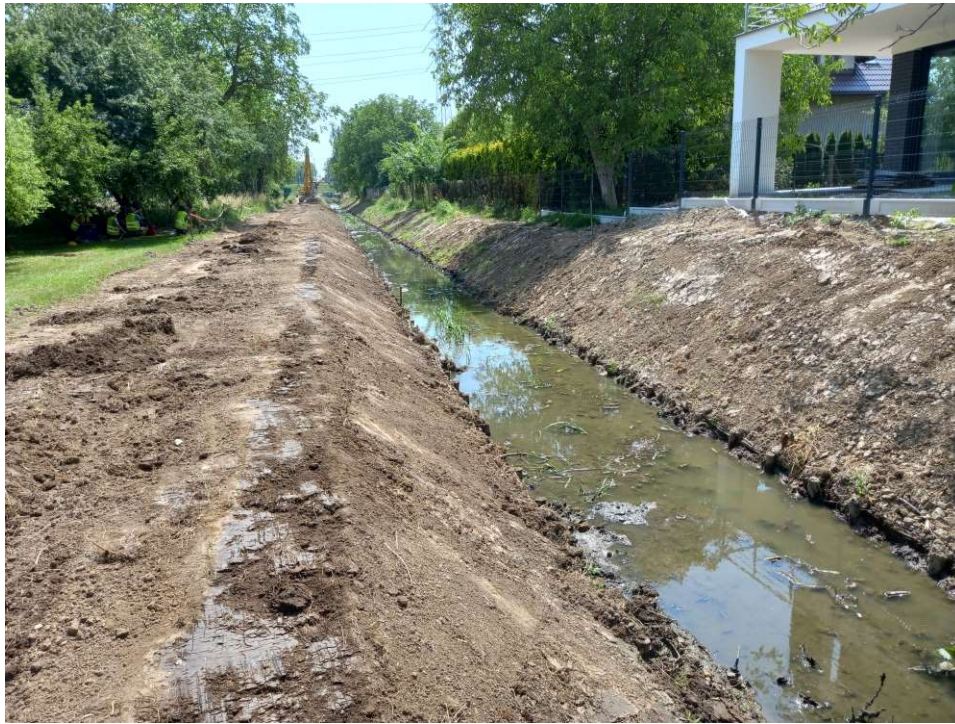
Photo. 35. Forming of bank slopes at Ditch 2a, status in the third decade of June 2022 (view towards the south).

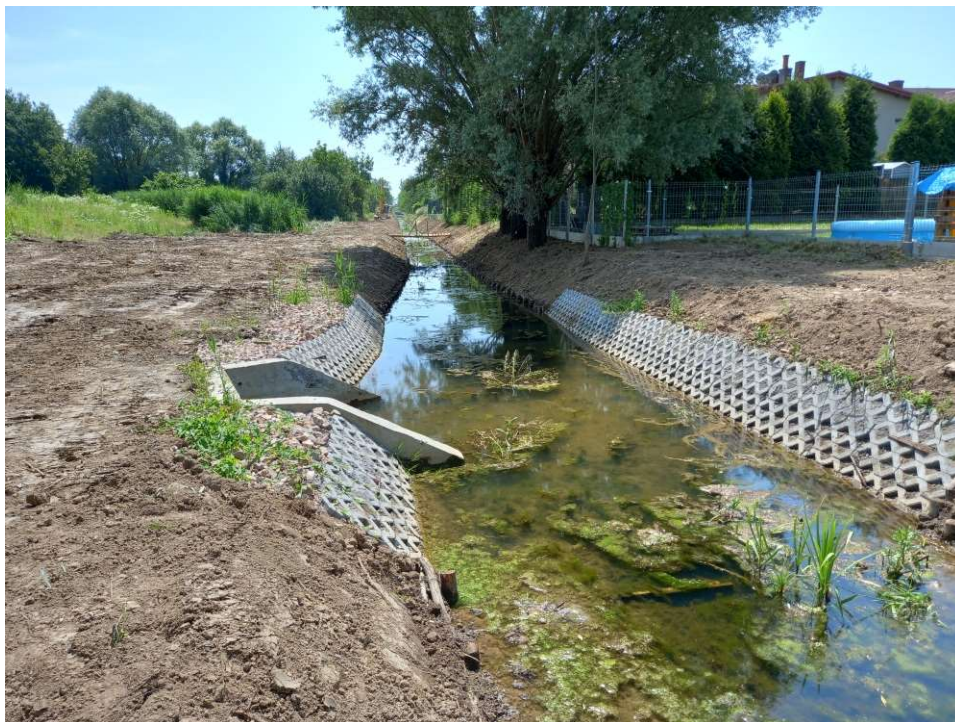
Photo. 36. Revetment of slope banks at Ditch 2a, status in the third decade of September 2022 (view towards the south).

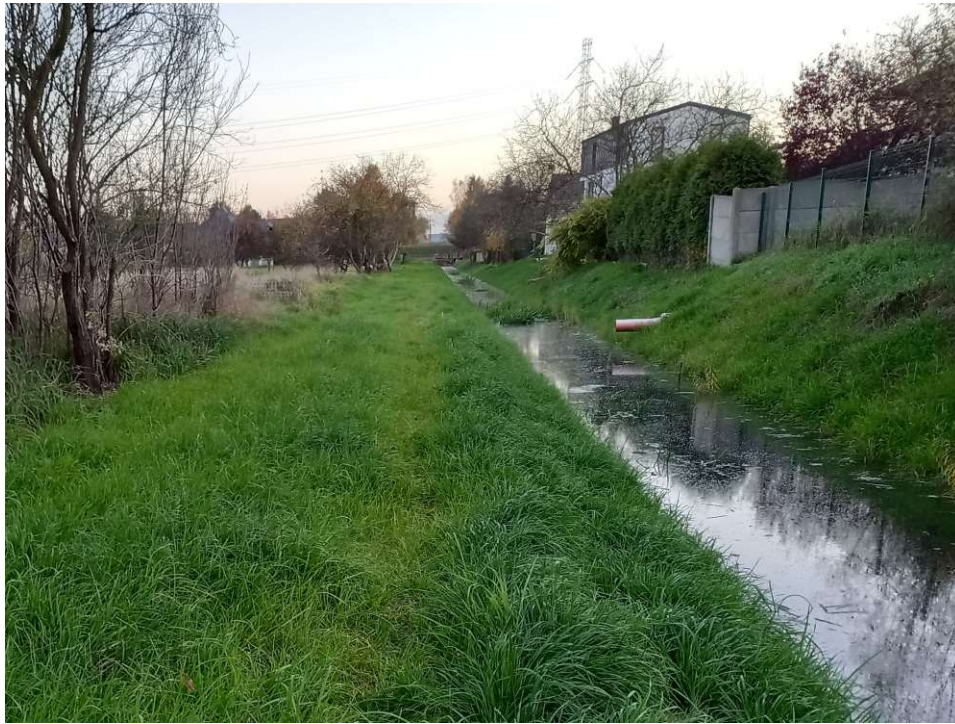
Photo. 37. Growth of grass on bank slopes at Ditch 2a after finishing the works at this section, (view towards the south).

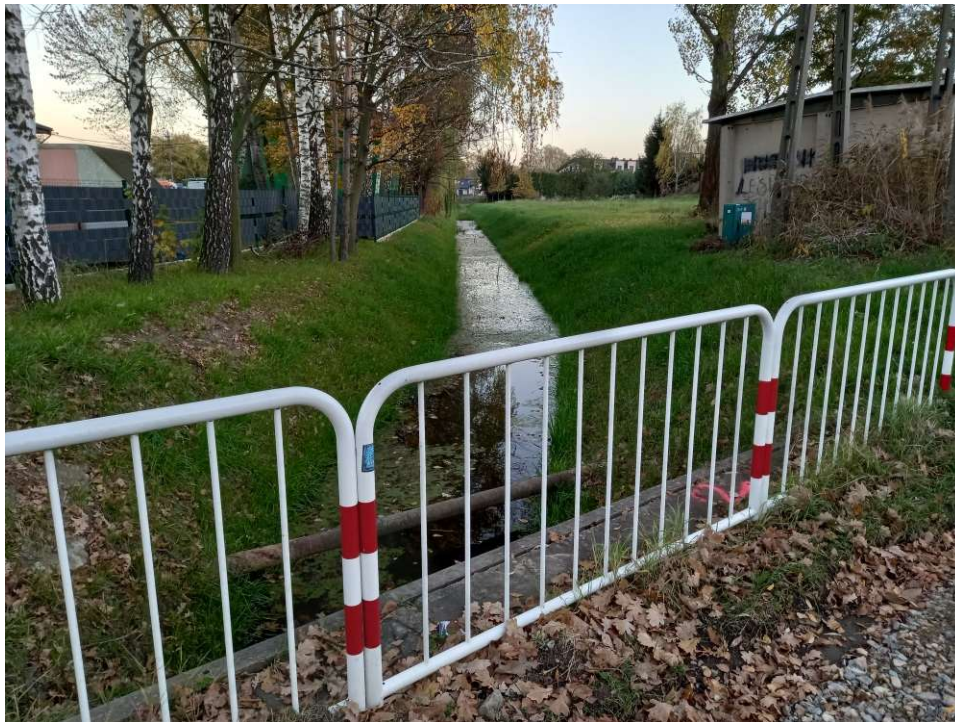
Photo. 38. Growth of grass on bank slopes at Ditch 2 after finishing the works at this section, (view towards the east).

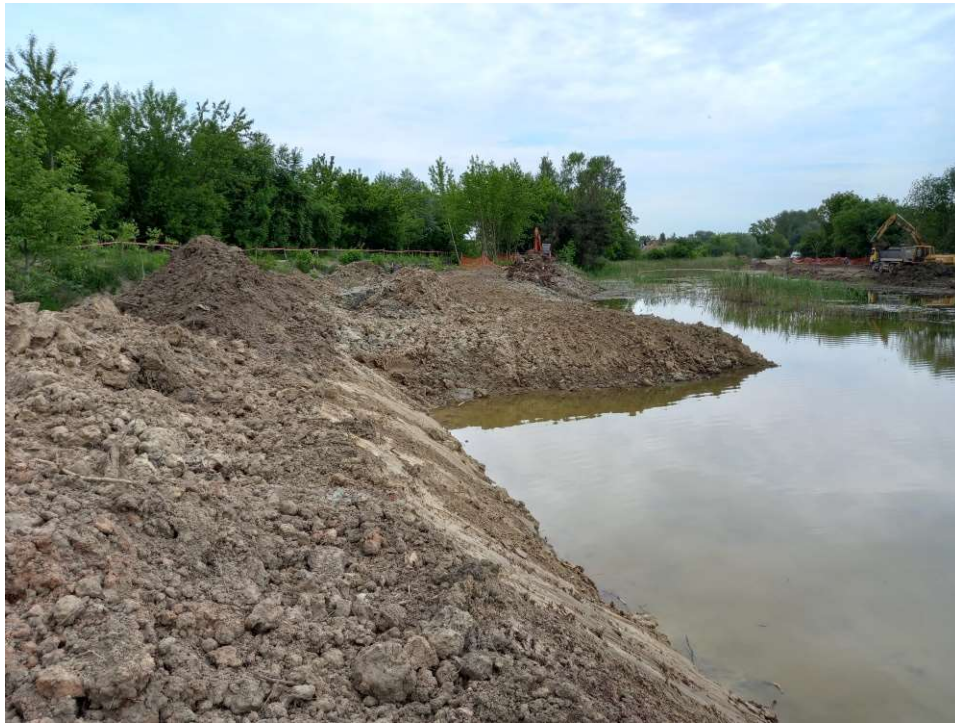
Photo. 39. Earthworks on the north bank of the enlarged reservoir at Ditch 2, status in the third decade of May 2022 (view towards the east).

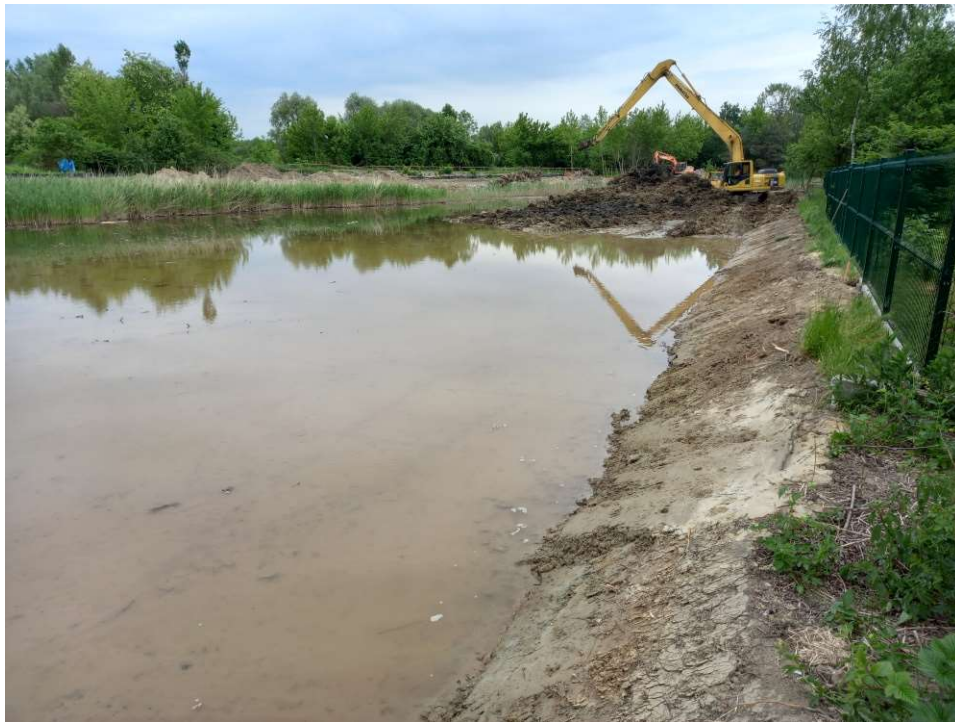
Photo. 40. Earthworks on the south bank of the enlarged reservoir at Ditch 2, status in the third decade of May 2022 (view towards the east).

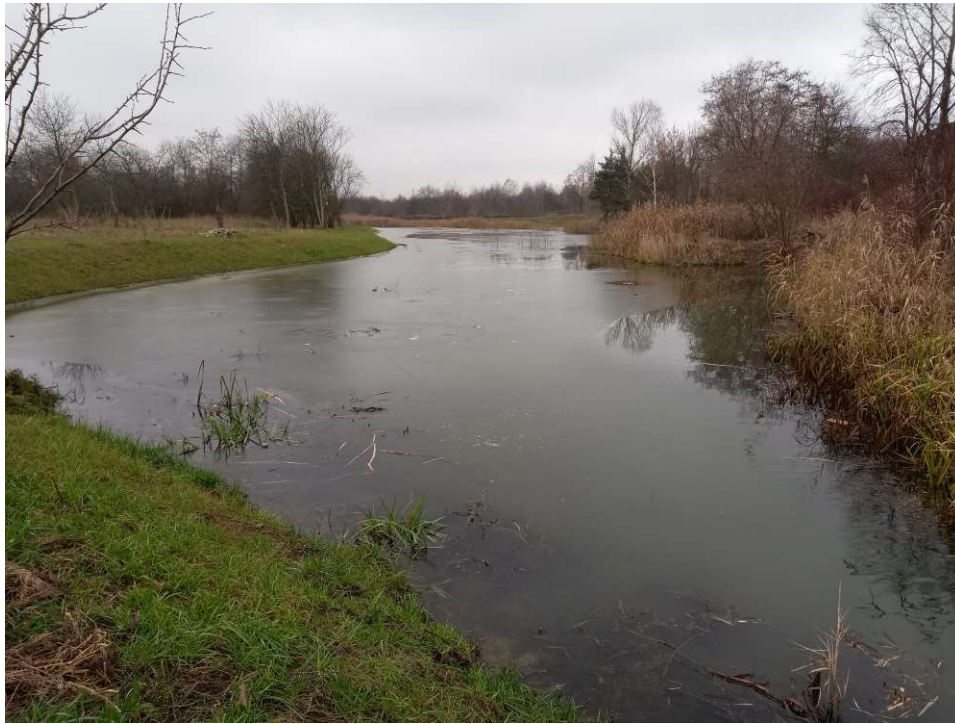
Photo. 41. Vegetation regeneration in the lower part of the enlarged reservoir at Ditch 2, status in the third decade of November 2022 (view towards the west).

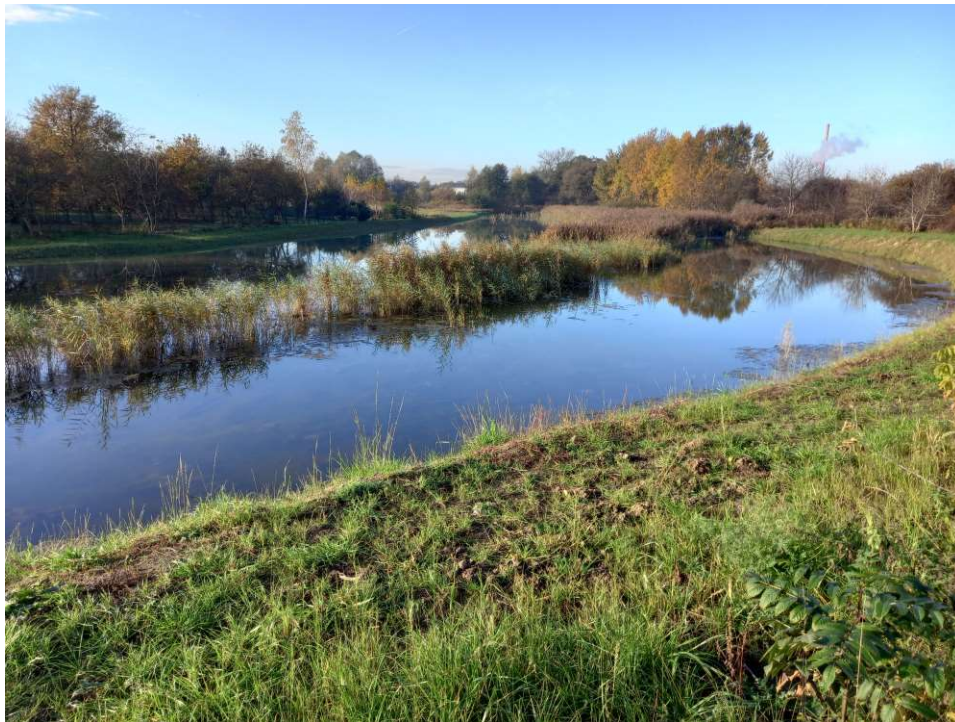
Photo. 42. Vegetation regeneration in the upper part of the enlarged reservoir at Ditch 2, status in the third decade of October 2022 (view towards the west).

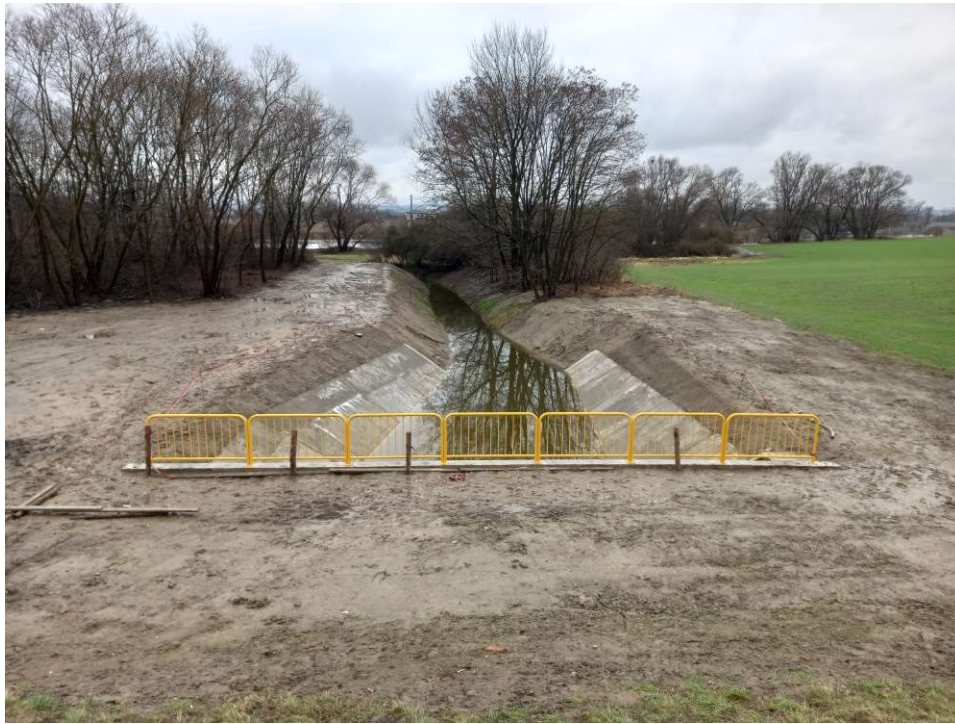
Photo. 43. Condition of the construction site in the last month of the execution of works – construction site of the embankment sluice at Ditch 2a from the side of the embanked area of the Vistula, status in the third decade of January 2023 (view towards the south).

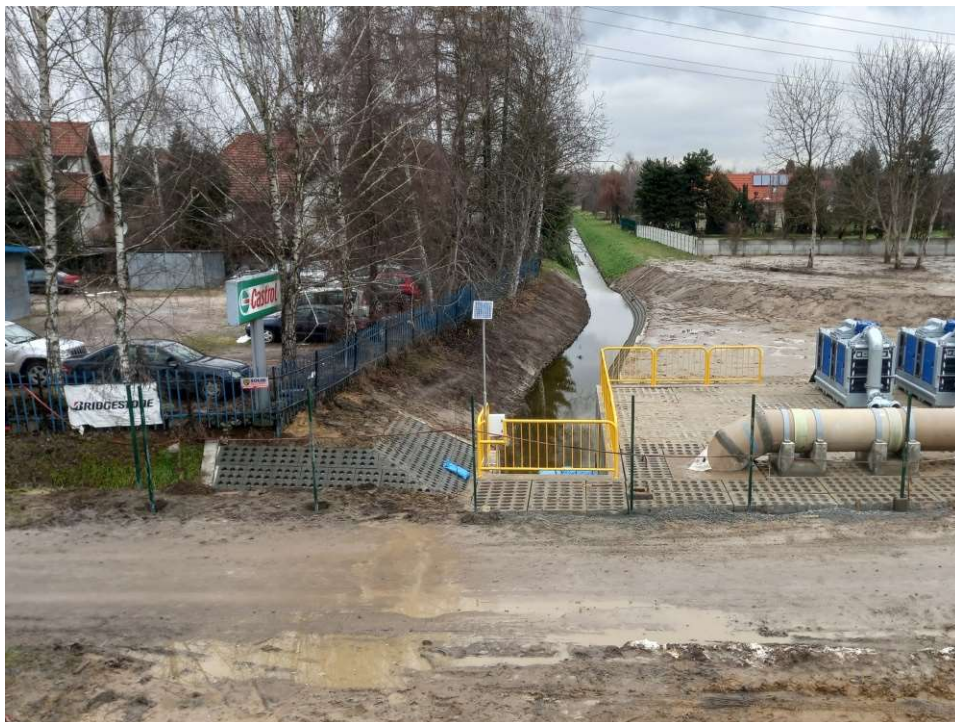
Photo. 44. Condition of the construction site in the last month of the execution of works – construction site of the embankment sluice at Ditch 2a from the side of the area beyond the embankment of the Vistula, status in the third decade of January 2023 (view towards the north).

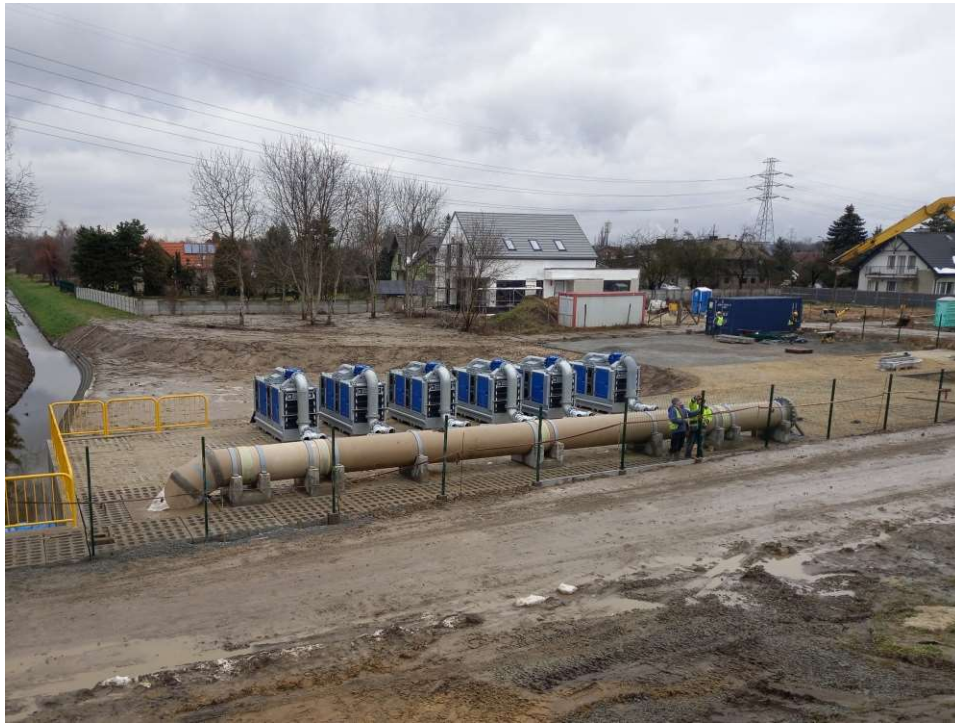
Photo. 45. Condition of the construction site in the last month of the execution of works – construction site of the pumping station for mobile pumps and the storage reservoir upstream of the embankment sluice, status in the third decade of January 2023 (view towards the north).

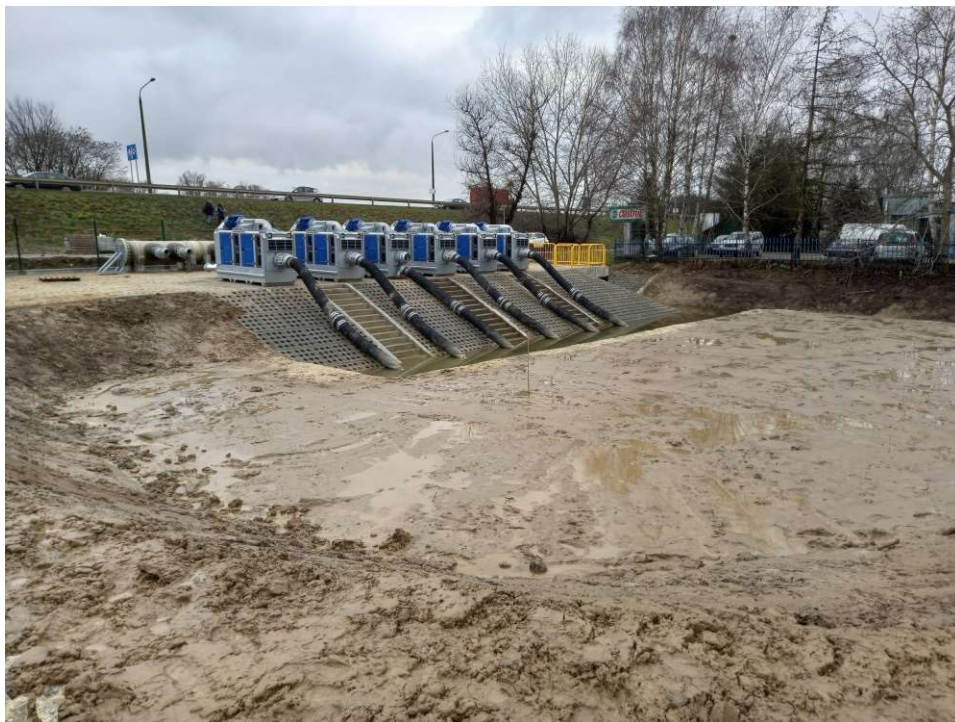
Photo. 46. Condition of the construction site in the last month of the execution of works – construction site of the storage reservoir upstream of the embankment sluice and of the pumping station for mobile pumps, status in the third decade of January 2023 (view towards the south).

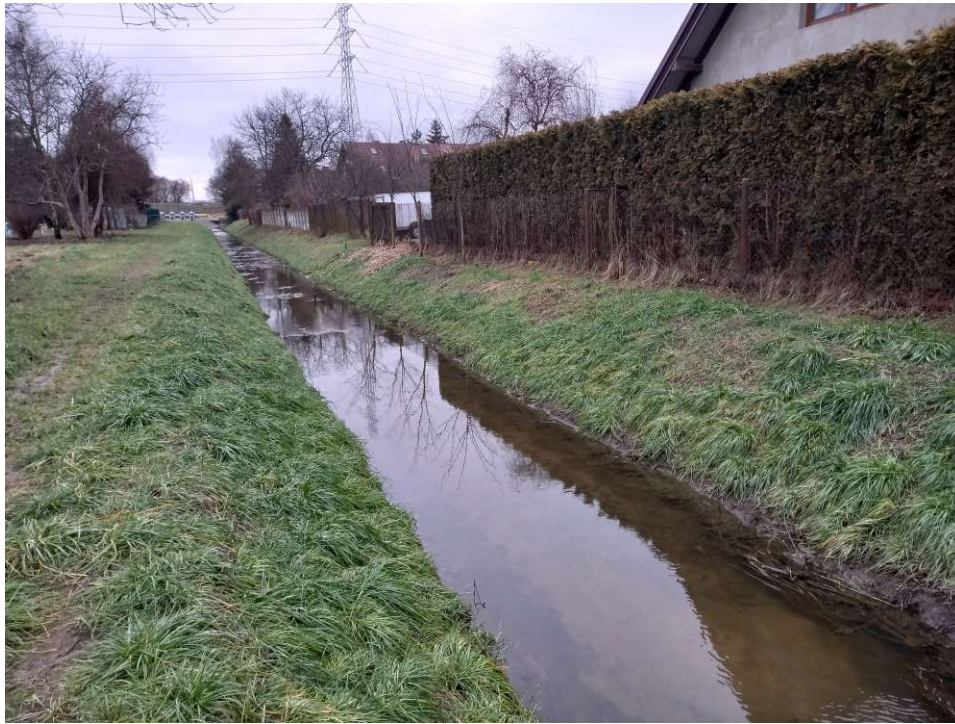
Photo. 47. Condition of the construction site in the last month of the execution of works – the reconstructed section of Ditch 2a – the lower part, status in the third decade of January 2023 (view towards the south).

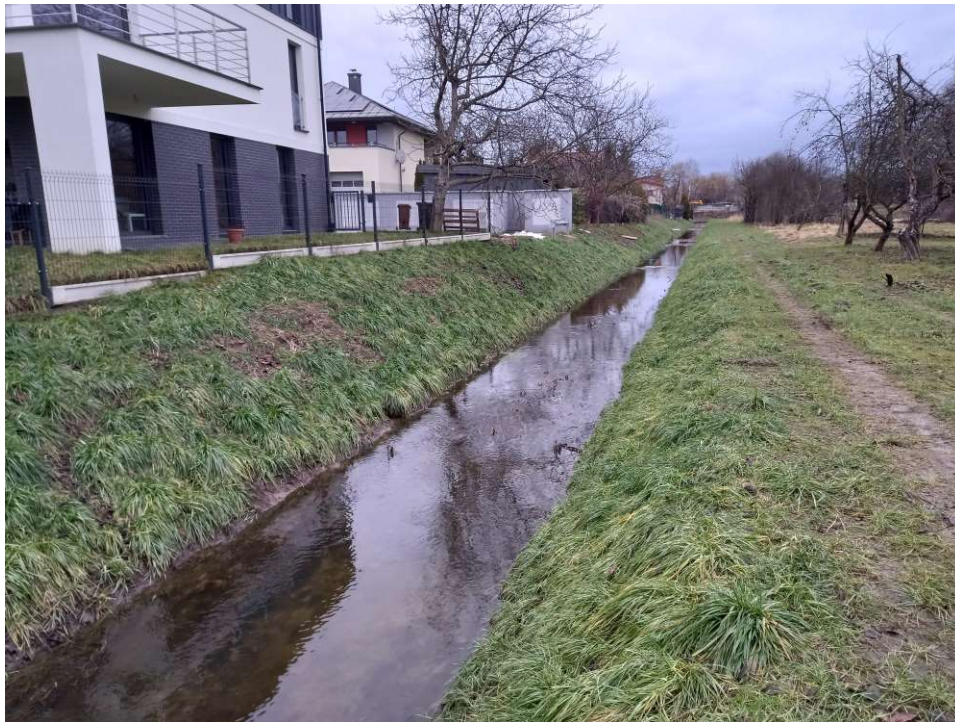
Photo. 48. Condition of the construction site in the last month of the execution of works – the reconstructed section of Ditch 2a – upper part, status in the third decade of January 2023 (view towards the north).

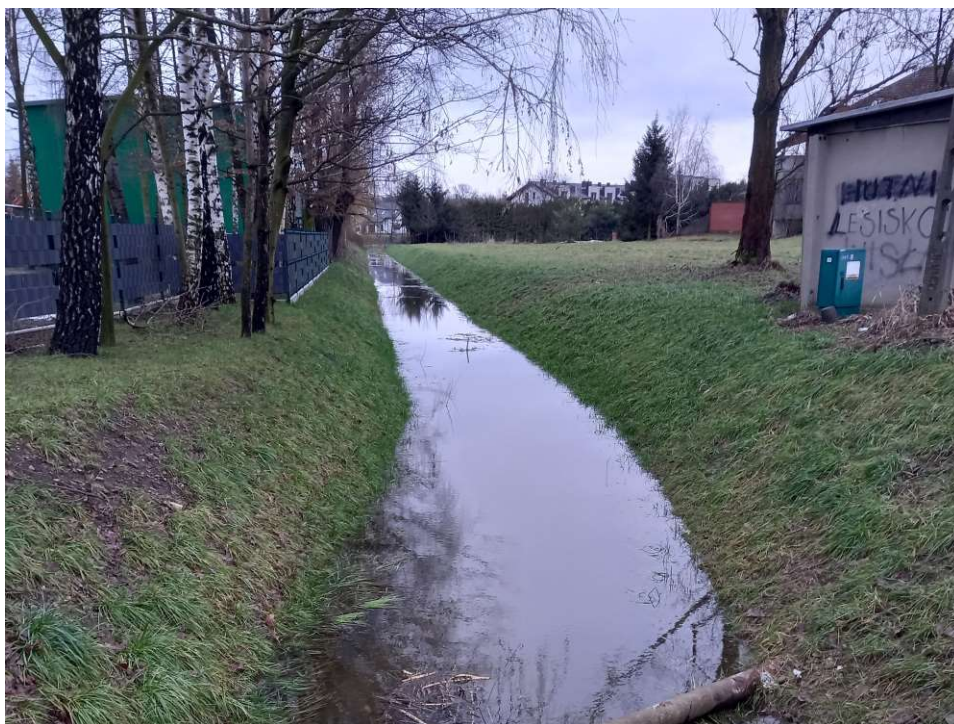
Photo. 49. Condition of the construction site in the last month of the execution of works – the reconstructed section of Ditch 2 – lower part, status in the third decade of January 2023 (view towards the east).

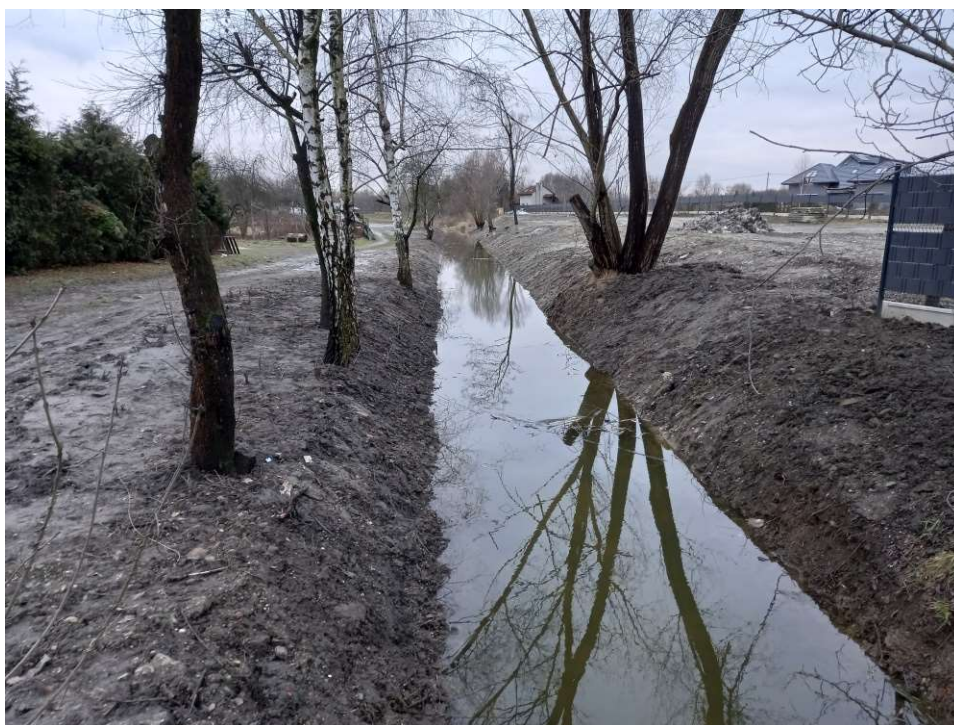
Photo. 50. Condition of the construction site in the last month of the execution of works – the reconstructed section of Ditch 2 – upper part, status in the third decade of January 2023 (view towards the west).

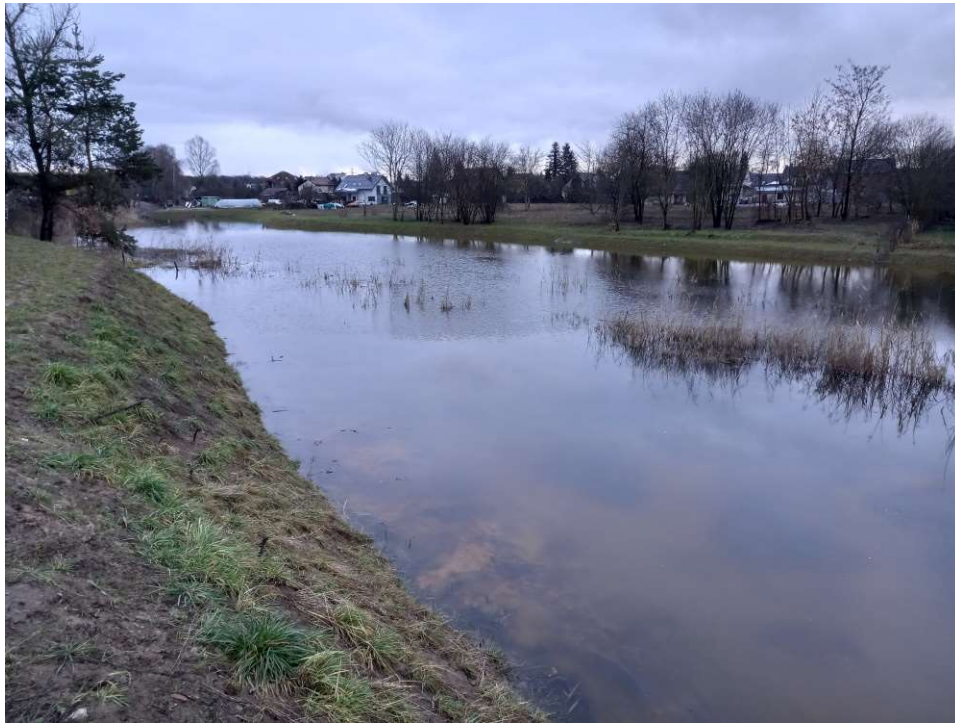
Photo. 51. Condition of the construction site in the last month of the execution of works – the reconstructed reservoir at Ditch 2, eastern part, status in the third decade of January 2023 (view towards the east).

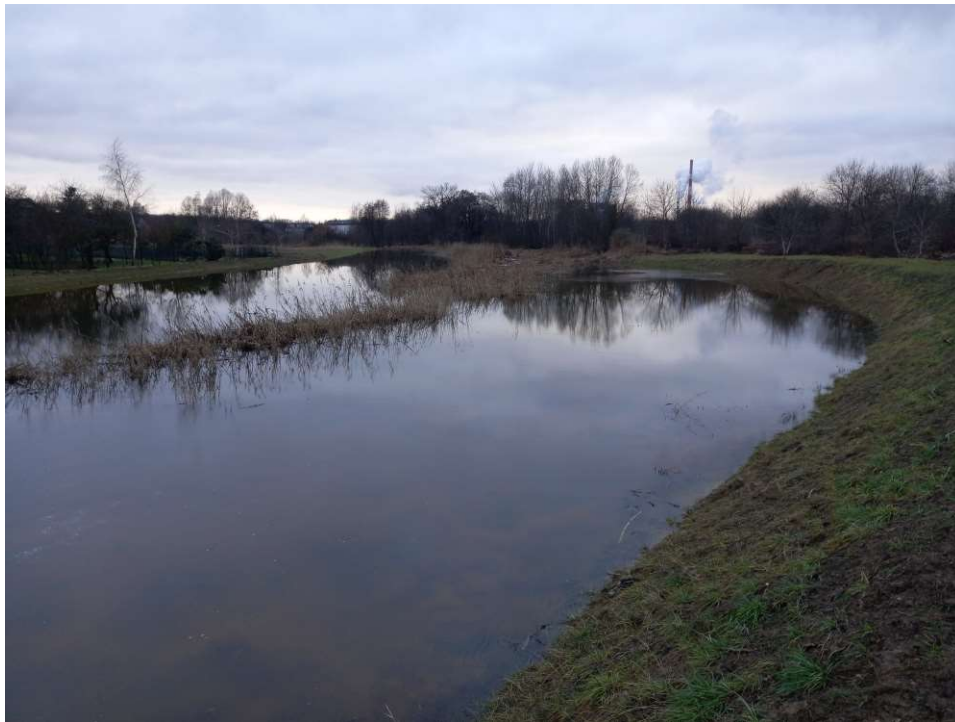
Photo. 52. Condition of the construction site in the last month of the execution of works – the reconstructed reservoir at Ditch 2, western part, status in the third decade of January 2023 (view towards the west).
